**ALLENBY ROAD**  
**SLOPE HAZARD OVERVIEW ASSESSMENT**

**McQuarrie Geotechnical Consultants Ltd.**

Cowichan Valley Regional District  
&  
Cowichan Tribes

March 27, 2019  
Project #17-5

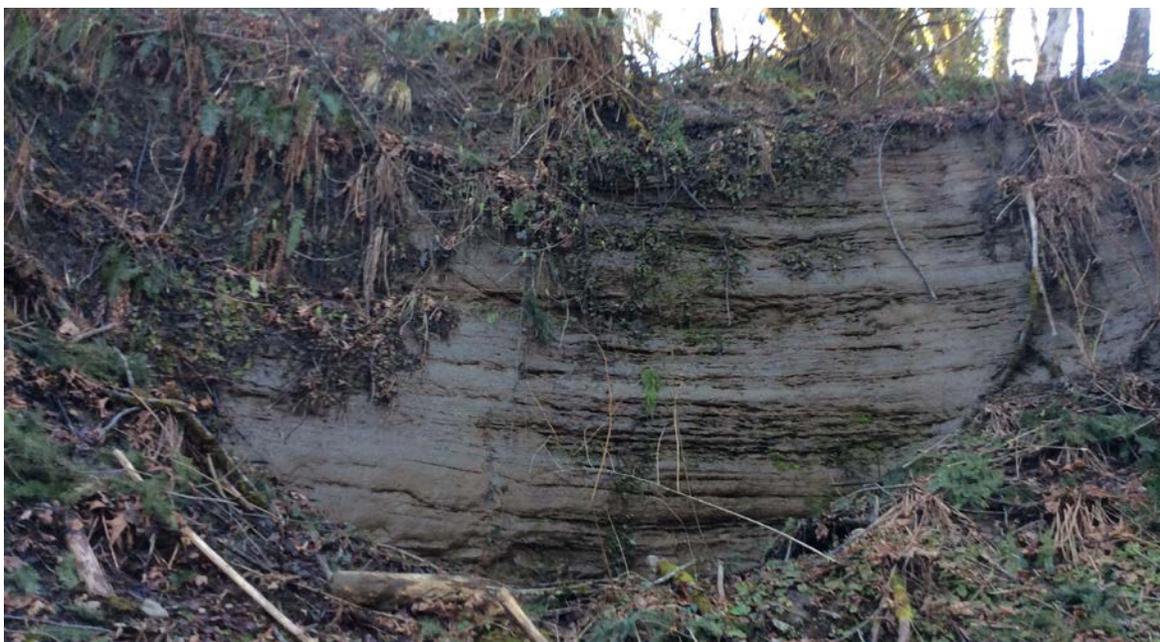
The glaciofluvial sand and gravel overlies sandy silt or silty fine-grained sand, mapped as part of the Quadra Formation, which is an interglacial unit deposited between the last two ice ages. In the field, this unit is found to be varved with thin seams of silt and fine sand (Photo 1). The deposit has been glacially over-riden and is typically very dense with a very low permeability. Past landslides on this slope generally appear to have initiated along the top of this unit where groundwater discharges.

*Photo 1: Varved silt and fine sand exposed in a landslide on 5451 Allenby Road.*

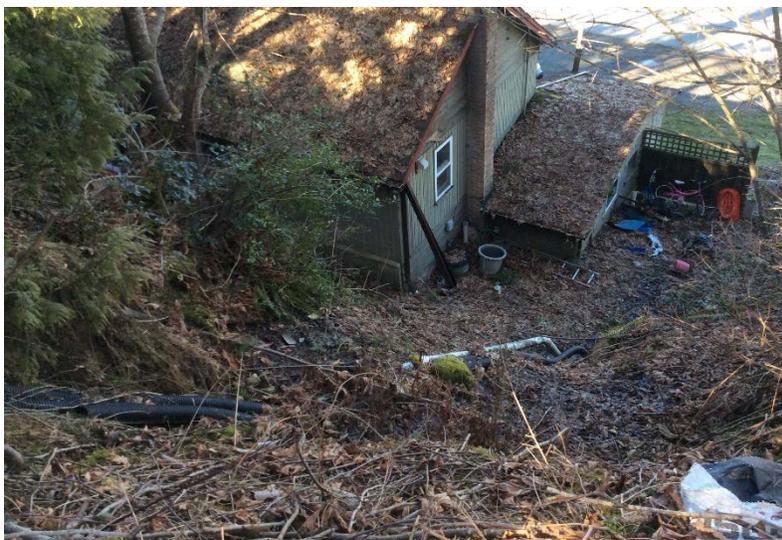
Groundwater discharge was also noted from the slope behind 2960 Allenby Road, where several Big 'O' pipes lead down the slope immediately behind the small house. The ground surface at the crest of this slope is poorly drained, indicating that the groundwater discharges from the upper slope.

*Photo 2 : Big 'O' pipes draining down next to 2960 Allenby Road.*

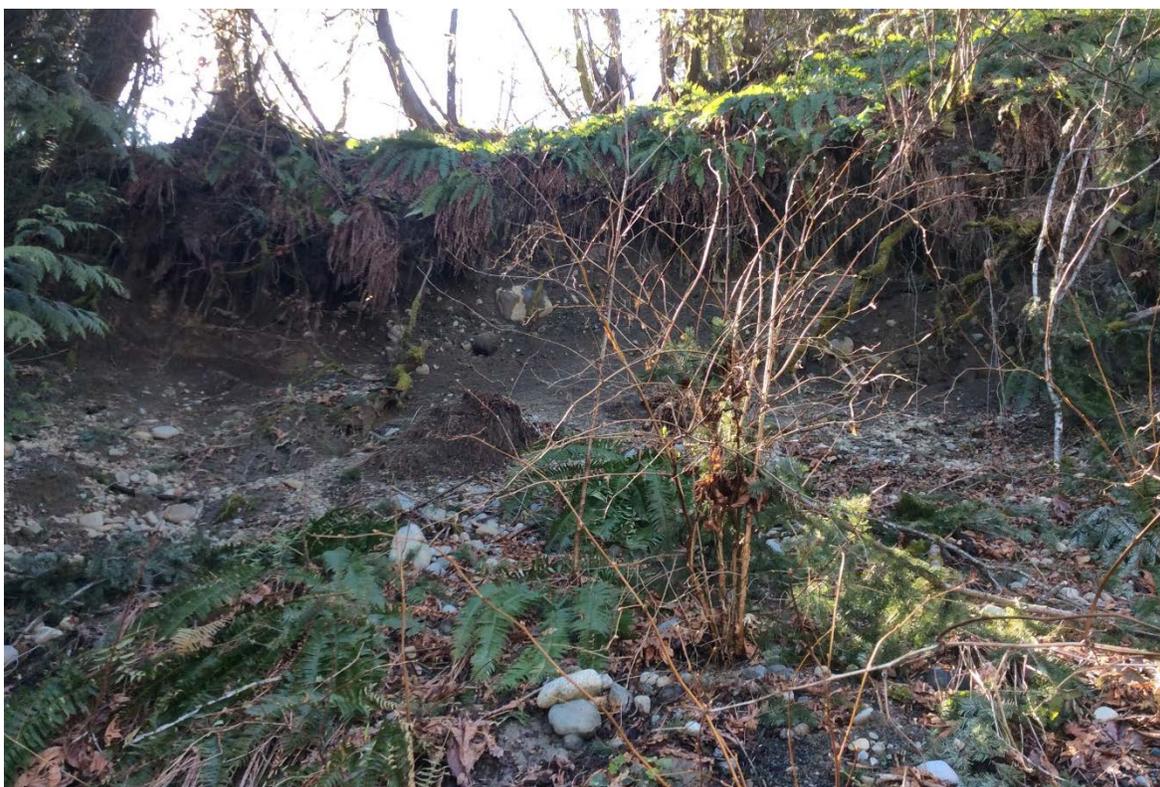
The slope is prone to frequent small-scale failures from the nearly vertical exposures of Quadra silts and the over-steepened gully headwalls. Larger debris slides tend to initiate in the overlying glaciofluvial sand and gravel. At least six debris slide headscarps were noted during the field reconnaissance, each 10 to 15 m wide and readily discernible suggesting that they occurred within the last 10 to 20 years (Photo 3). Several older landslide scars are less discernible by vegetation and timber but could be delineated based on the surface form.

*Photo 3: One of several landslide headscarps.*

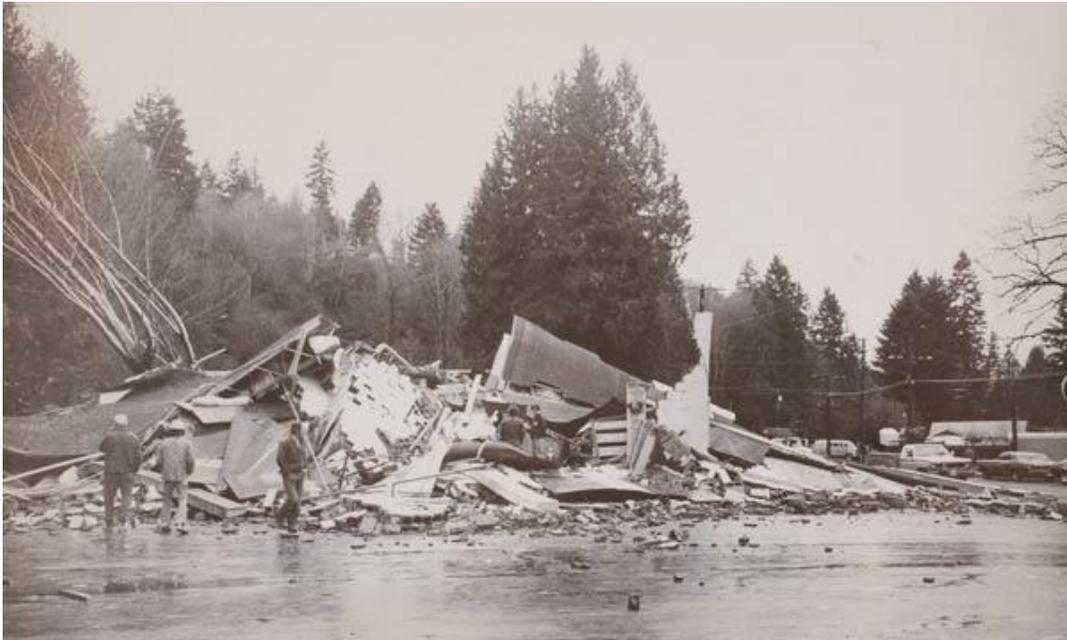
A large landslide reportedly occurred on December 3, 1975, destroying the Windsor Plywood building on Allenby Road (Photo 4). The property is assumed to have been at 3030 Allenby Road but may have been on 3050 Allenby Road. The landslide is no longer discernible but both slopes have been disturbed by past instability and are now forested with deciduous trees such as alder (Photo 5).

*Photo 4: 1975 Landslide at Windsor Plywood (photo from Cowichan Valley Museum & Archives).*

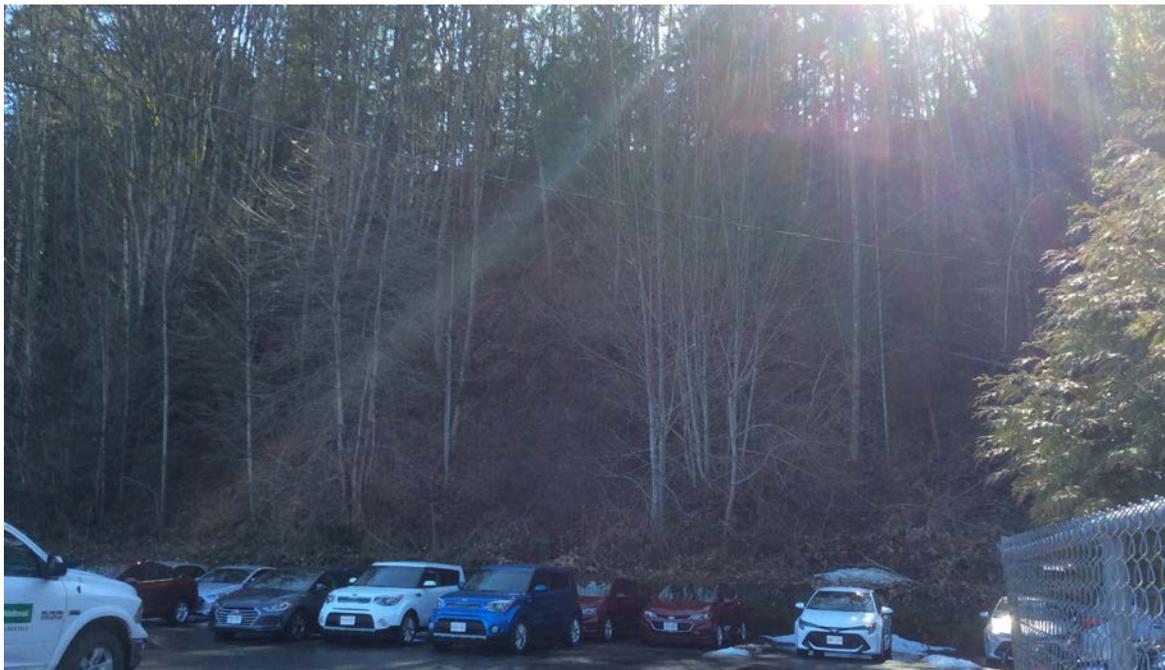
*Photo 5: Slope above 3050 Allenby Road forested with alder instead of fir or cedar.*

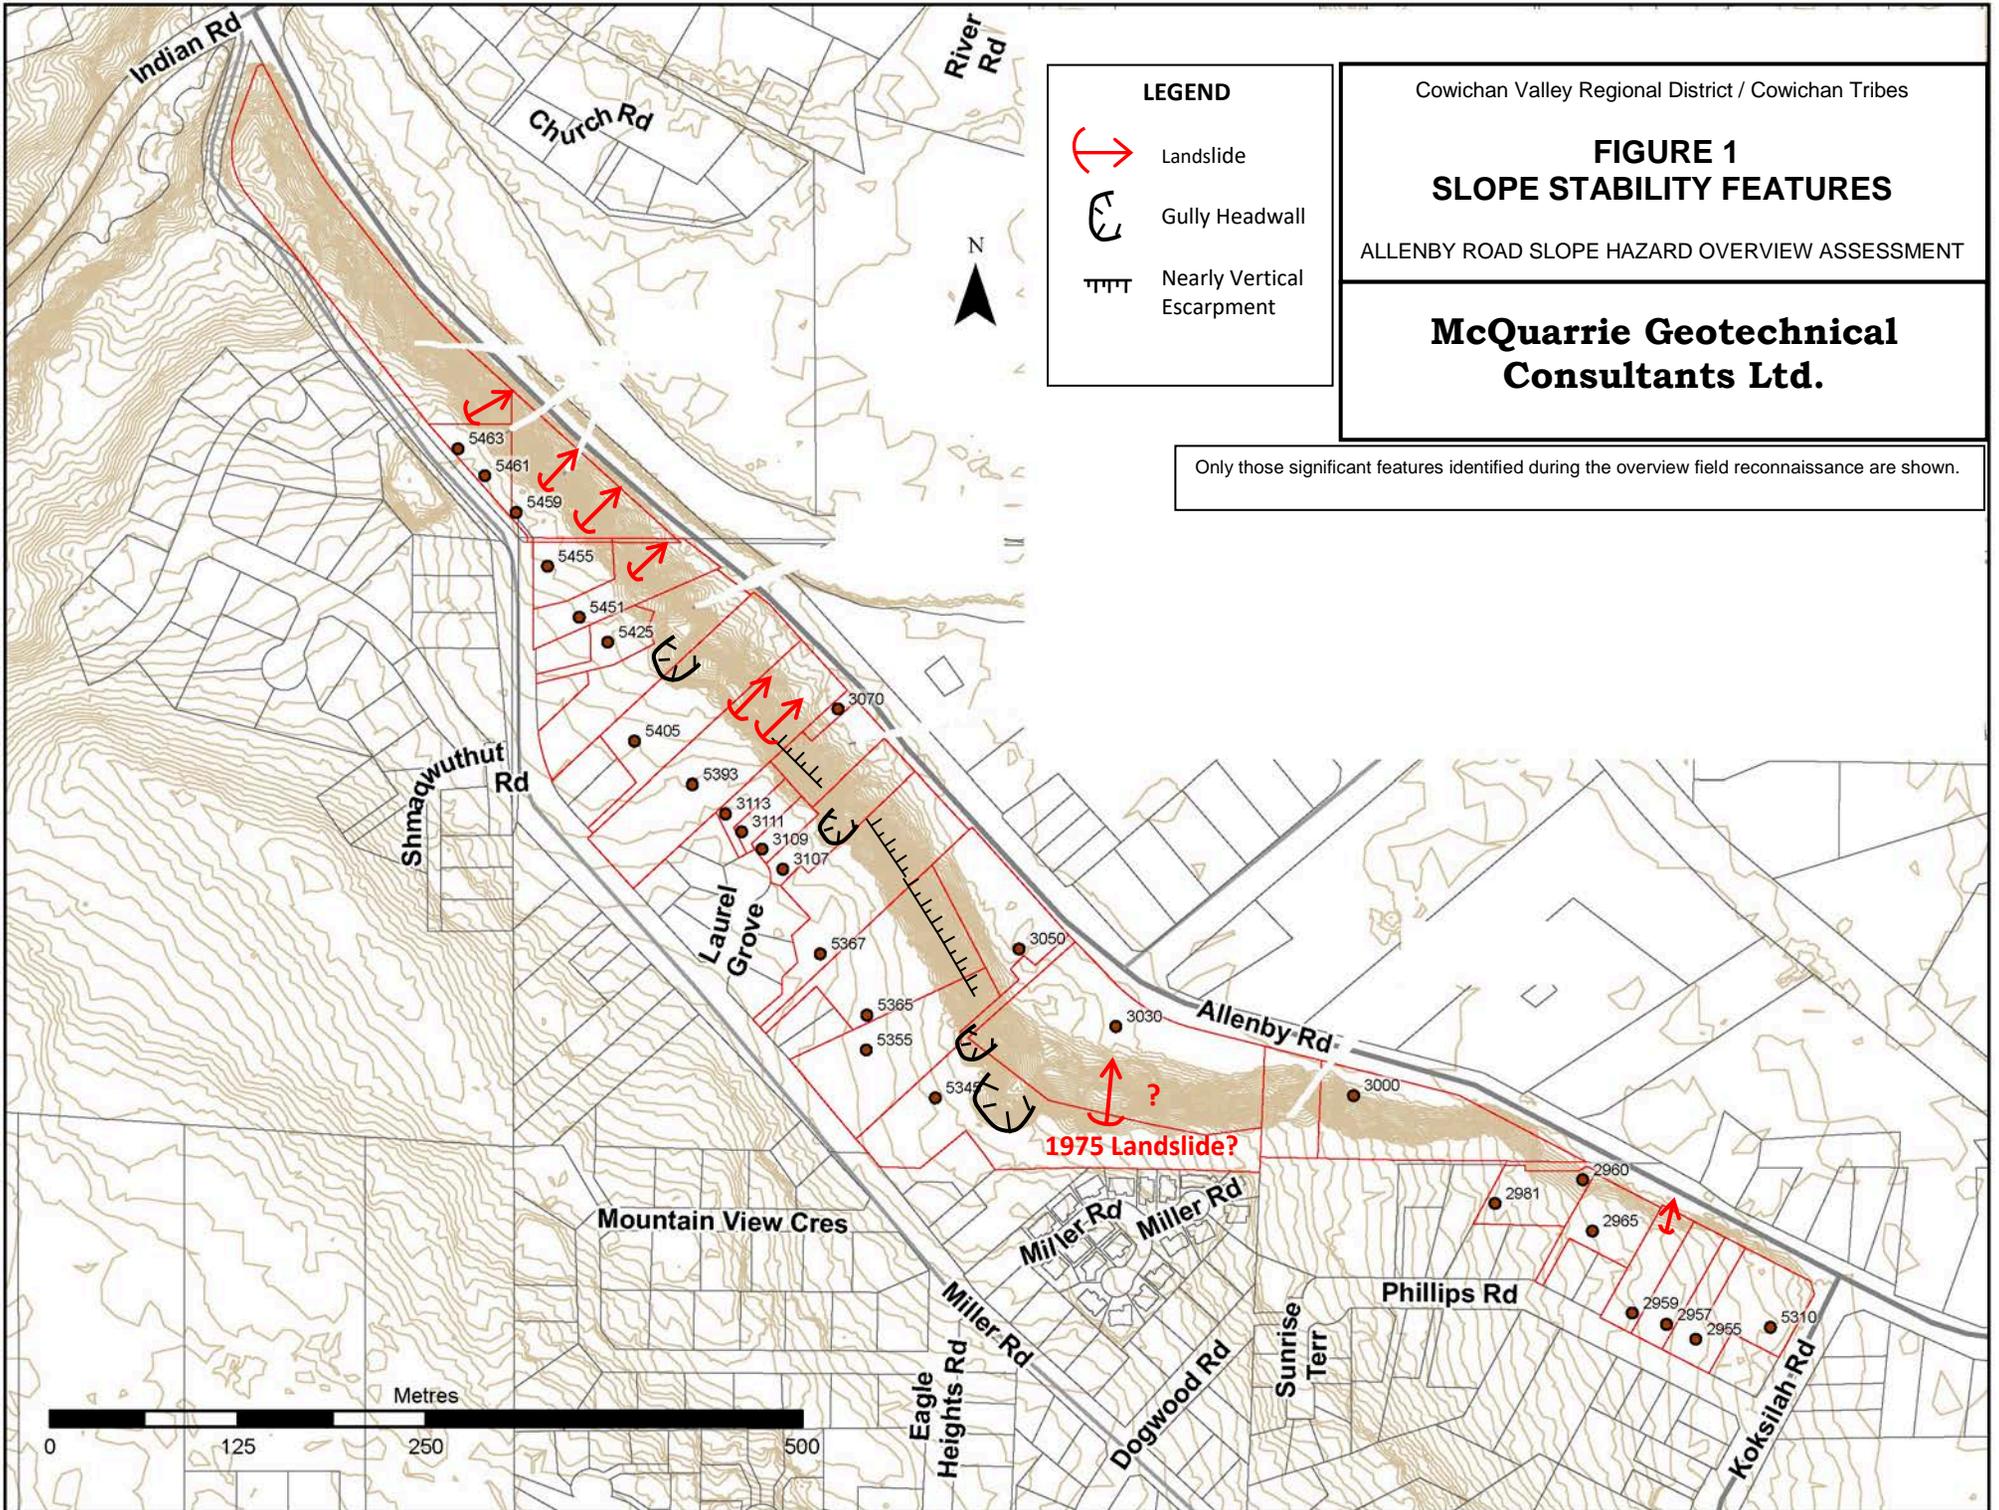
# FIGURE 1 SLOPE STABILITY FEATURES

Only those significant features identified during the overview field reconnaissance are shown.
