Dam Safety Review and Risk Assessment of Ashburnham Creek Dam

March 2019

GK-18-020-CVD

Cowichan Valley Regional District
175 Ingram Street
Duncan, BC V9L 1N8

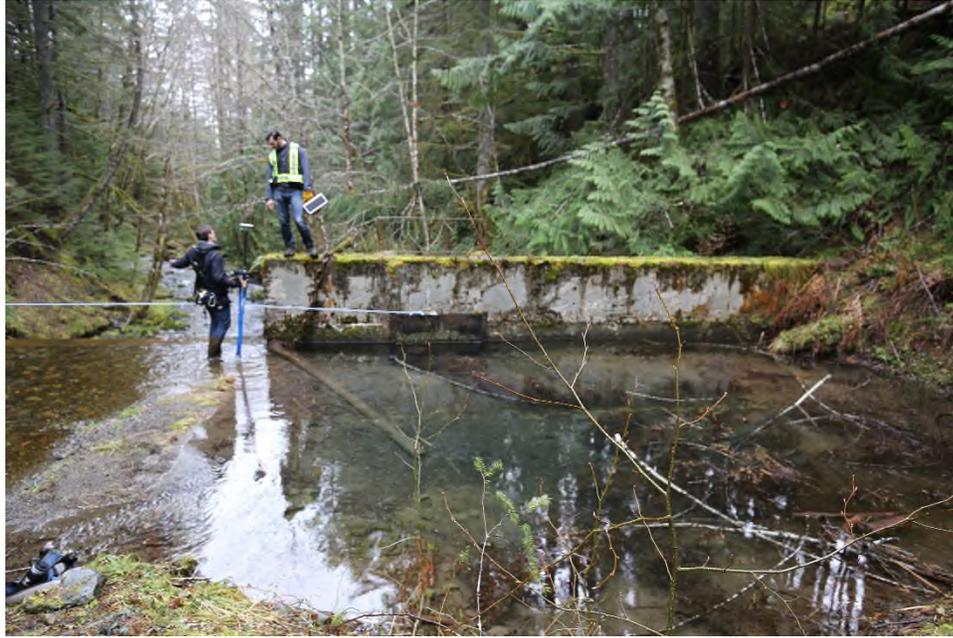
- Signs of erosion and weathering were noted on the upstream side of the west (right) wing wall about 300 mm above the water line at the time of the site visit (Photo 3).
- Extensive organic growth (moss) was noted throughout the surface of the concrete structure, which has caused the concrete paste near the surface to deteriorate and reduced visibility of exposed concrete over the majority of the surfaces of the concrete wing walls (Photo 11).
- A build-up of oxidization residue appeared to be staining the mossy growth on the concrete surface of the downstream side of the west abutment, therefore it is suspected the reinforcing steel has corroded (Photo 14).

Photo 3 Right wingwall viewed from upstream. Erosion and weathering noted.

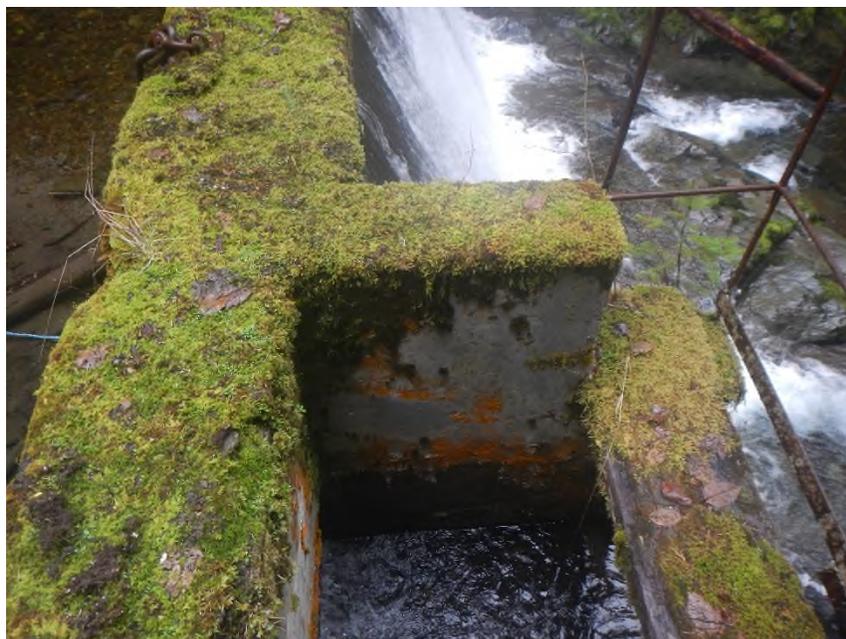
Photo 11 Moss growing on dam reducing visibility.

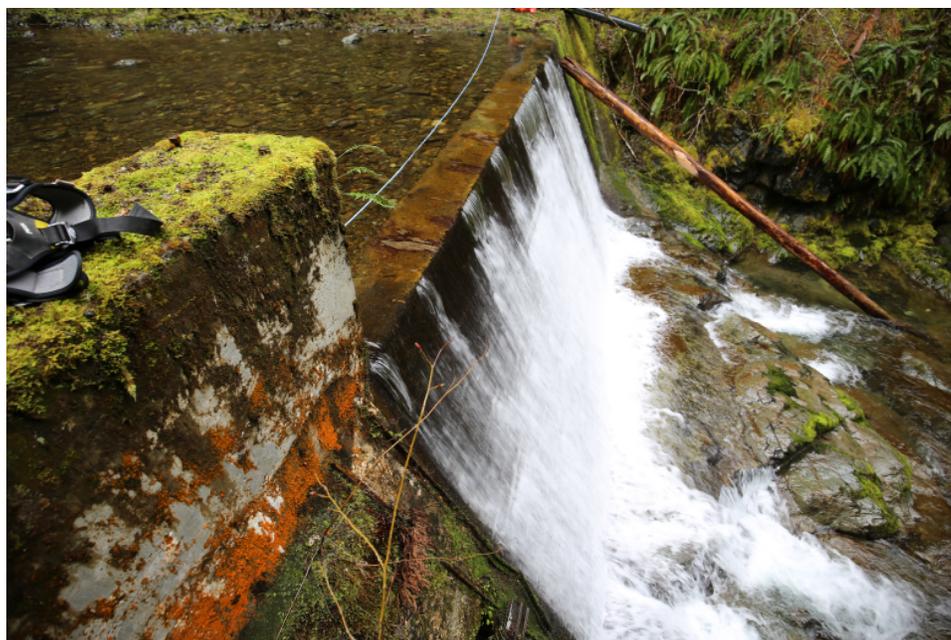
- The reservoir level at the time of both site visits was above the spillway elevation (Photo 12);
- There was a cold joint located on the right wall with efflorescence (recent and old) observed (Photos 13 & 14);

Photo 12 Main spillway as viewed from the right side of the dam.

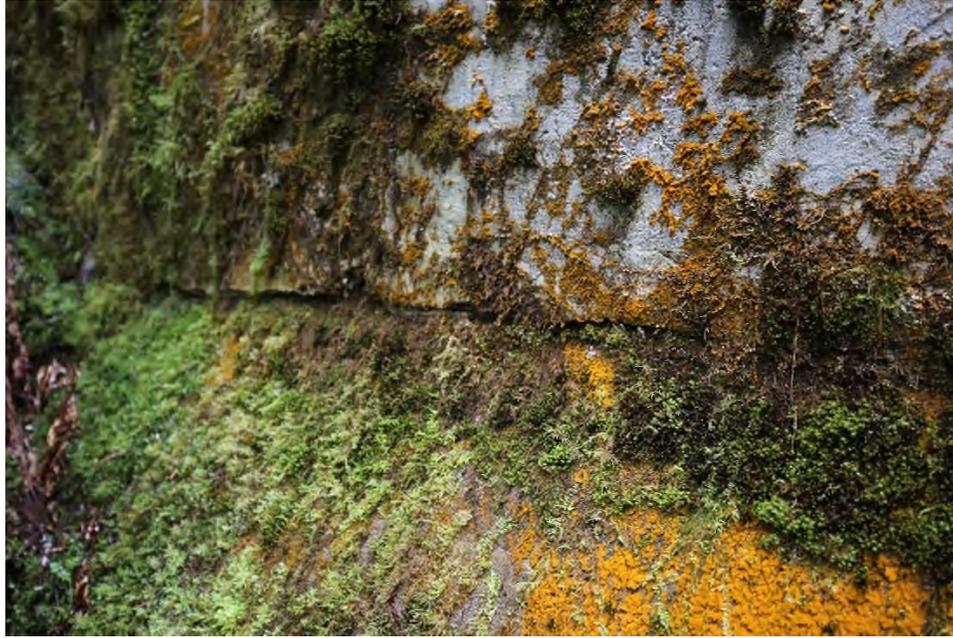
Photo 13 Cold joint at the right side of the dam between headwall and sloped part of the structure. Looking towards abutment.

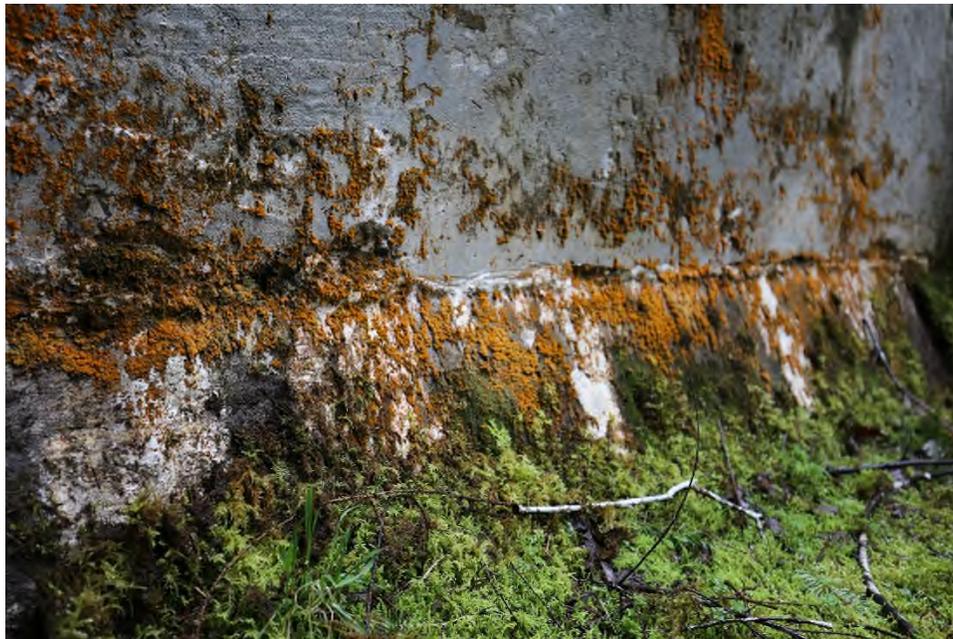
Photo 14 Cold joint at the right side of the dam between headwall and sloped part of the structure. Looking towards spillway.

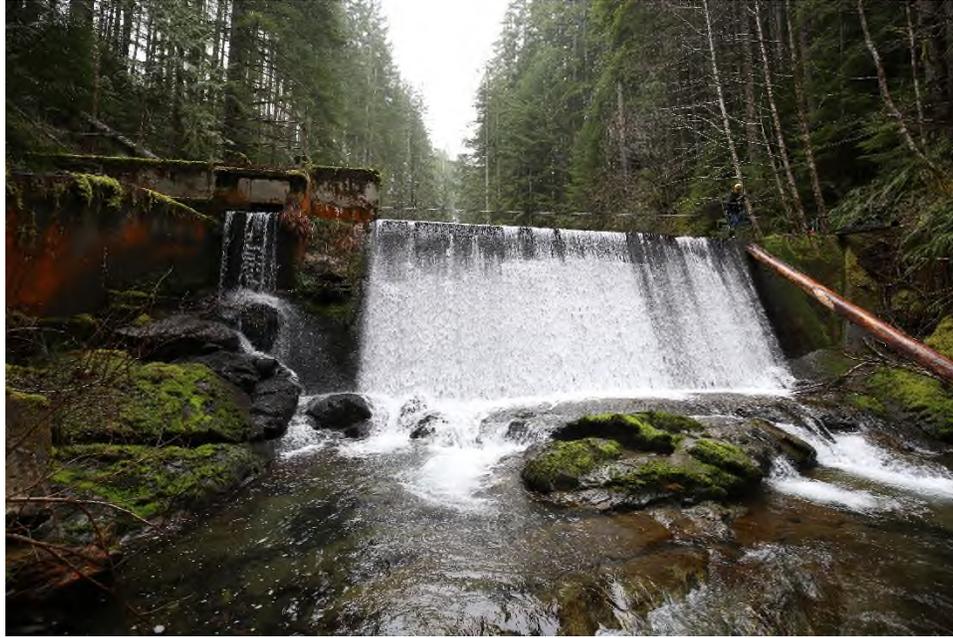
- The dam foundation consists of bedrock with possible colluvium at the left abutment (Photo 15); and
- The spillway is approximately 11.6 m long at an elevation of approximately 1.32 m below the dam crest elevation on the left portion of the dam (Photo 15);

Photo 15 Downstream face as viewed from downstream.

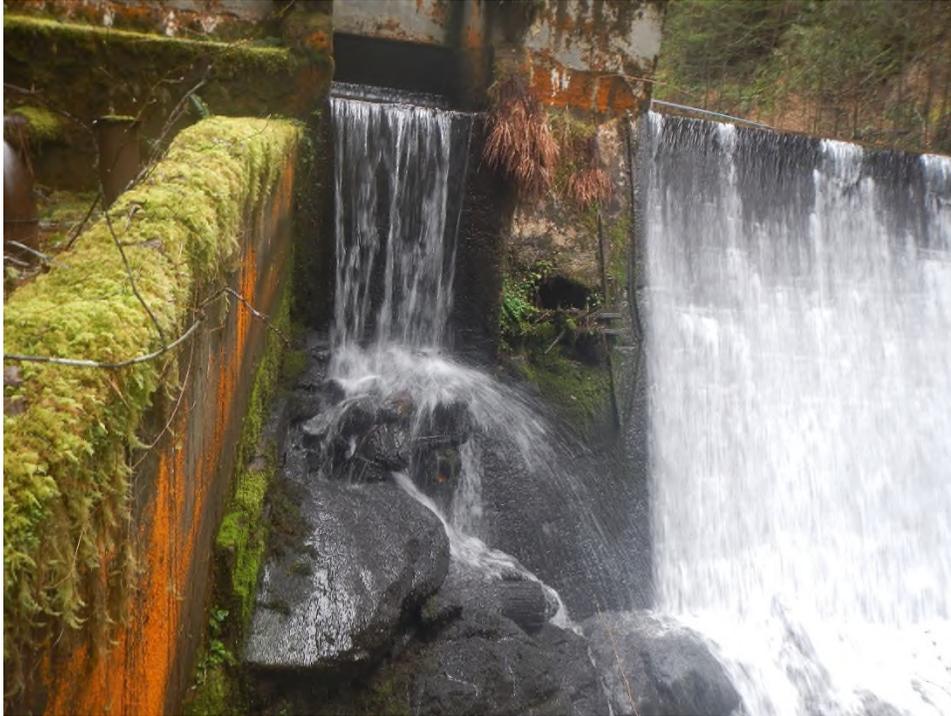
Photo 17 Spillway channels viewed from wingwall. Outlet in center is blocked.
