Dam Safety Review and Risk Assessment of Shawnigan Lake Weir

March 2019

GK-18-020-CVD

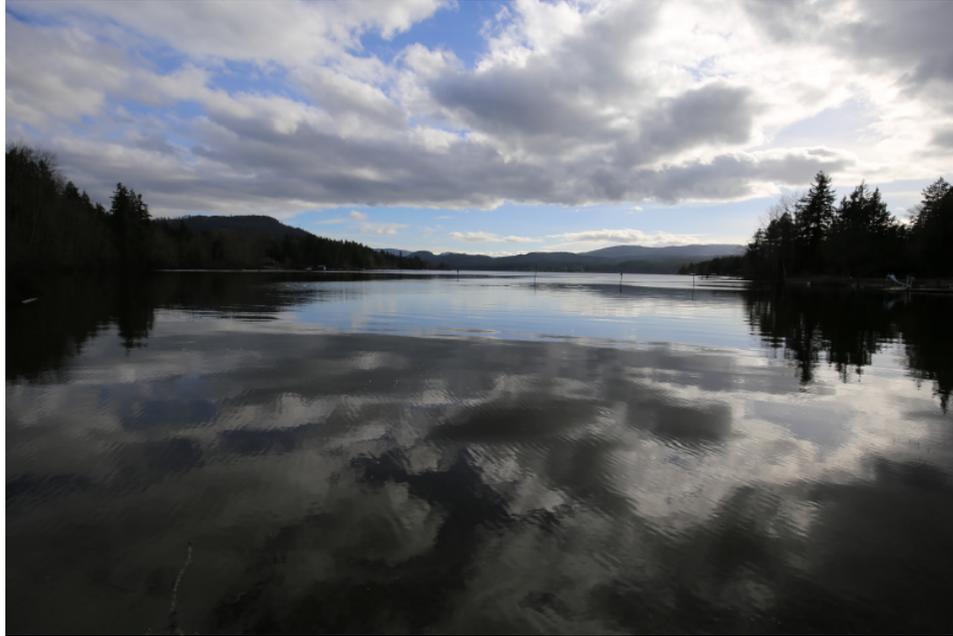
Photo 1 Shawnigan Lake as viewed from entrance to Shawnigan Creek above the weir.

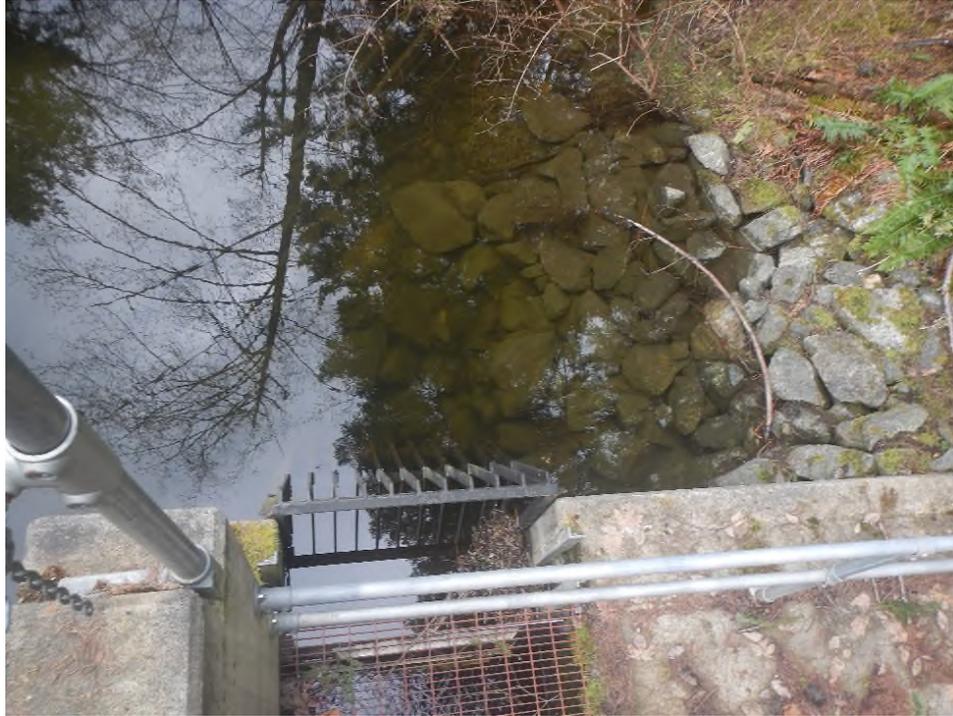
Photo 5 Entrance to fish bypass channel.

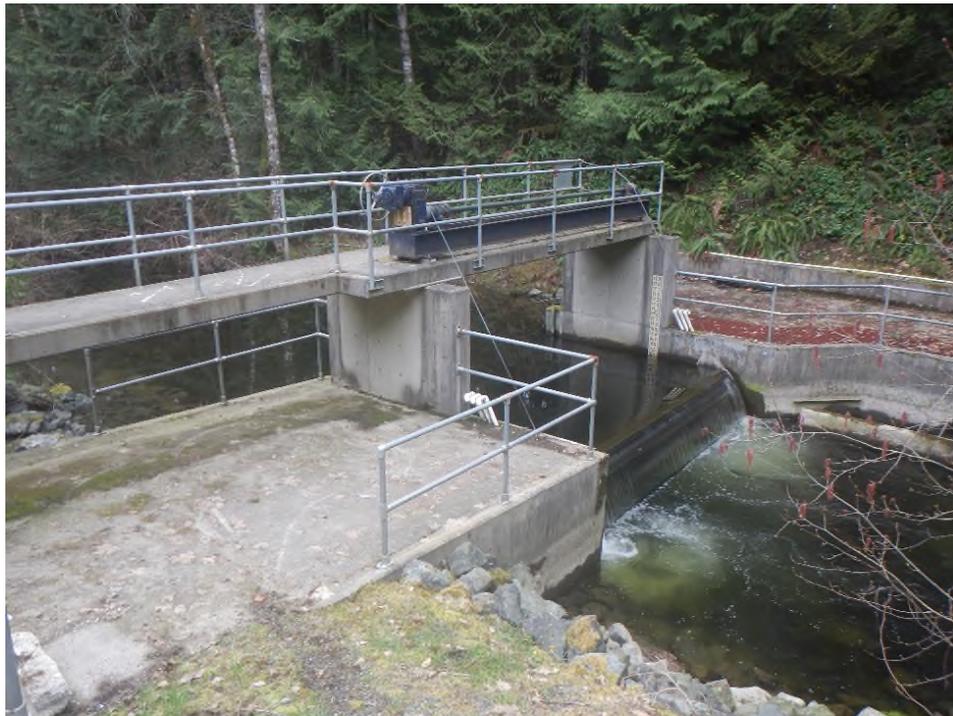
Photo 6 Weir as viewed from the right abutment.

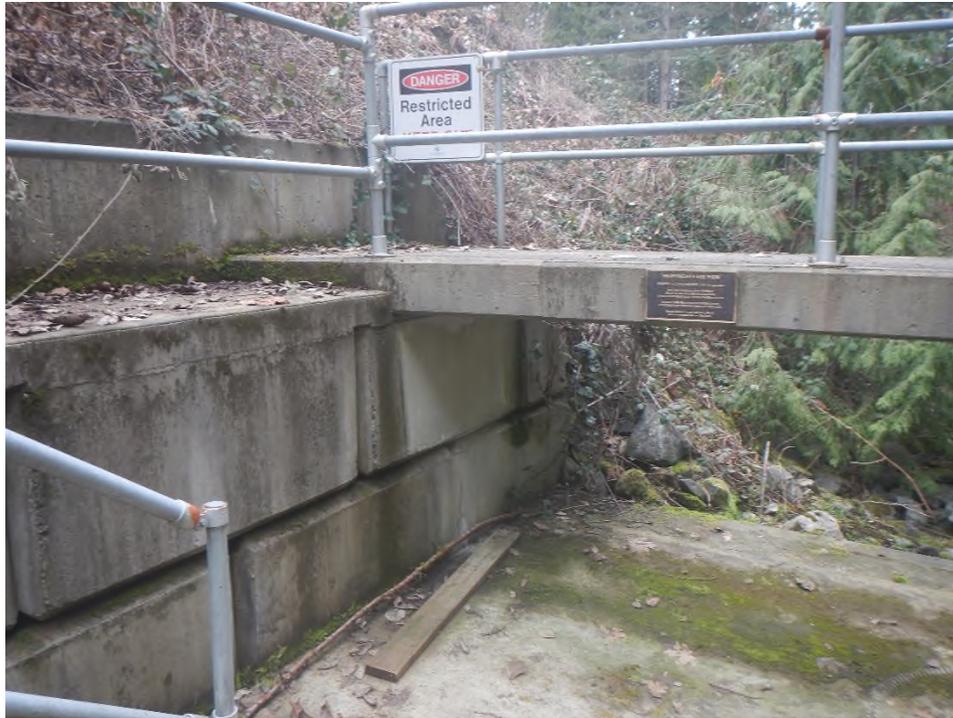
Photo 7 Retaining wall at right abutment.

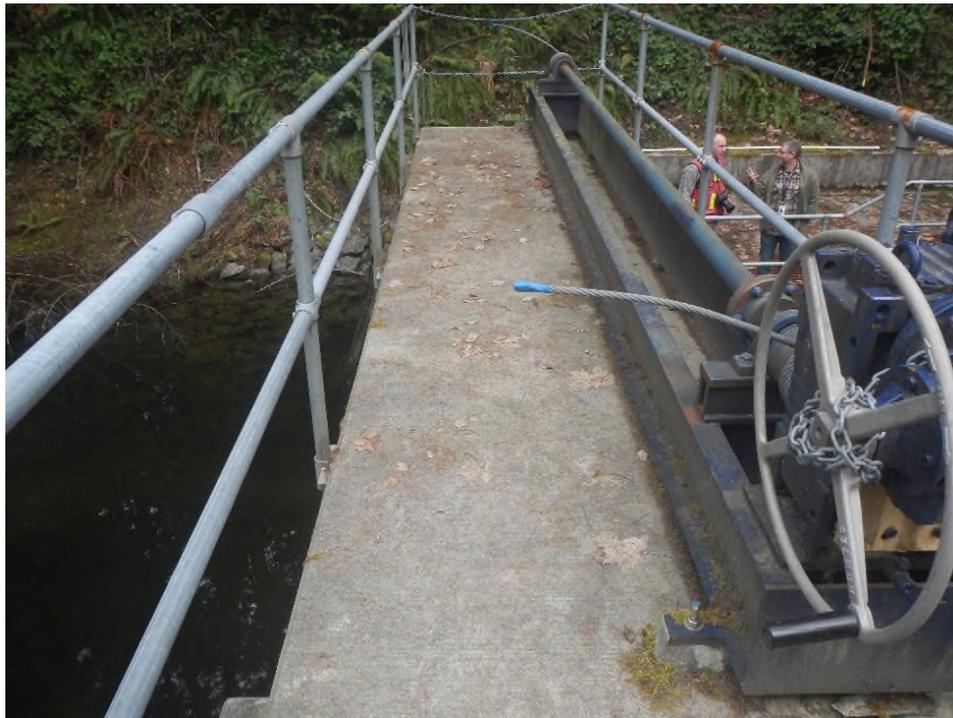
Photo 8 Walkway with cable reel above the weir.

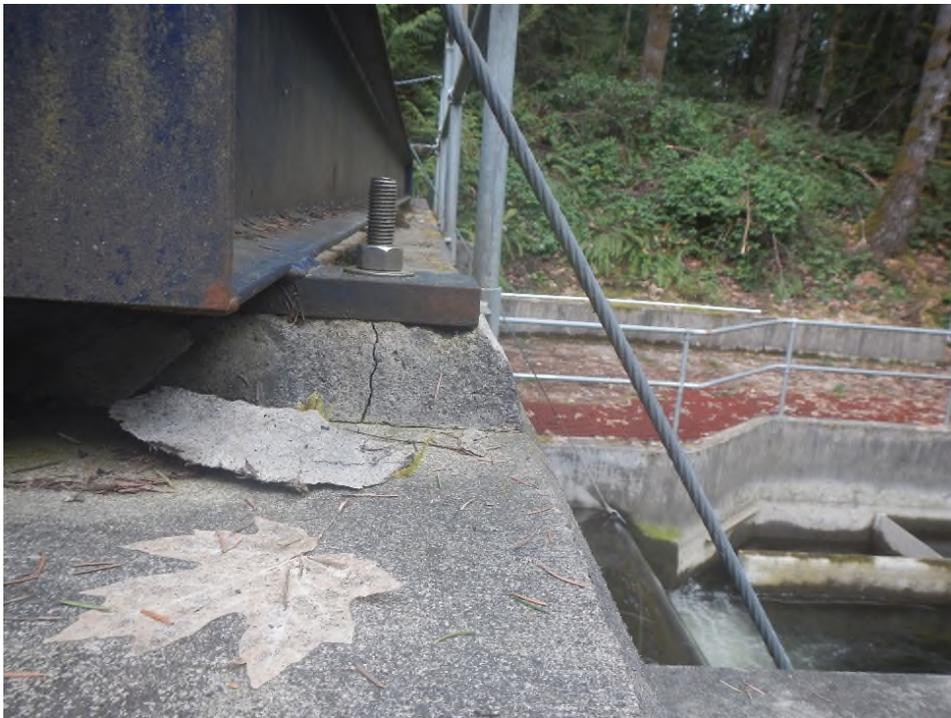
Photo 10 Crack on the grout pad underneath mechanical lift (right side).

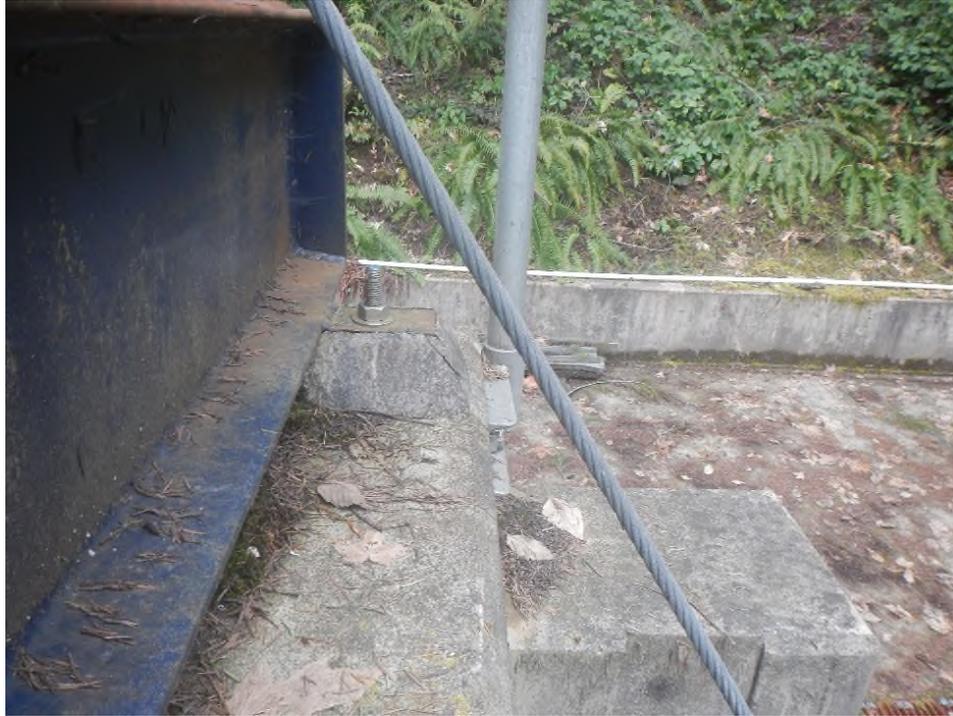
Photo 11 Crack on the grout pad underneath mechanical lift (left side).

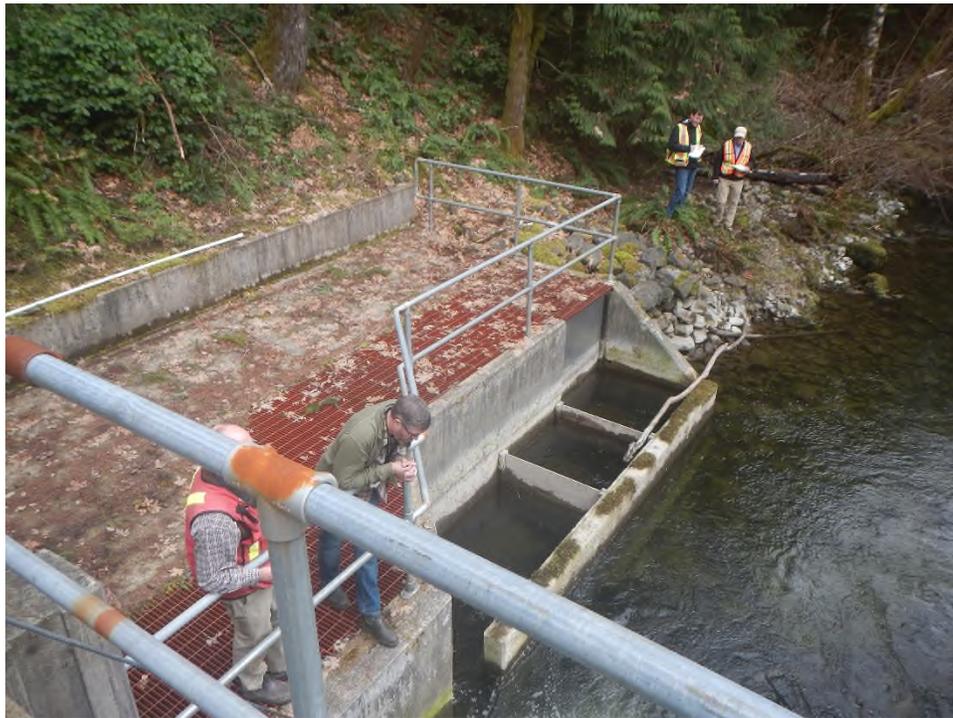
Photo 12 Mild corrosion on steel guardrail pipe connections.

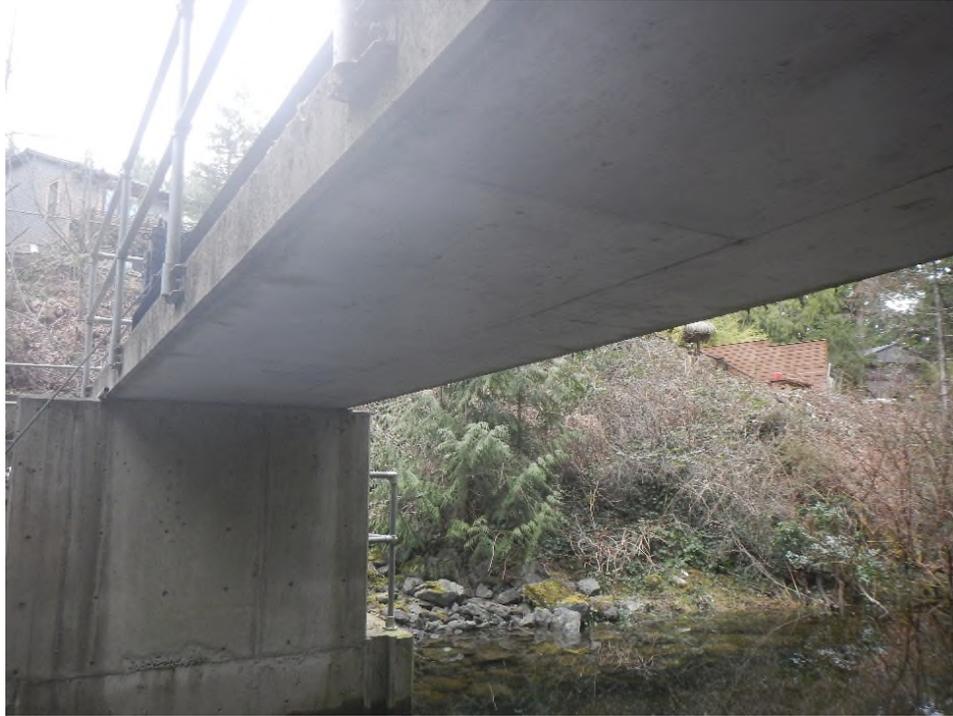
Photo 13 Underside of the walkway above the weir.

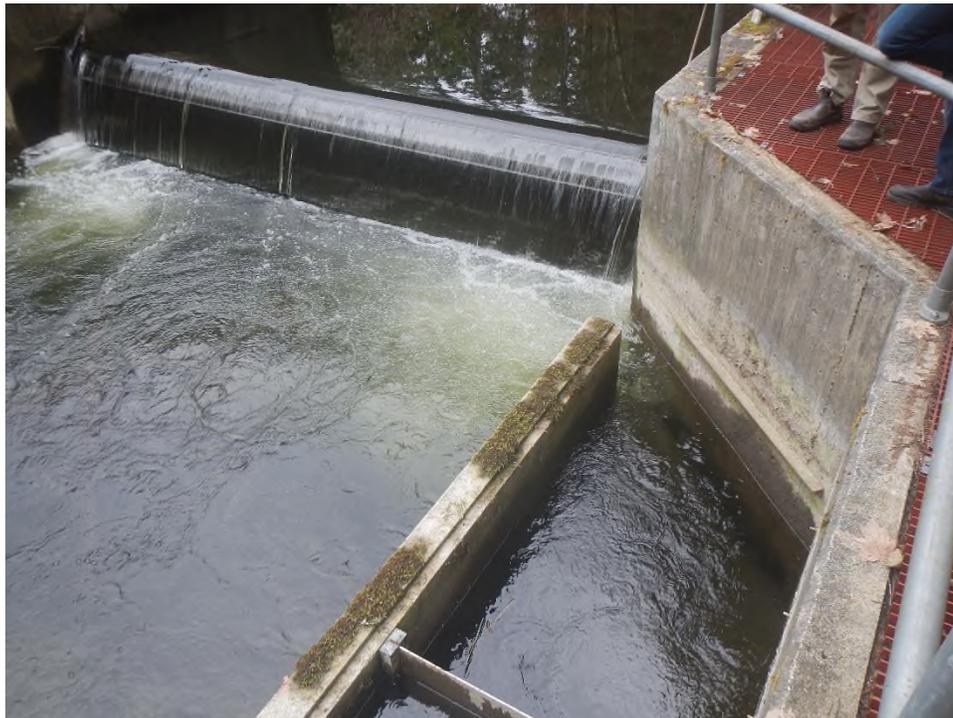
Photo 14 Moss growing on the fish bypass side wall.

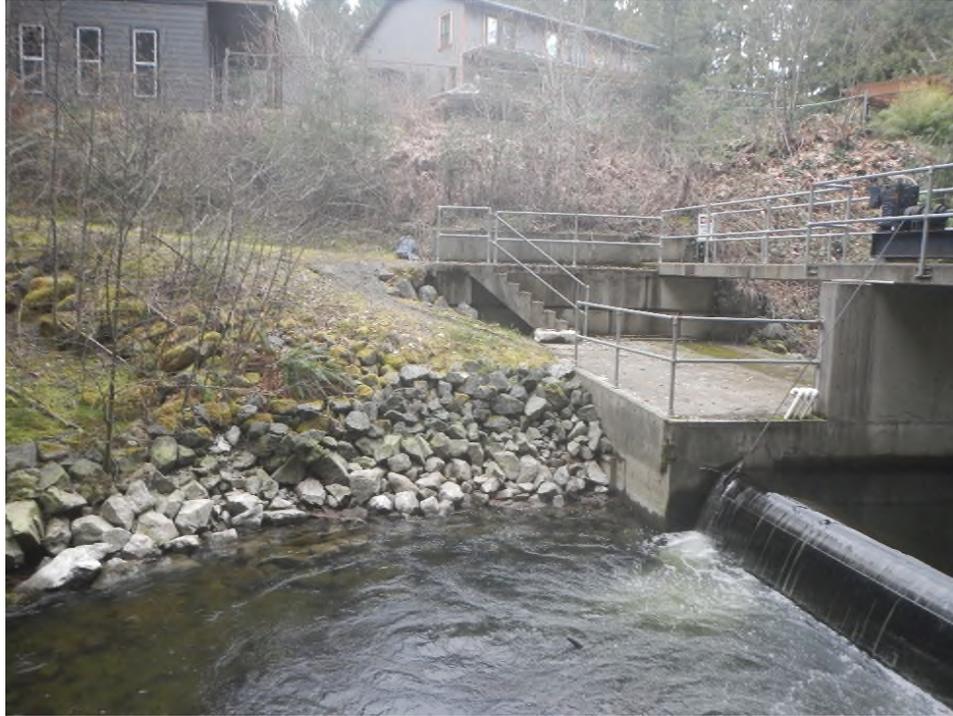
Photo 17 Riprap located on the downstream side of the weir.
