Dam Safety Review and Risk Assessment of Stocking Lake Dam

November 2018

GK-18-020-CVD

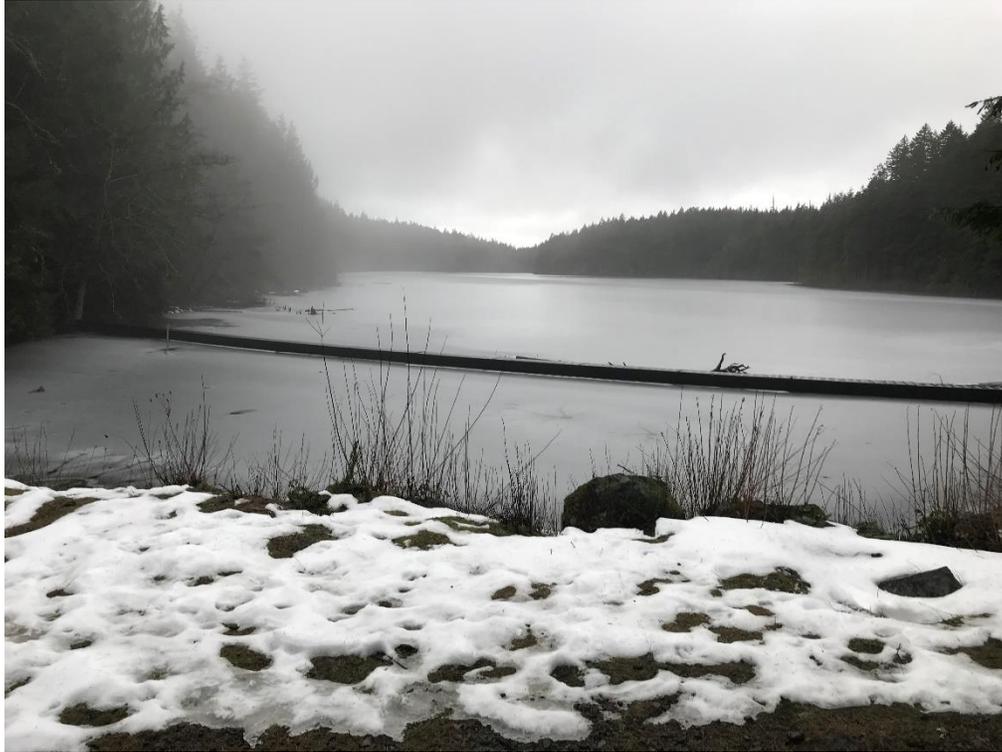
Photo 1 Stocking Lake Dam, January 17, 2018

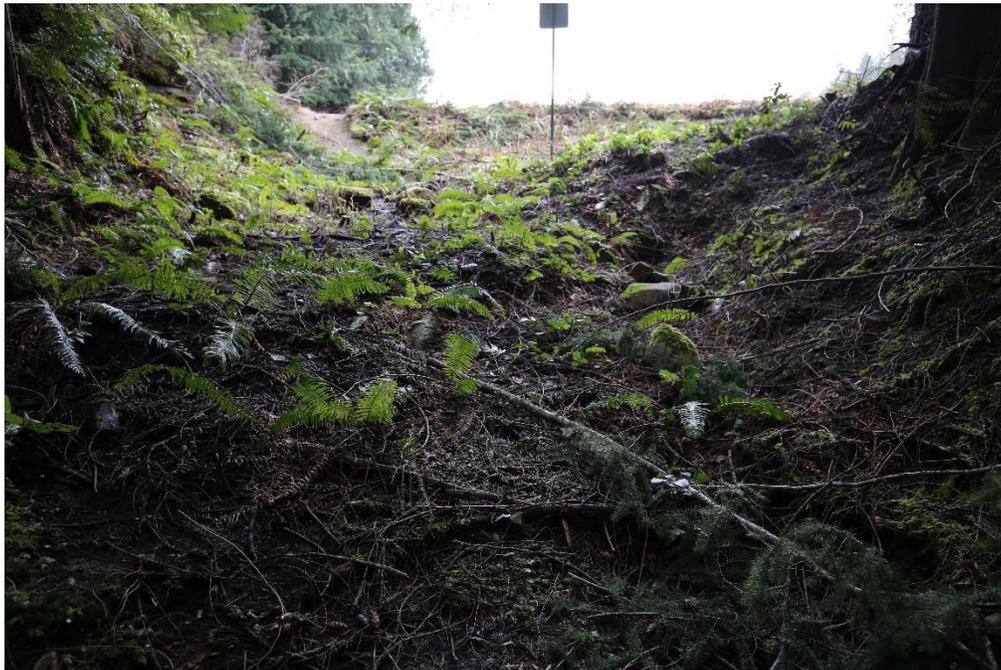
Photo 4 Sinkhole at the location of the right abutment observed in January 2018, not flowing on March 29, 2018

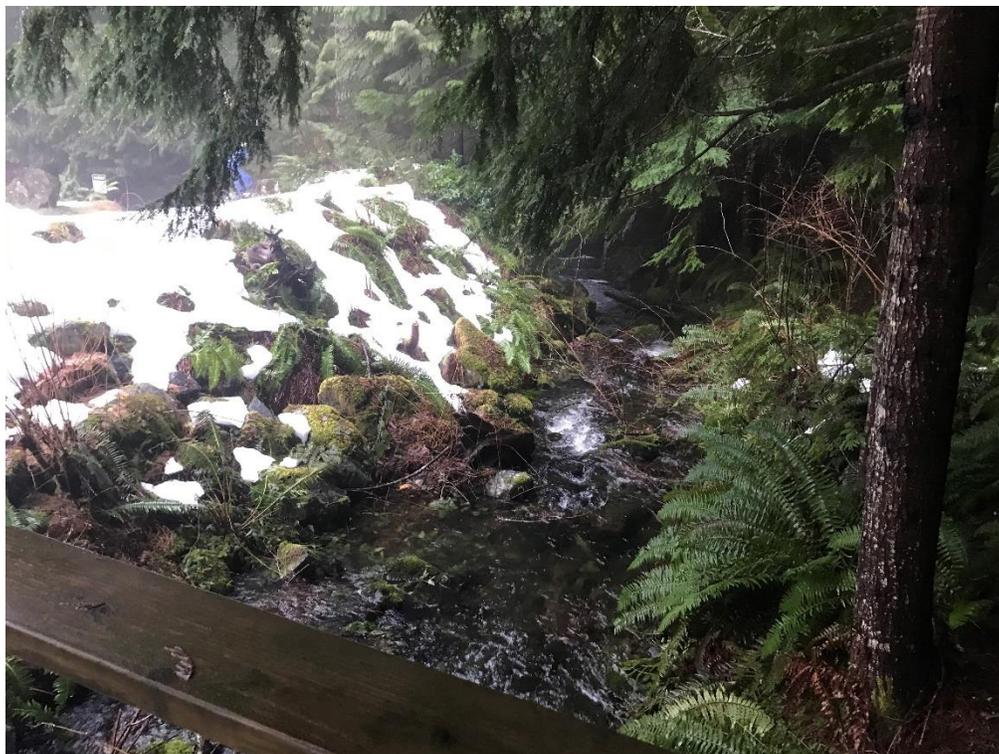
- Debris was noted in the spillway outlet channel (Photos 5-7).
- A sign was in place at the base of the dam in the spillway channel (Photo 8).
- The spillway approach channel had a log boom in place (Photo 9).

Photo 5 Spillway channel, January 17, 2018
