Chemainus River Geomorphic Atlas

October 2022
Final Report, Rev. 0

Chemainus River Flood Mapping Program

Geomorphic Atlas

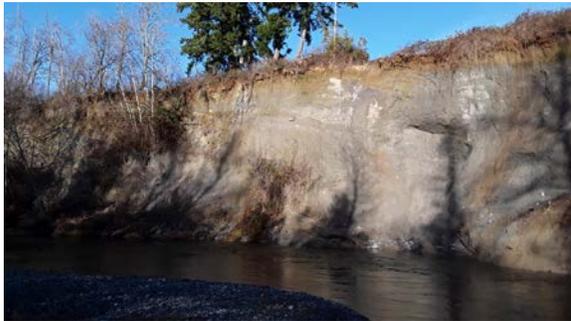
▲ Terrace bluffs in the lower watershed composed of compact glaciomarine sediment.

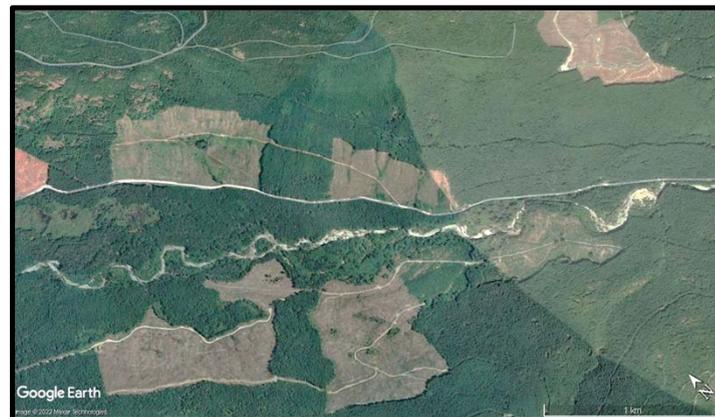
▲ Copper Canyon at the falls (Olsen, W.H., 1981), reportedly the narrowest location on the Chemainus River. Steep, narrow canyons in the upper watershed create a potential for channel blockages.

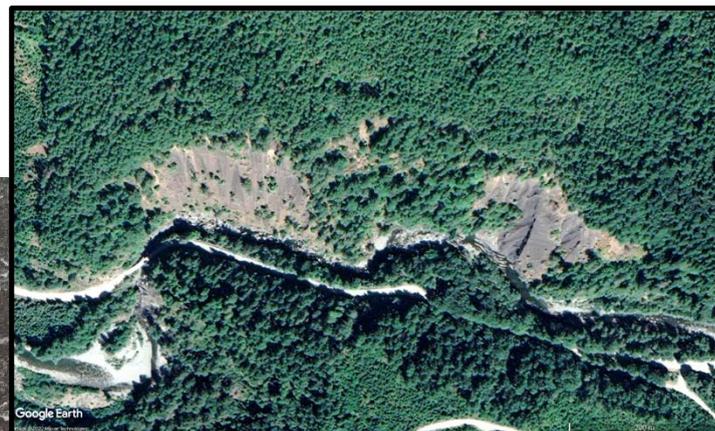
▼ Recent image of the watershed forest cover area. Inset image at the top left illustrates an unstable channel reach in the upper watershed that is a sediment supply source. The image at bottom left shows slope failures along a steep stream bank located within a confined channel reach, also a noticeable source of sediment.

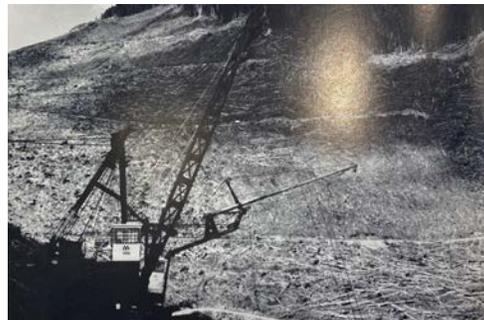
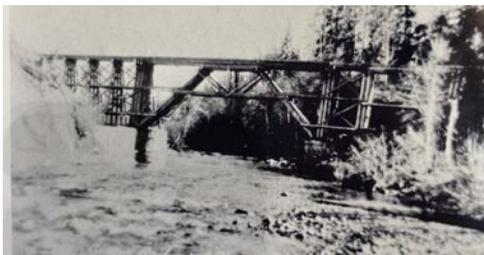
▲ Top photo: Historical logging operations in the Chemainus River watershed. Bottom photo: First bridge over Chemainus River. (Copper Canyon Commemorative Committee, 1990).

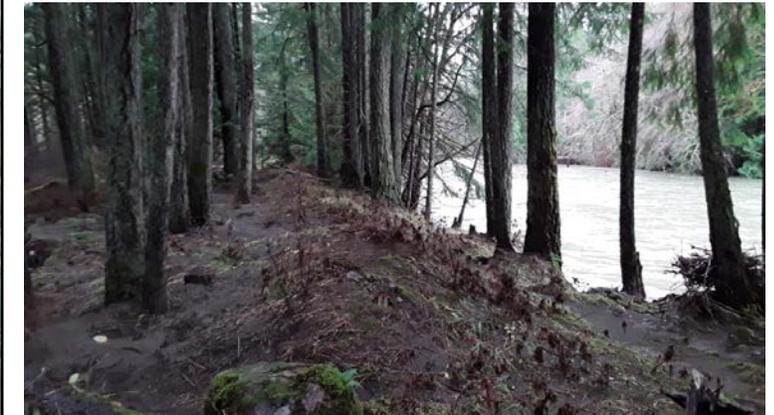
▲ Photo 6.3 Earthen berm reduces the amount of flow that spills out onto the floodplain during peak flood events.

Relic channels in the floodplain south of the modern-day channel, reveal insights into historical channel positions. Should the earthen berm that runs along the southern channel bank fail or be removed, these old channels are potential primary pathways for overbank flow.

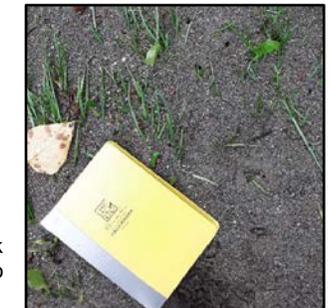
► Photo 6.4 Overbank sand deposits 0.1 to 0.2 m deep.

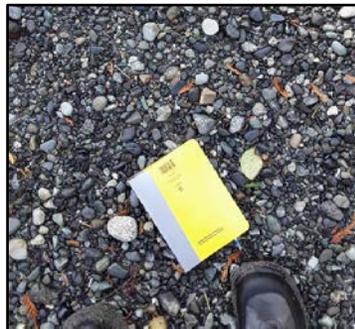
► Photo 6.8 Fine to medium gravels on the tail of the bar opposite the bluff. This is much finer sediment than found along the toe of the bluff and head of the next bar downstream highlighting the within-channel spatial variation in shear stress and stream energy.

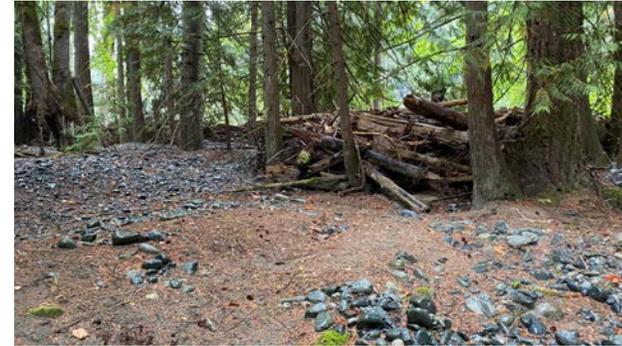
► Photo 6.5 LWD accumulation and sediment lobes on the island.

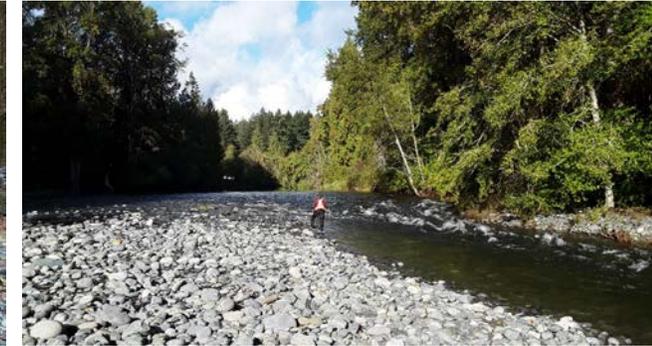
▼ Photo 6.6 A steep riffle at the head of the bar. Surface sediment at the bar head is primarily cobbles.

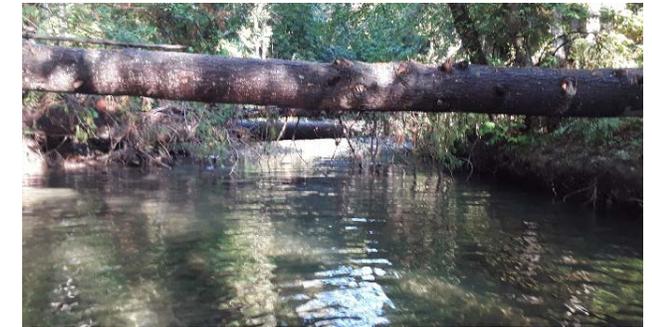
▼ Photo 6.7 (Upstream view) Back-channel has multiple downed trees spanning the channel width.

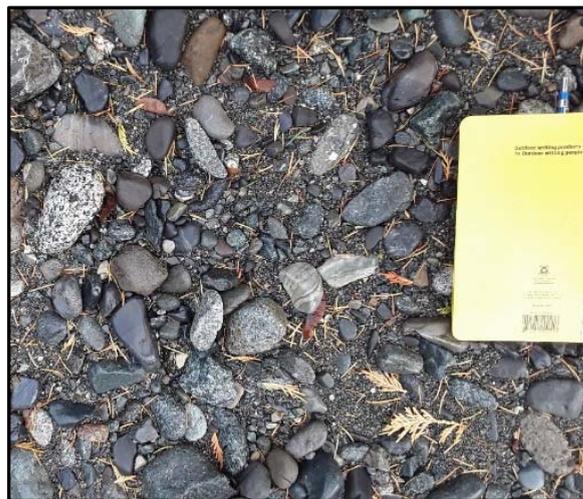
▲ Pebble count taken at RK 6.45, just upstream of the Highway 1 bridge. D₉₀ refers to the sediment grain size diameter that is not exceeded 90% of the time in the sample dataset.

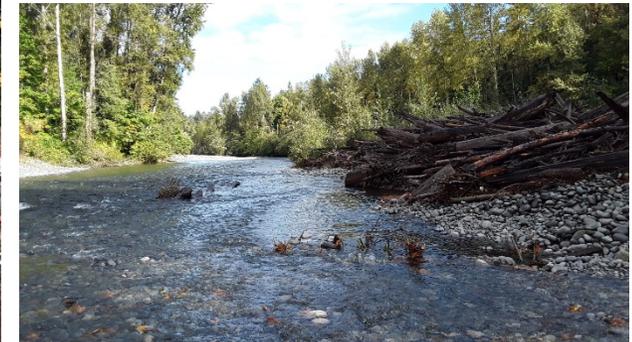
▼ Photo 5.8 Upstream log jam on the vegetated island.

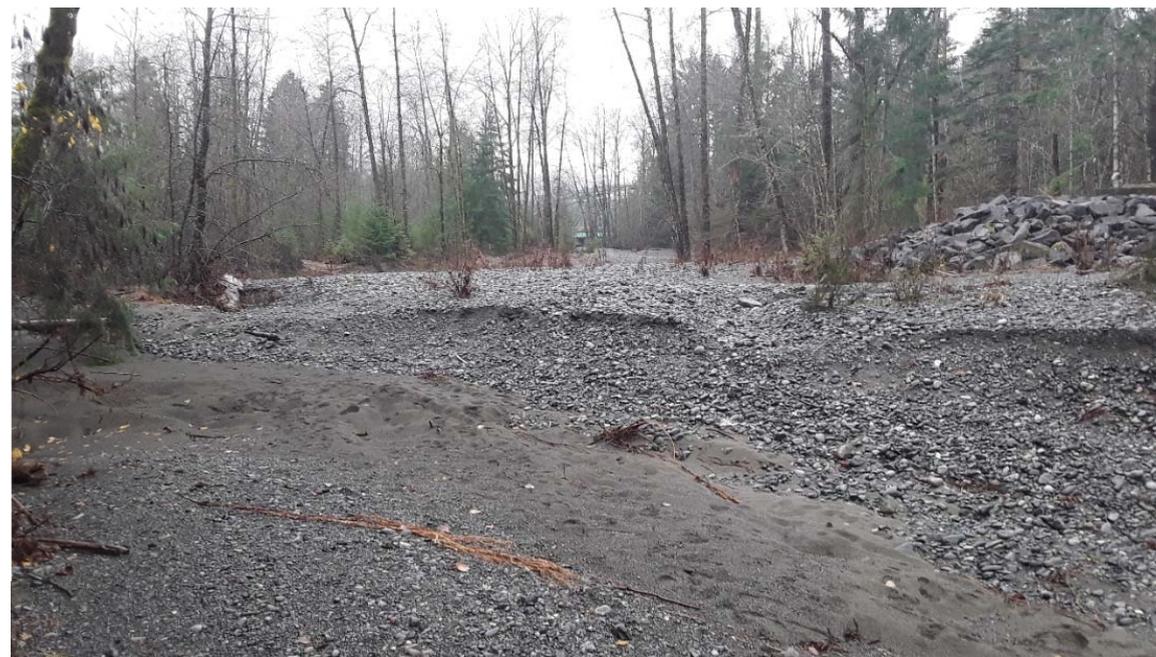
▲ Photo 5.10 High-flow channel on the bar surface. Sandy lobes are left behind during the falling limb of the flood as water levels drop and the finer sediment falls out of suspension. The boulders at the right of the photo armour the water well installed on the bar.

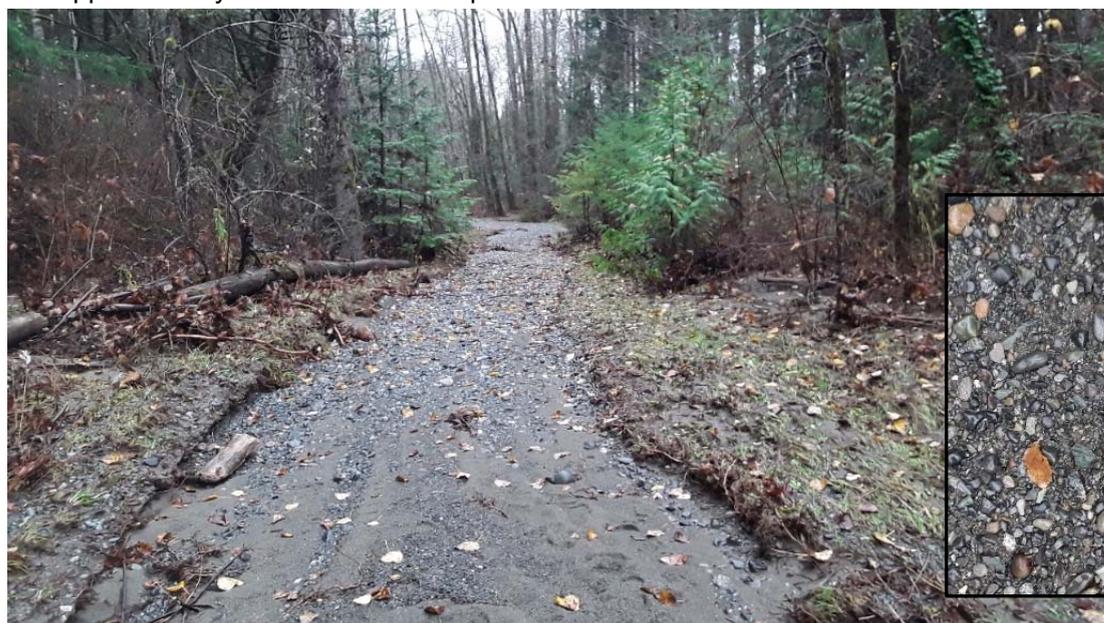
▼ Photo 5.12 Fine to medium gravel and sand is transported through a back-channel along the inside of the point bar. The channel is about 2.5 m wide and incised approximately 0.3 m into the floodplain.

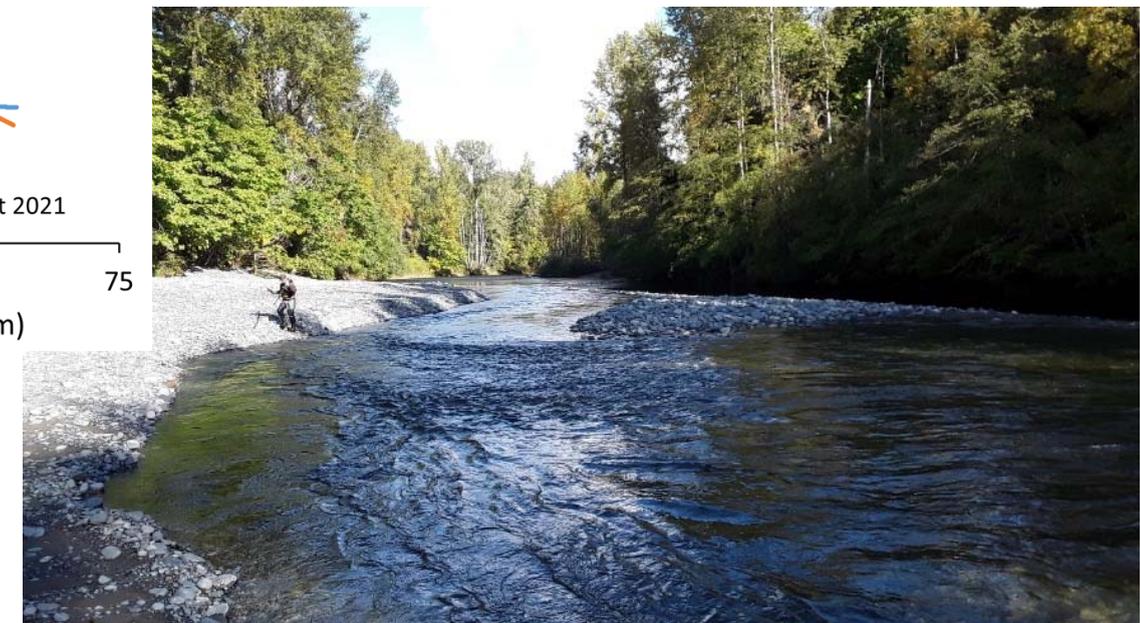
► Photo 5.13 Sediment was removed from the bar tail (2021) to create a wider wetted channel and to reduce flow towards the opposite bank.

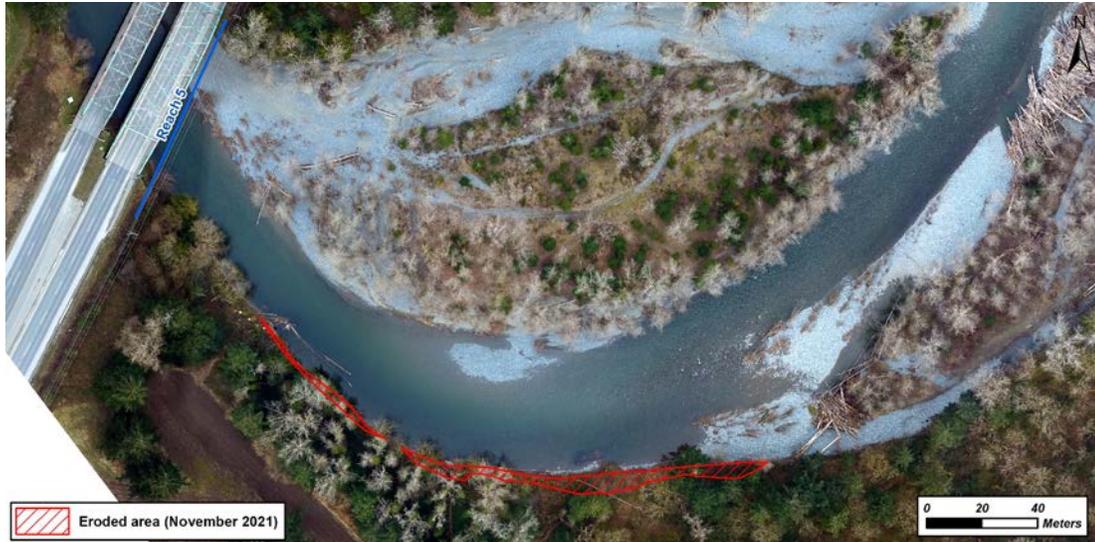
- ▲ The November 2021 flood eroded a 200 m section of bank line downstream of Highway 1. As a result, the bank retreated away from the channel by up to seven metres. 2021 FLNRORD orthophoto.

- In November 2021, the atmospheric river that hit the Pacific Northwest produced a substantial flood on the Chemainus River. Topographic survey measurements collected pre- and post-flood indicate that this event caused the outer bank to retreat by 2.5 to 6.3 m. This magnitude of bank retreat is 2.7 to 7 times higher than the historical erosion rate.

- The largest magnitude of bank retreat in Reach 5 (in 2021) was observed in the downstream most section of bank line, just upstream of the island. This area is most directly exposed to high-velocity flows from upstream and has a very shallow root network offering little to no stabilization.

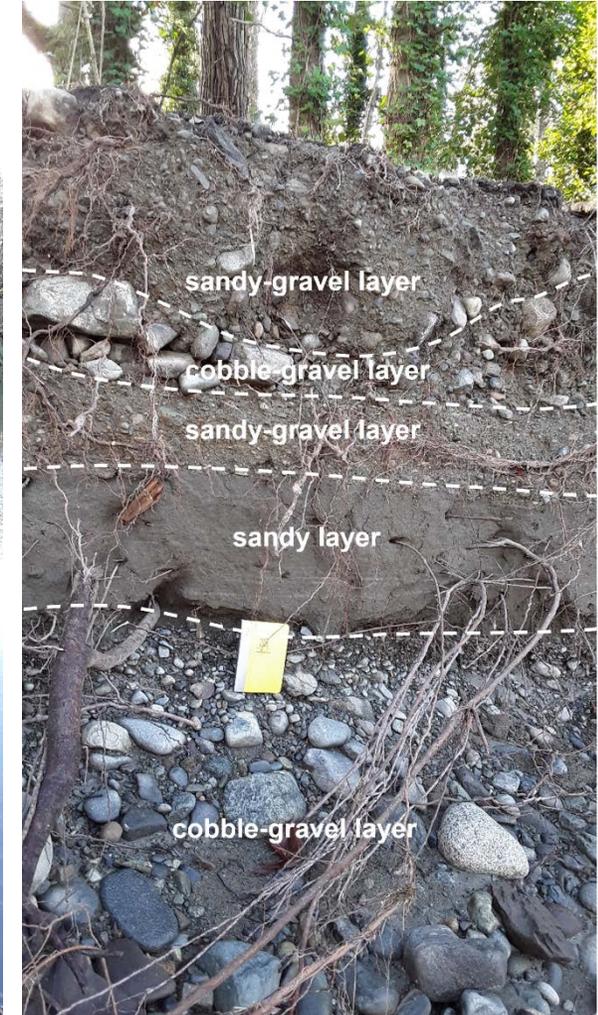
- ▲ Photo 5.2 Exposure at the downstream end of the eroding bank line. The sandy layer near the toe is easily eroded. Coarser material is loose and uncompacted. The roots through upper horizon offer minimal stabilizing benefit.

- Downstream of the concrete, the channel bank is composed of loosely consolidated layers of cobble, gravel and sand with varying degrees of root-strength provided by riparian vegetation. Coarse gravel and cobble deposits in the bank stratigraphy are deposited by relatively high energy flood events, whilst finer-grained sand deposits reflect deposition during more moderate flow conditions.

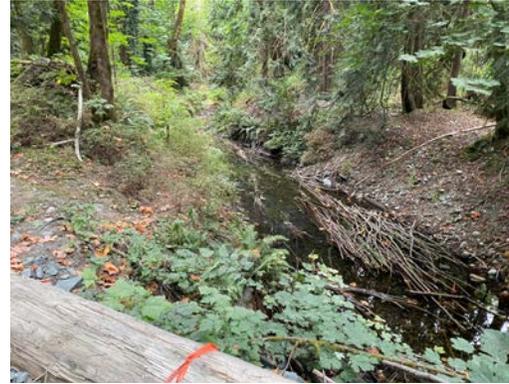
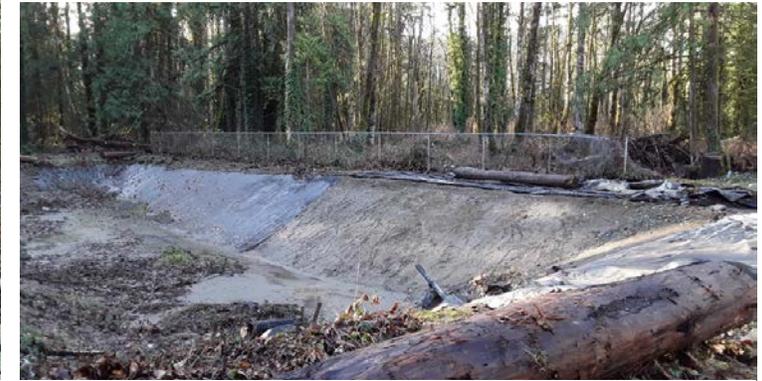
▲ Photo 5.9 The floodplain channel and pond system is used for rearing juvenile fish by Halalt Fisheries. Photo at left shows a floodplain channel in August 2021. Photo at right shows the facility following the November 2021 flood event.

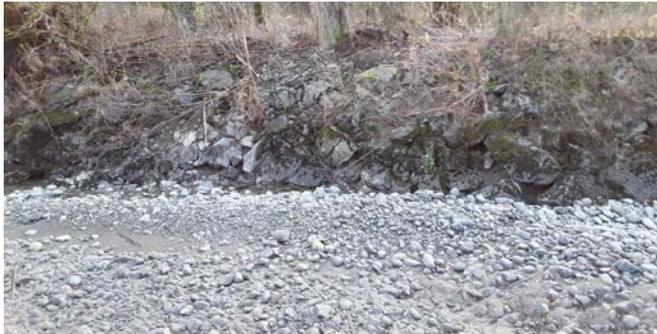
▲ Photo 5.5 Riprap along the right channel bank behind the island.

- Near the right (south) bank of Reach 5, an approximately 10 m wide side-channel flows around an elongate vegetated island. The island and secondary channel bank lines are exposed to high-velocity flows, and as such have been the focus of ongoing river management works.
- Upstream of the island, the southern channel bank is armoured with riprap and is connected to the head of the island via placed LWD and boulders.
- The secondary channel flowing behind the island is also reinforced with riprap along its outer bank. In spot areas where riprap is absent, the banks are composed of uncompacted sand and gravel at the upstream end and soft fine-grained loamy material downstream where the back-channel rejoins the mainstem.
- The island bank adjacent to the main channel experiences high-velocity flows during peak floods and has been reinforced with piled gravel and placed LWD.

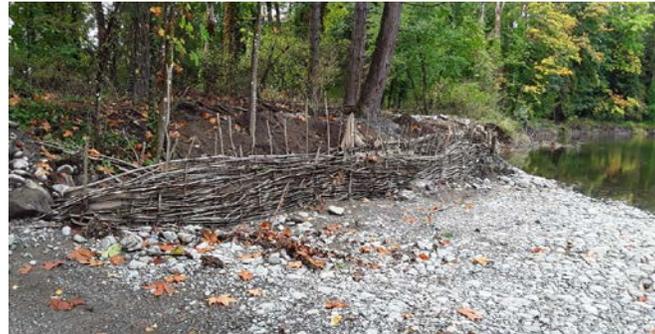
▲ Photo 5.4 Wattle fencing at the head of the island installed in 2021.

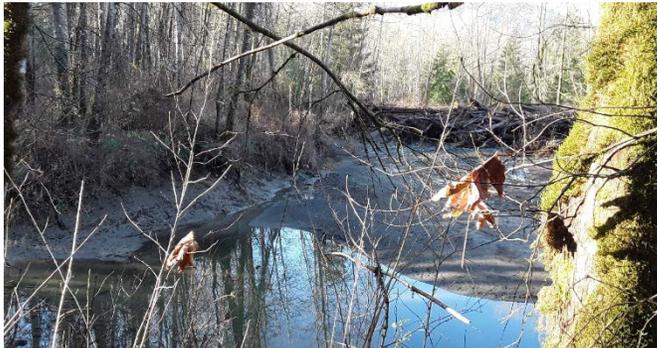
▲ Photo 5.11 Soft, loamy material along the bank is easily eroded.

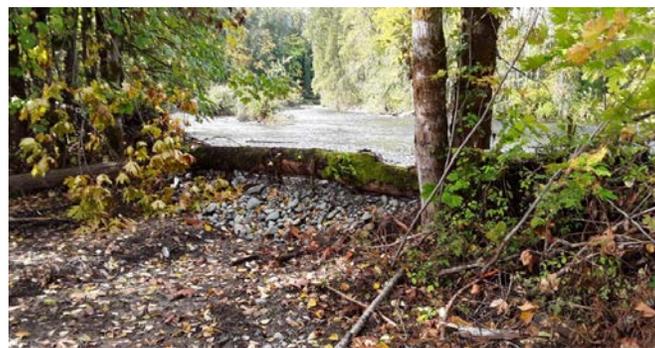
▲ Photo 5.7 Gravel pile-up along island bank is reinforced with LWD.

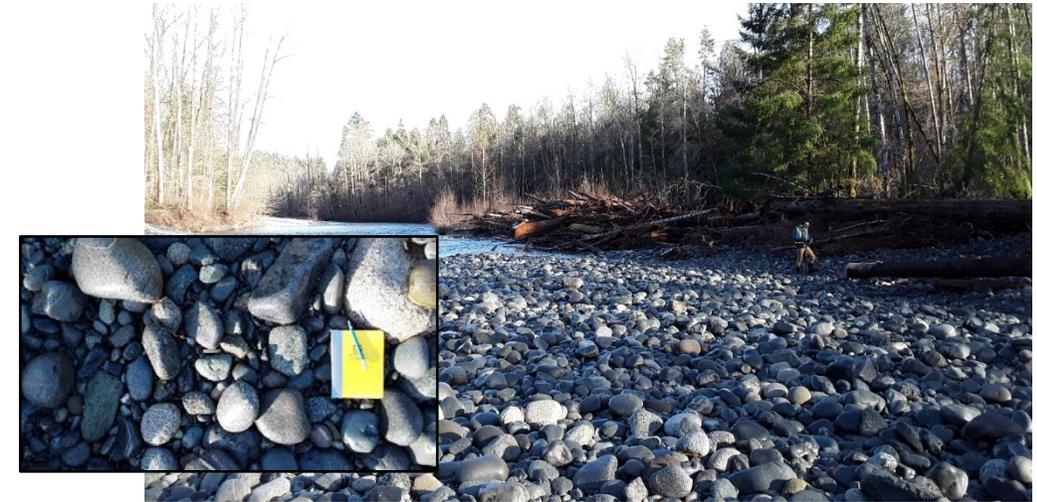
▲ Photo 5.6 Coarse cobble and boulder substrate on the vegetated island is indicative of a high energy environment. The river mobilizes smaller particles downstream.

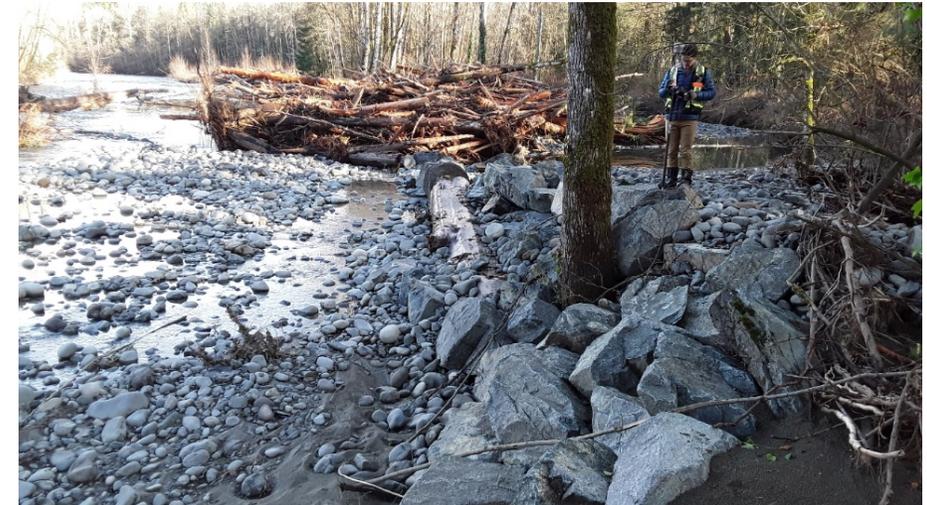
▼ Photo 5.3 LWD was placed at the entrance to the side channel to reduce flow into this area. The LWD connects riprap armour along the upstream bank to the log jam at the head of the island.

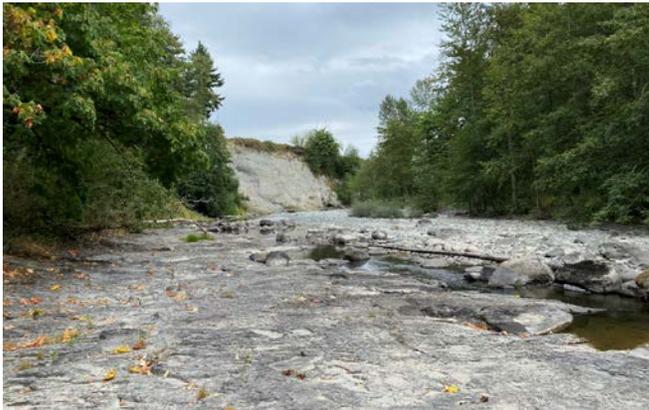
◀ Photo taken at low-flow, exposing the bedrock channel bed at the top of reach 4. This provides an important control on the channel gradient in this reach.

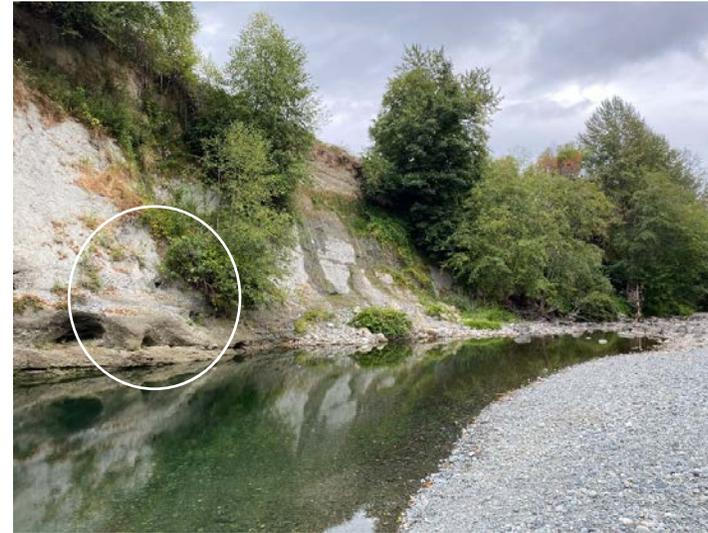
▲ Photo 4.1 from August 2021 prior to the winter storm season.

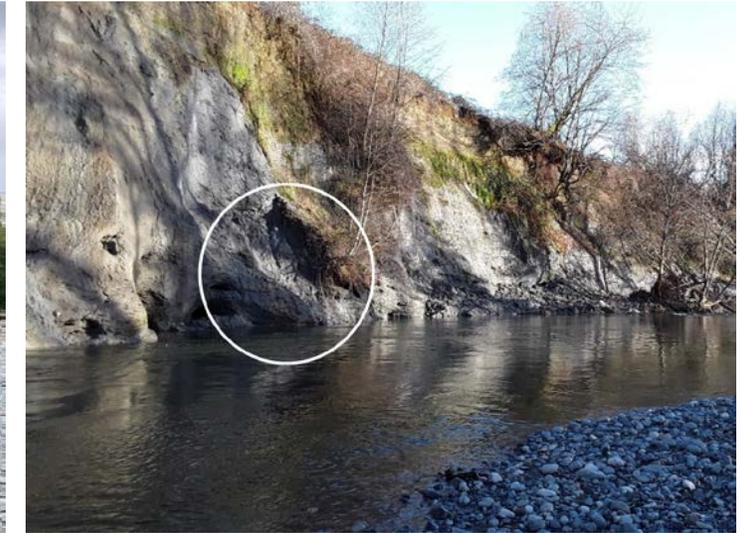
▲ Photo 4.1 Erosion at the toe of the bluff from the November 2021 flood.

- The bluffs are more resistant to erosion than other alluvial banks within the channel and have remained relatively stable in the air photo record dating back to 1950. However, undercutting of the toe of the bluff was observed during the November 2021 atmospheric river flood. Given the height of the bluffs, continued undercutting by fluvial erosion has the potential to trigger a mass wasting event which could block the river. For this reason, these banks were flagged as geotechnical hazards in the geomorphic hazard maps.

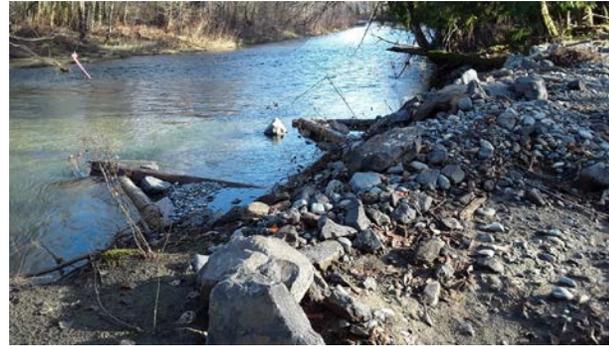
Photo 4.3 Log spurs along the right bank of the channel designed to deflect flow and mitigate against erosion. Rocks placed along bank to supplement the armouring.

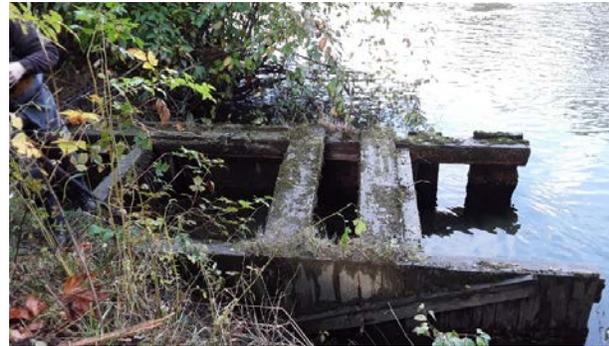
Photo 4.4 The Halalt Fisheries rearing channel rejoins the Chemainus River just upstream of the railroad bridge.

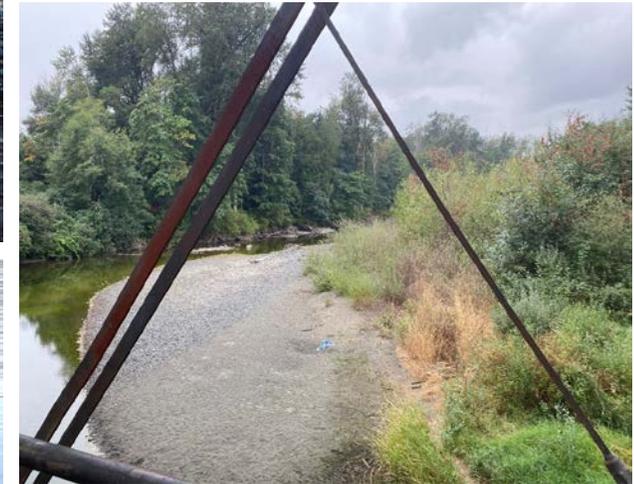
Photo taken from the railroad bridge during low-flow conditions, looking upstream at the exposed sand and gravel bar and vegetated area on the inside of the bar.

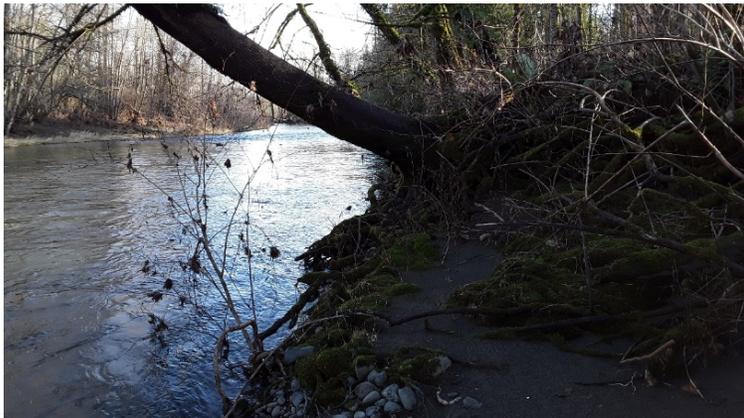
Photo 4.2 Undercutting and exposed root structure along the right bank of the channel.

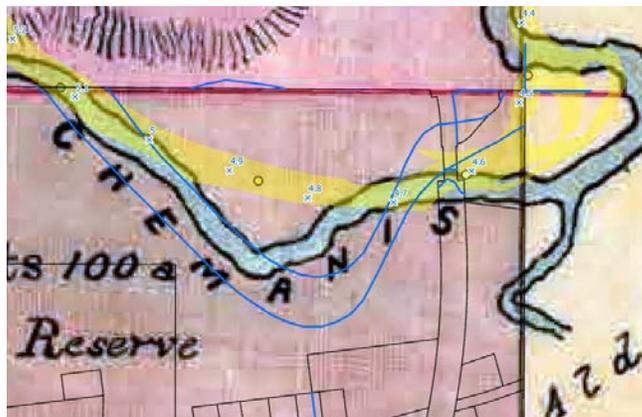
- A Canada Lands 1877 survey of the area indicates the presence of an approx. 55 m wide old river-bed south of the present-day channel from approximately RK 5.1 to RK4.7.
- This southern relic channel comprises part of the historic channel migration zone and occurs within the Halalt First Nation lands.
- If the log spurs and riprap at RK 5.1 (described on Page 23) do not control the local undercutting along the right bank, and if further erosion occurs at RK 5.1 to RK 5.2, it is possible that the Chemainus River may re-occupy the relic channel at RK 5.1 to RK 4.7.
- South of the approx. 55 m wide old river-bed is another, narrower (approximately 15 m wide) relic channel that runs south of the present-day Chemainus River channel from approximately RK 5.9 to RK 4.8 (shown with the white dashed line on the figure at right).

▲ DEM showing historical channel and visible relict channel paths.

There is a risk of avulsion into the relic channel if a triggering mechanism produces a breach of the channel banks near the upstream entrance to this historic channel in Reach 5.

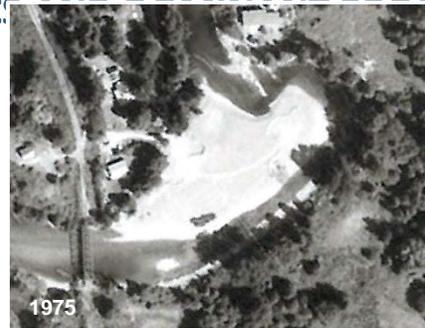
◀ Surveyed bed elevations at the mid-channel bar at RK 4.5. Between 1986 and 2021, the left channel deepened and widened. Accretion occurred along the right margin of the mid-channel bar and within the right channel.

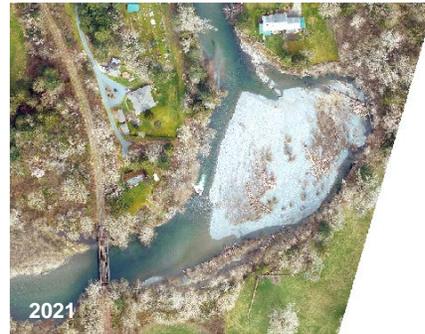
▼ Coarse to very coarse gravel deposits along the bar edge.

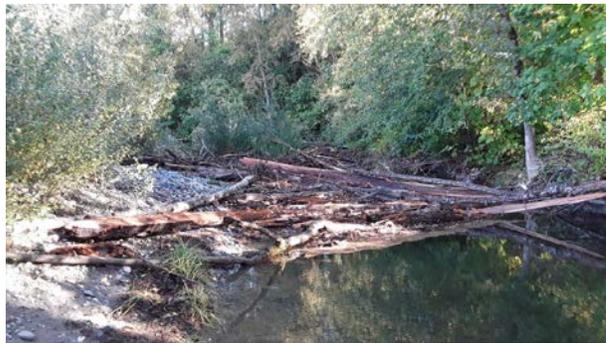
◀ 3.1 Small log jam spanning the back channel flowing behind the gravel bar.

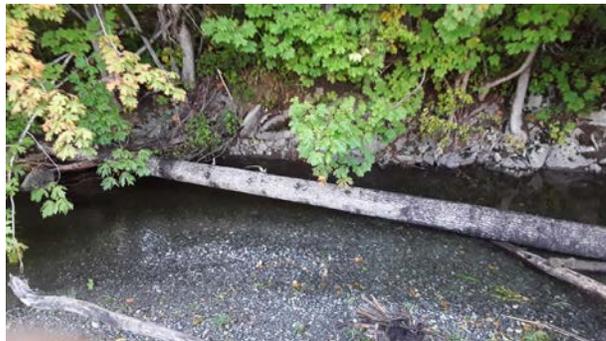
◀ Photo 3.2 Back-channel bank is armoured by riprap, which shows signs of scour along the toe.

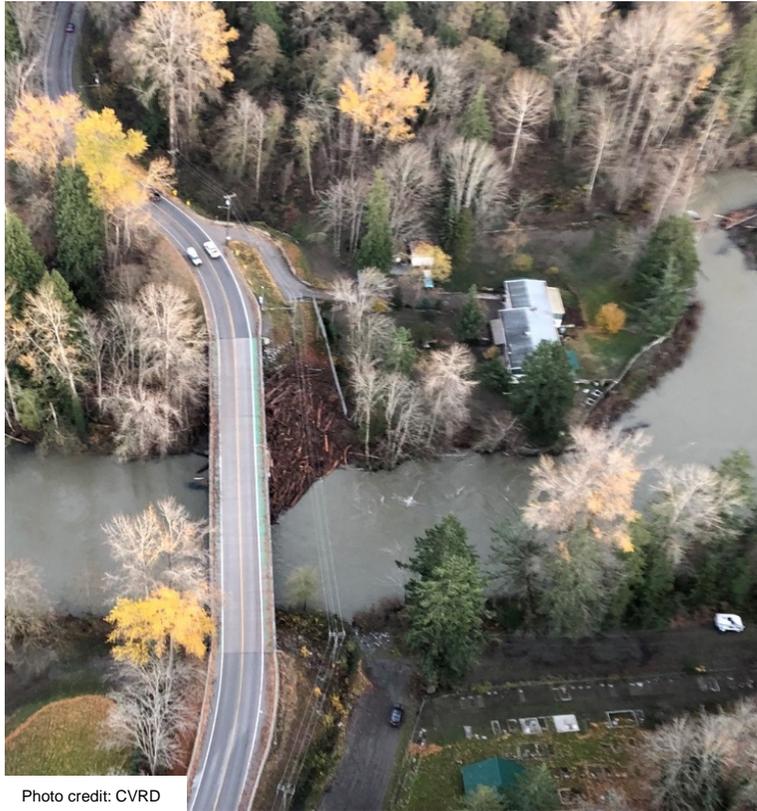
▲ Massive pile up of LWD at the Highway 1A bridge from January 2022.

The railroad and Highway 1A bridges form a distinctive hydraulic control on the system and form a zone of sediment and LWD deposition in between them.

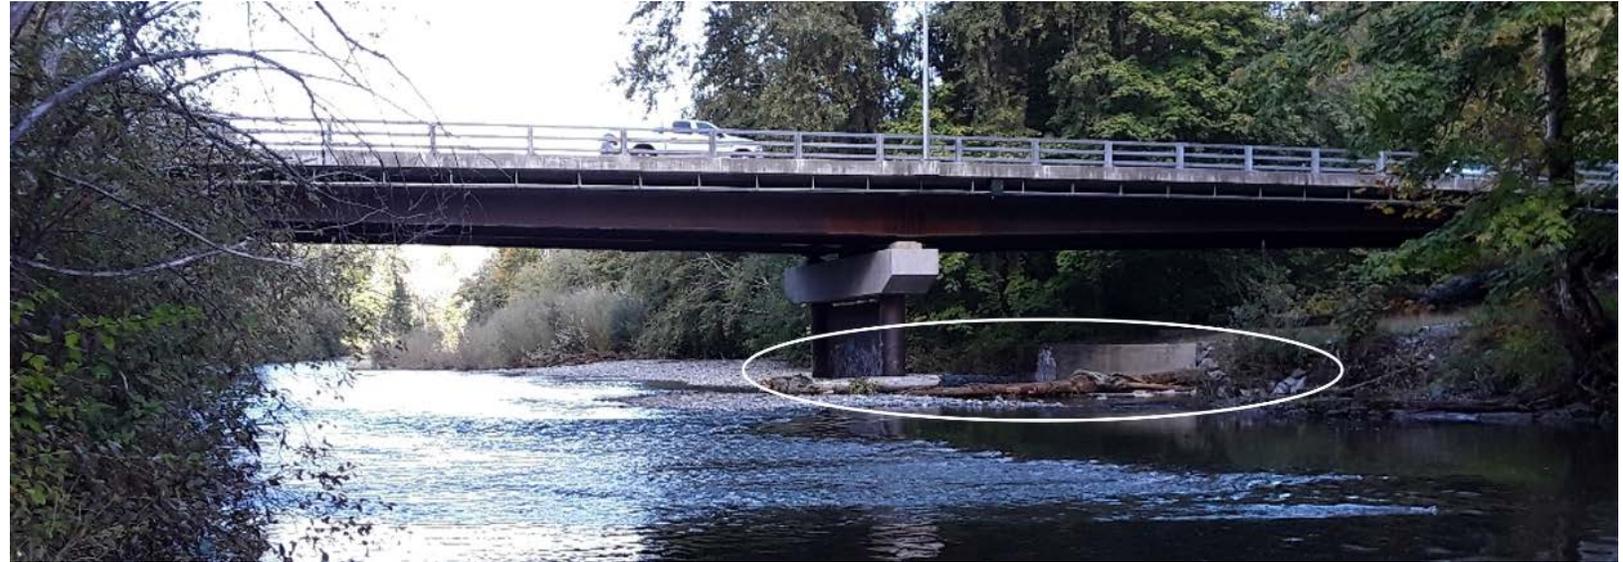
▲ Photo 3.3 Multiple logs, floated downstream by a 2021 flood, caught on the foundation structures of the Highway 1A bridge.

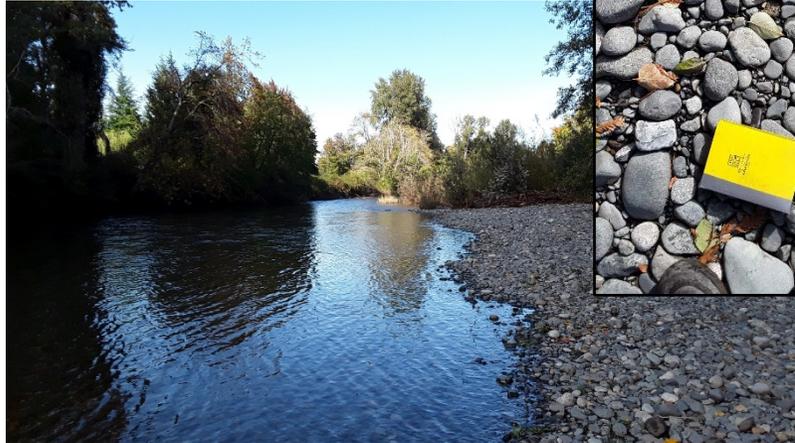
▲ Photo 2.1 Sediment accumulation along the right side of the channel downstream of the Highway 1A bridge.

- Deposition in this area is largely influenced by hydraulic expansion effects downstream of the bridge, and localized dynamics associated with LWD trapping patterns on the upstream side of the bridge.
- Bedrock along the right (east) bank at the downstream end of Reach 3 provides increased flow resistance locally and may help deflect some portion of the flow towards the left (west) side of the channel.
- Riprap armouring has been installed along an approximately 40 m section of the right bank line downstream of the bridge. The channel has widened in this area since 1992, likely prior to riprap installation.

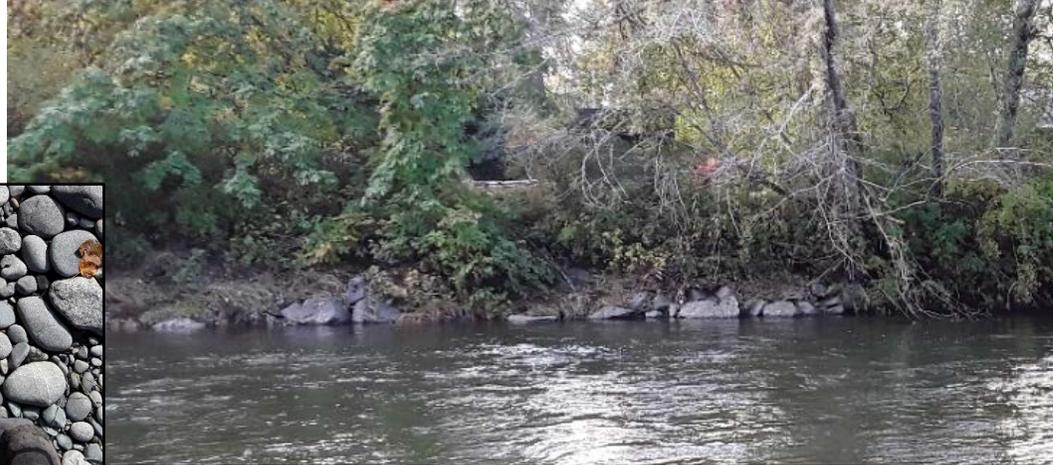
► Photo 2.3 Downstream of the riprap, the bank is composed of silty material with clay and fine sand. The toe of the bank is a gravel-sand mix.

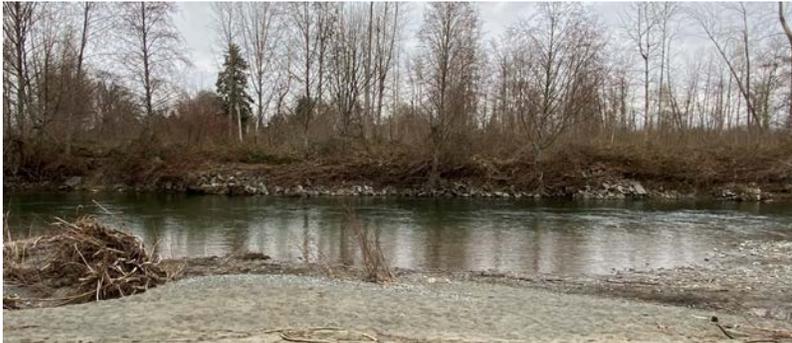
▲ Photo 2.5 The bar tail has a high proportion of sand. The bank opposite the bar has been stabilized with riprap.

- Bar texture is finer than observed in upstream reaches, with gravel deposits along the bar head and bar margin, and a high proportion of sand deposited on the mid-bar and bar tail.
- During high-flows, water is conveyed across bar-top channels and a back-channel that flows behind the bar.
- As the bar has developed and migrated downstream since 1992, the outer bank across from the bar has been eroded to accommodate the space occupied by new bar area.
- Across from the bar, riprap armouring limits the channel's ability to erode an approximately 100 m long section of its banks. The erosive force focused on this area is likely transferred downstream, affecting patterns of downstream erosion.

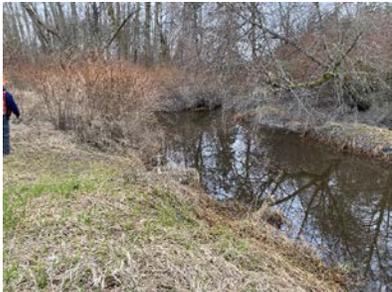
▲ Photo 2.6 Channel flowing behind the bar-island complex.

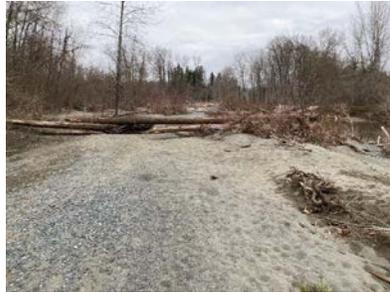
▲ Photo 2.4 LWD deposited across the tail of the bar.

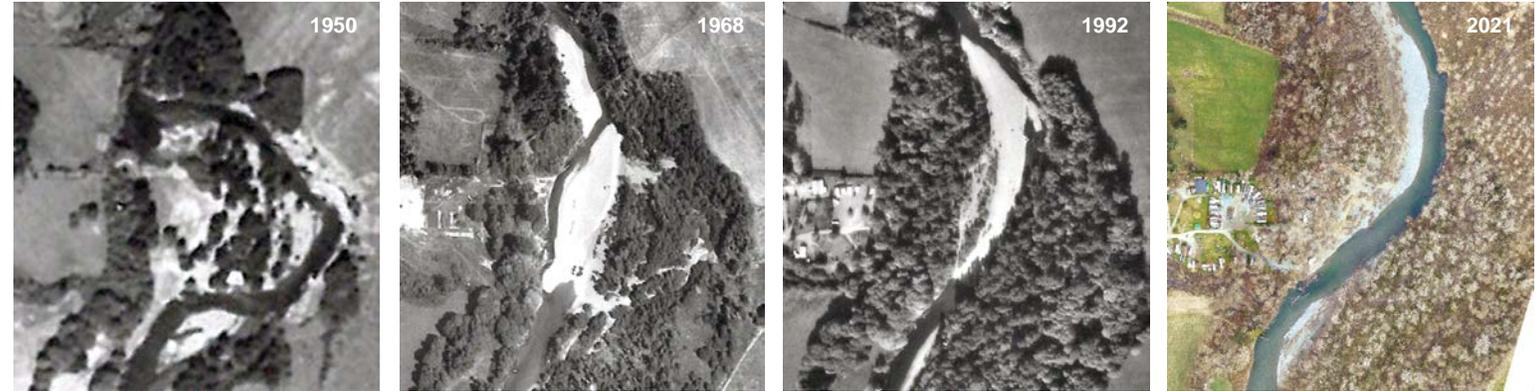
▲ A channel avulsion occurred between 1950 and 1968. Since then, the gravel bar has become increasingly stable as vegetation has established on the bar interior. The bar and meander bend have migrated downstream since 1992 as sediment is eroded from the bar head area and deposition occurs on the bar tail.

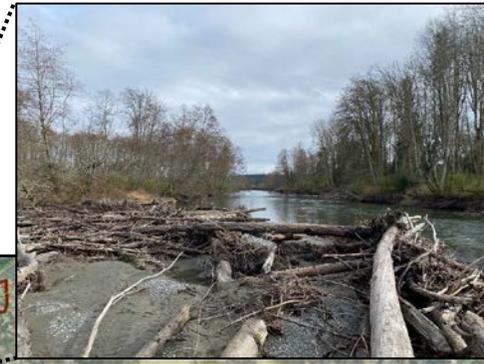
◀ LWD and sediment accumulation at the head of a distributary channel, viewed downstream toward the mainstem.

- The primary flow path for the Chemainus River used to flow farther north and has been blocked by sediment and LWD accumulating at the entrance over the past decade or so. The lower reach of this channel borders the boundary of the Stz'uminus First Nation Squaw-Hay-One administrative boundary located approximately 800 m to 1,000 m downstream, to the northwest.
- Hydraulic effects of this blockage on mainstem channel overbank flooding and erosion potential is uncertain and has not been verified.
- The Reach 1 slope (0.0005 m m^{-1}) is much flatter than upstream resulting in a finer bed texture, and increased deposition of sediment and LWD.
- The position of the channel network is constrained at several locations by the presence of northwest to southeast oriented bedrock ridges in the estuary.

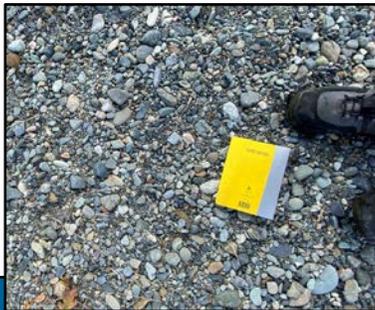
▶ Example of the fine to medium gravels deposited on the bar surface at the pebble count location.

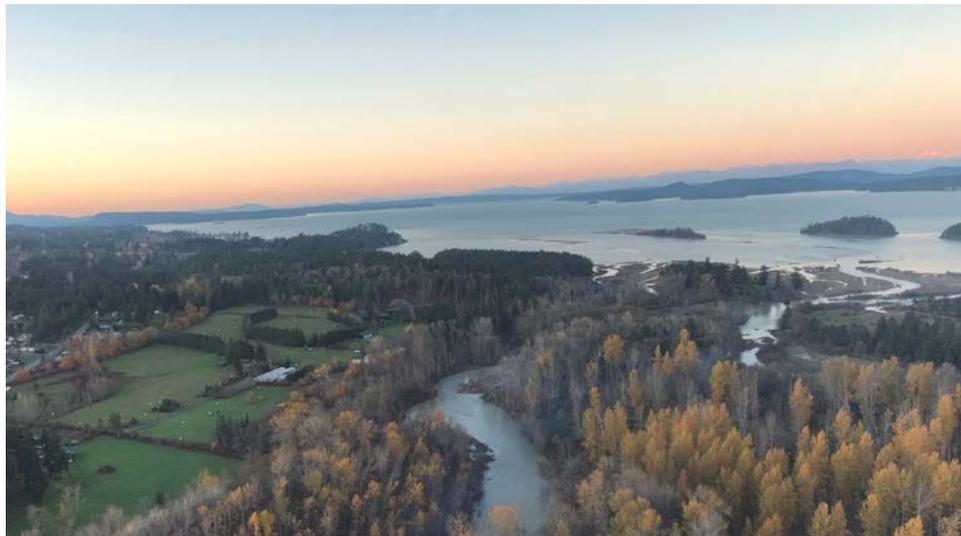
▲ Photo looking north over the Chemainus River Estuary (CVRD photo).
