**COWICHAN VALLEY REGIONAL DISTRICT
ENGINEERING AND ENVIRONMENTAL SERVICES DEPARTMENT
DUNCAN, BRITISH COLUMBIA**

**ENVIRONMENTAL REVIEW
1355 AND 1345 FISHER ROAD, COBBLE HILL, BRITISH COLUMBIA**

N23101632

November 23, 2010

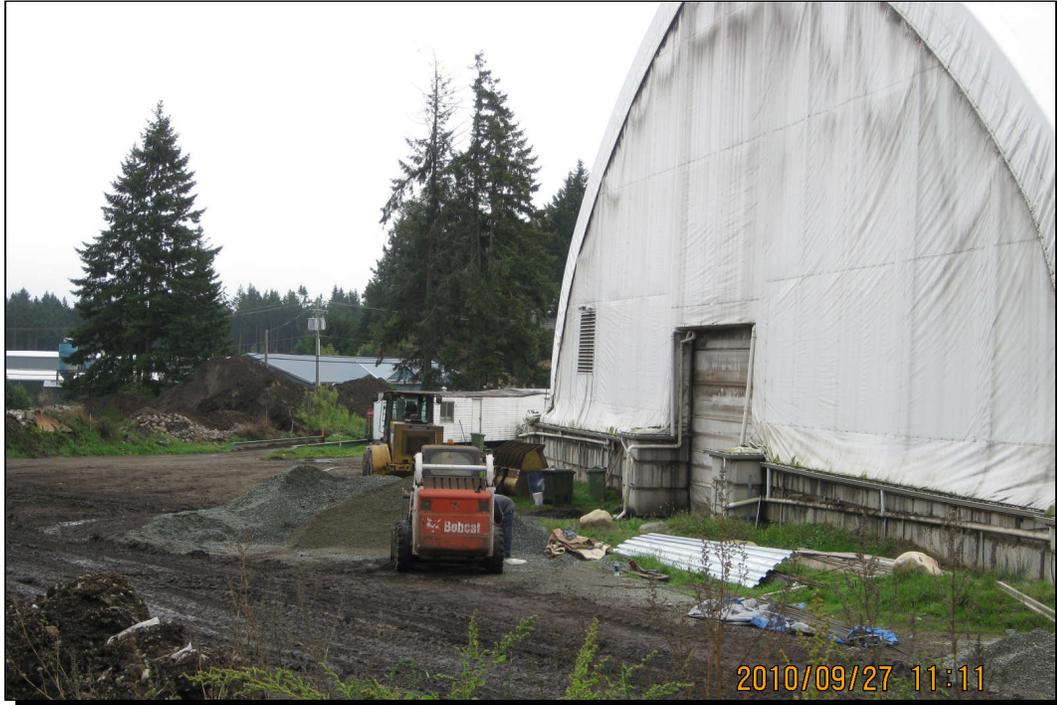
Photo 1

View of the entrance to the indoor facility at Fisher Road Recycling Facility.

FRRF is currently licensed under CVRD Bylaw 2570 Waste Stream Management Licensing to operate as a commercial compost facility and operates under the Organic Matter Recycling Regulation (OMRR), with an annual operating capacity of 18,000 metric tonnes. Photos 1 and 2 show the site operation and the finished product.

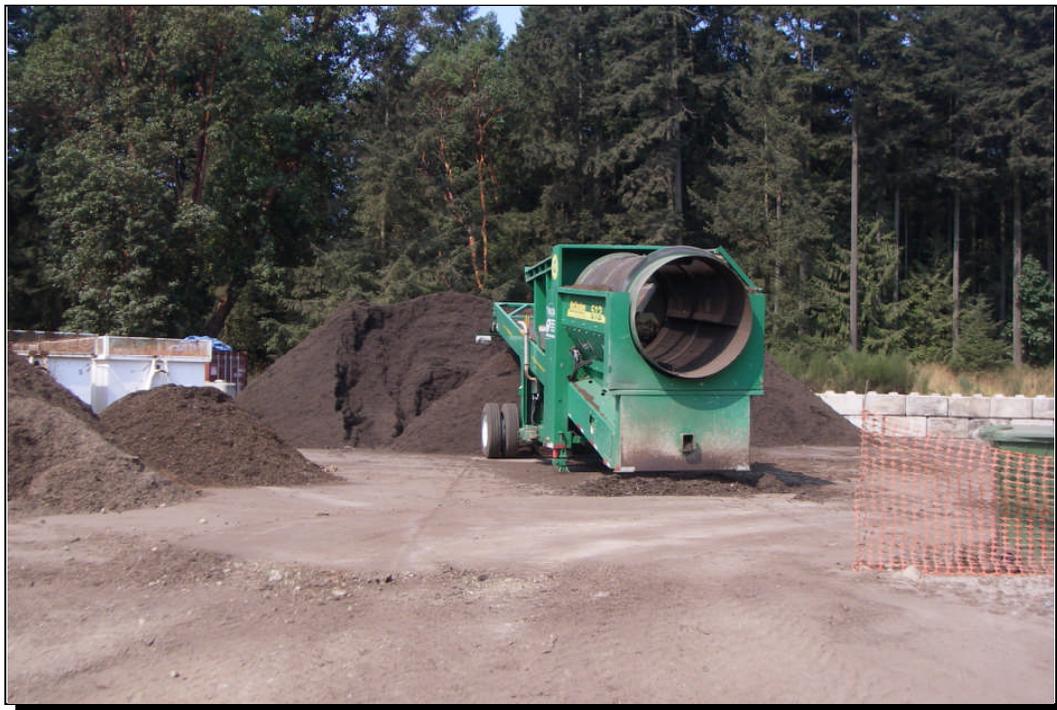
Photo 2

View of the finished screened Class A compost on concrete pad.

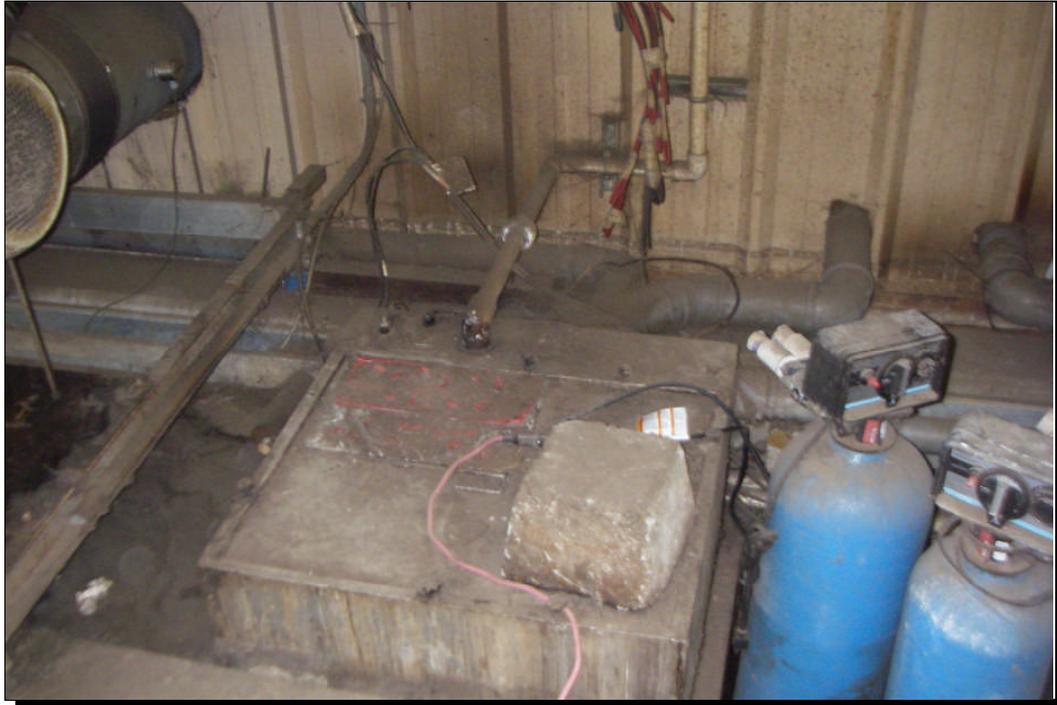
Photo 3
View of the leachate collection tank.

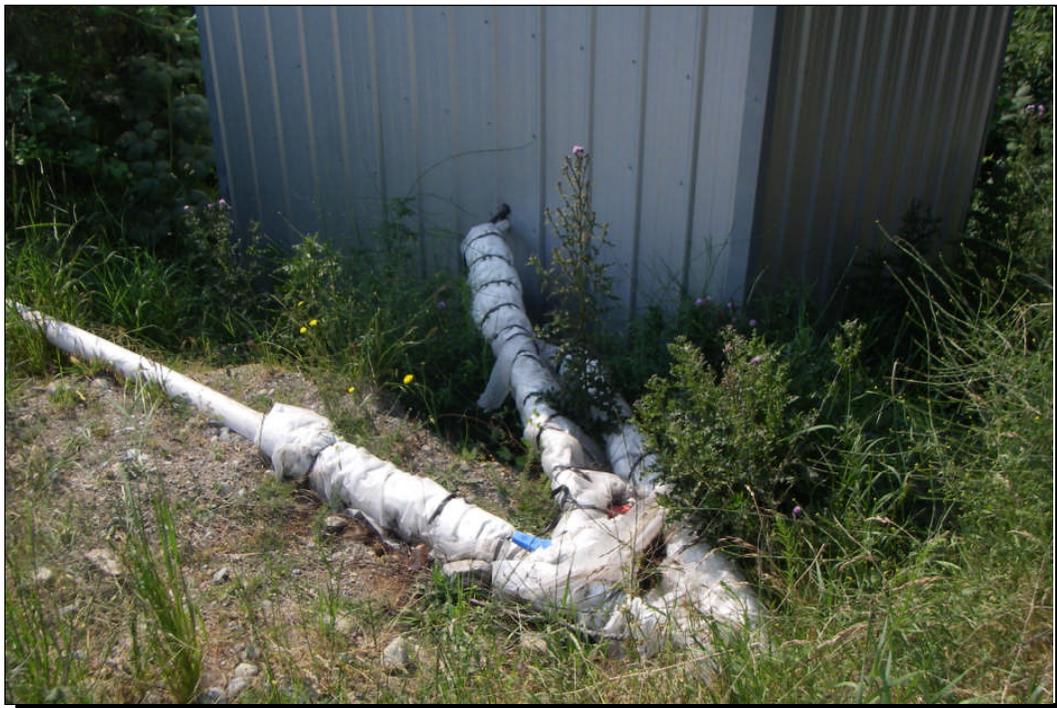
Photo 4
View of the leachate and condensation collection tank and associated piping for recycling.

Leachate and condensations collected during the other indoor curing building is collected in gutters located near the edge of the concrete pad and is then directed by pipe to a secondary leachate collection tank. Leachate and condensation that forms in the biofilters (processing buildings) is also collected in gutters and directed to the secondary leachate collection tank (Photo 5). Leachate is recycled in the cell and used as a source of moisture. The facility requires moisture for the curing process and recycles the leachate from the tanks onto the curing piles to add moisture to enhance organic breakdown. Water from the groundwater well is also used to add moisture to the compost piles. The facility attempts to collect as much moisture as possible to assist with and expedite the curing process.

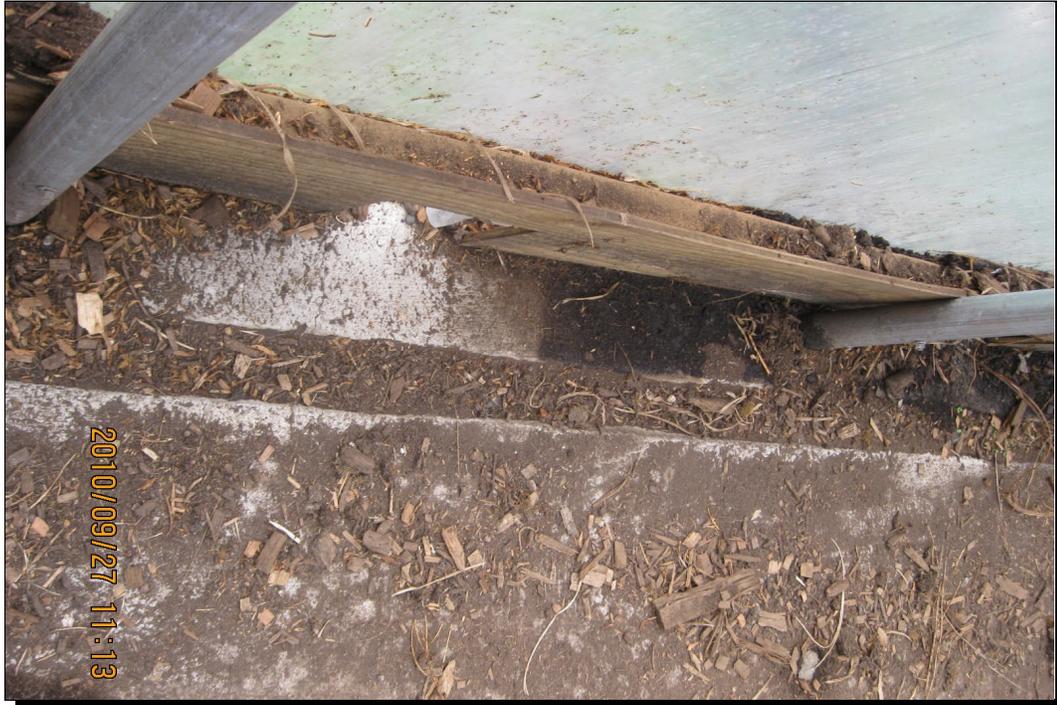
Photo 5
View of the condensation collecting gutter system on the concrete pad inside the biofilter.

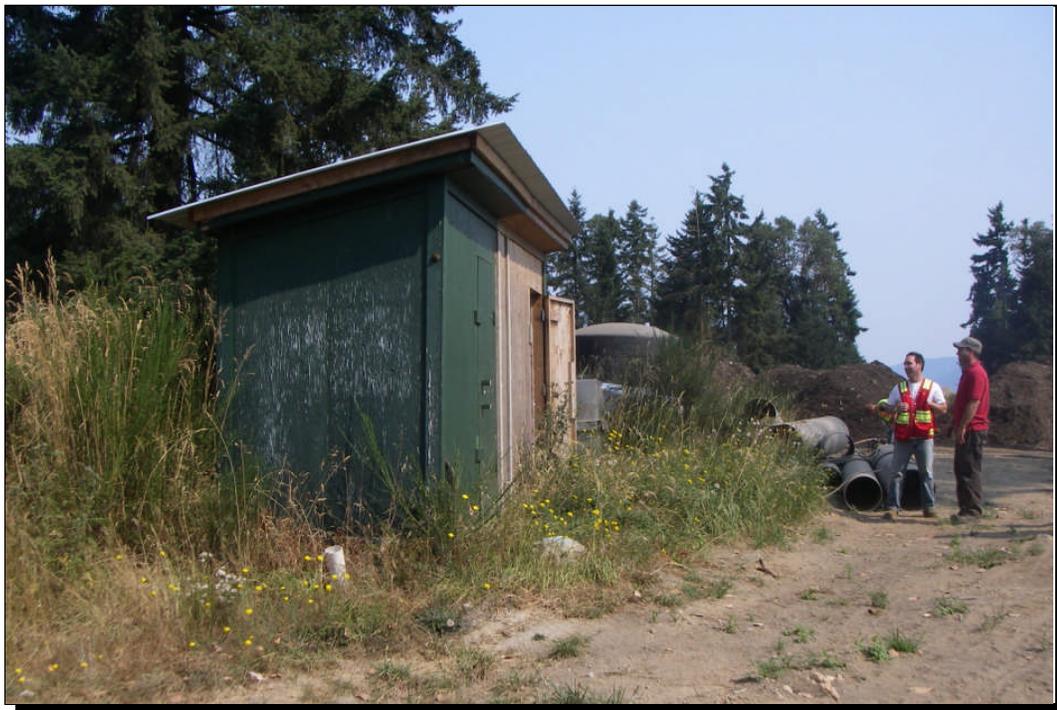
Photo 6
View of the shed containing the onsite groundwater well.

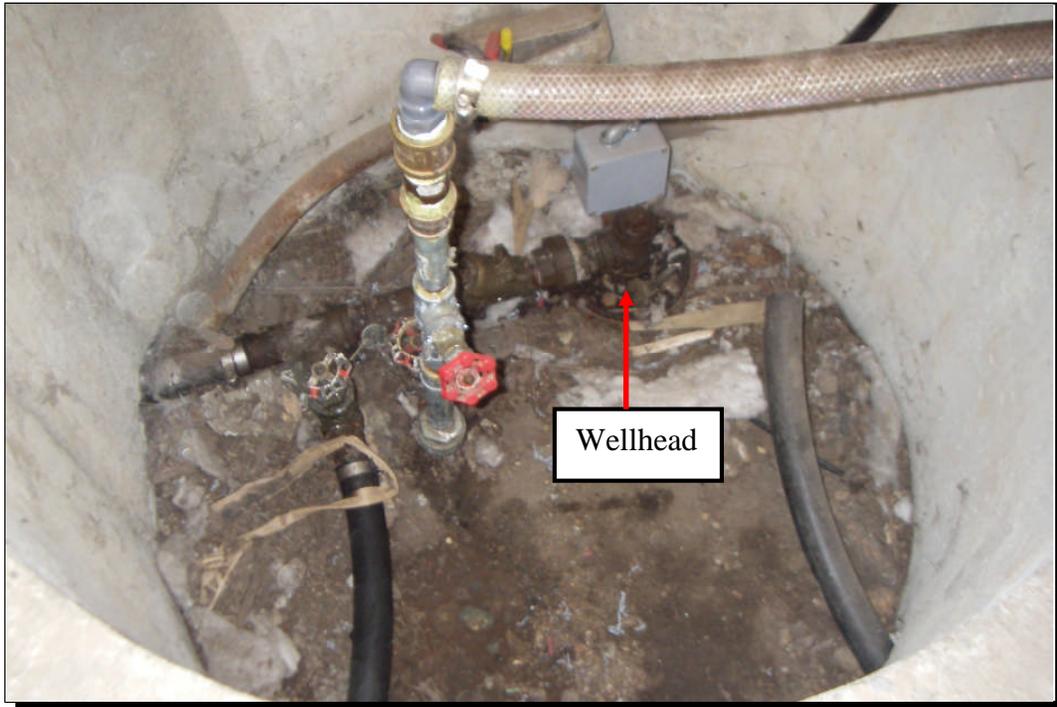
Photo 7
View of the wellhead at the base of a 1 m concrete ring.

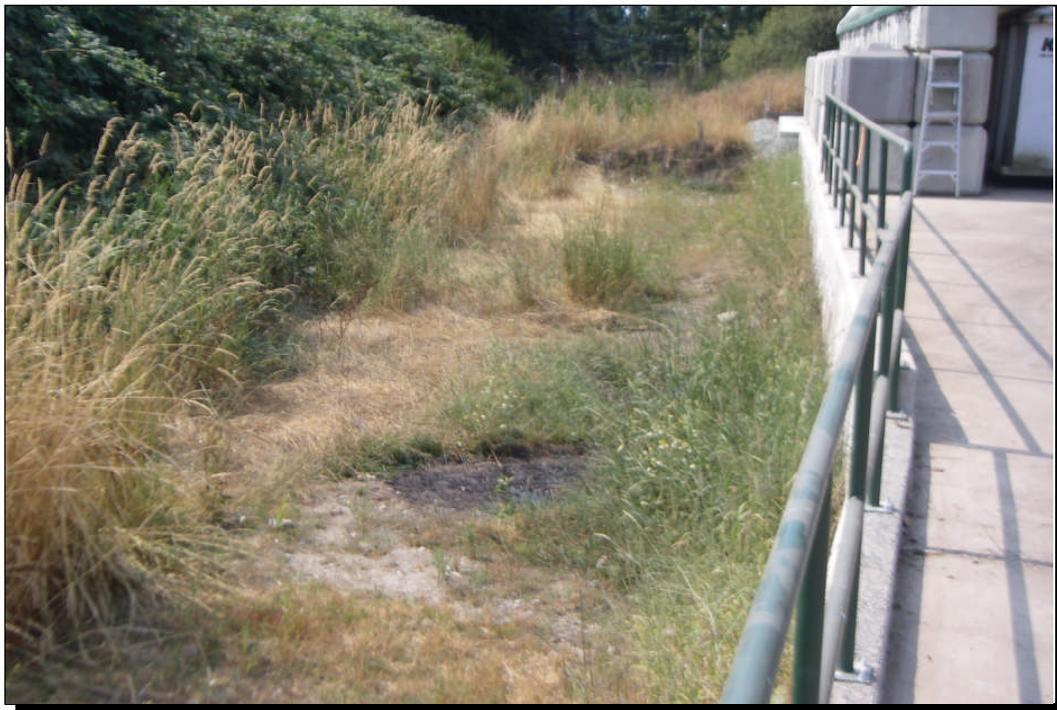
Photo 8
View of the Swale that parallels Fisher Road. Runoff from the infiltrates into the subsurface here.

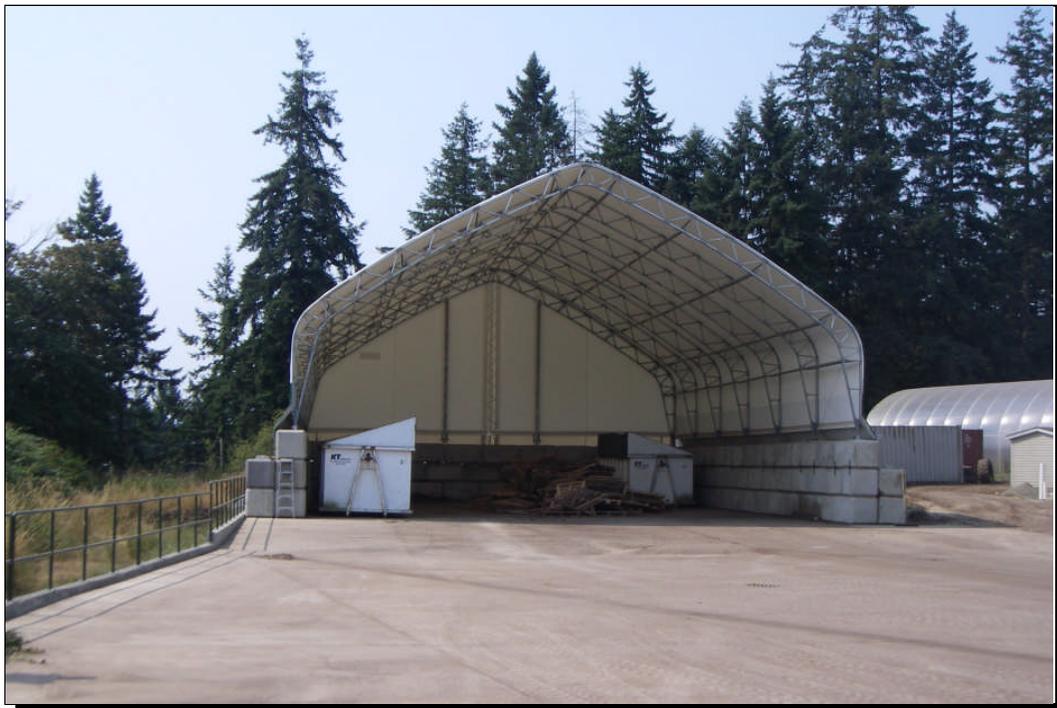
Photo 10

Household garbage drop-off area.

General refuse will be received on a concrete pad within a covered building with an open front and no doors (Photo 10). All putrescible waste (i.e., odorous household garbage) will be stored in closed bins at the end of each day to be transferred to the CVRD Bings Creek facility for disposal as per their operating plan. Mixed recyclables will be sorted and stored in wheeled carts, bags, and/or other secure containers (Photo 11). Other materials will be received in a designated covered bunker area. Stored general refuse has the potential to be a source of odour during the day and at the end of each day the refuse will be loaded into a closed roll-off container for storage prior to transfer to Bings Creek facility for disposal. None of the other items that will be disposed in the recycling area are expected to be odiferous.

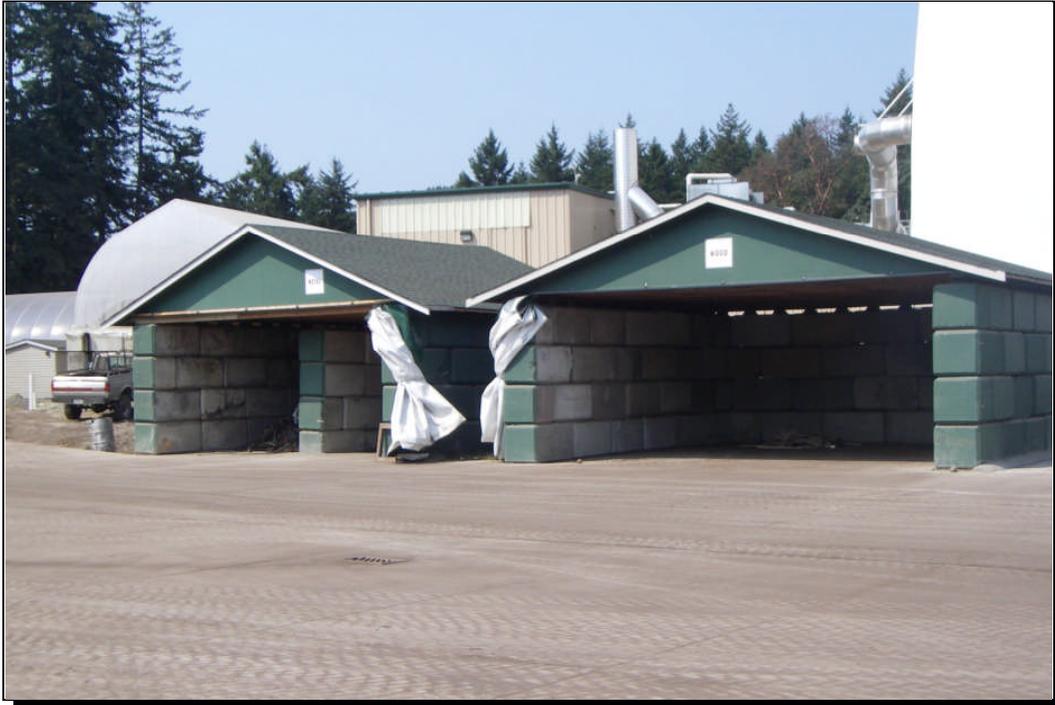
Photo 11
New recycling goods drop off facility.

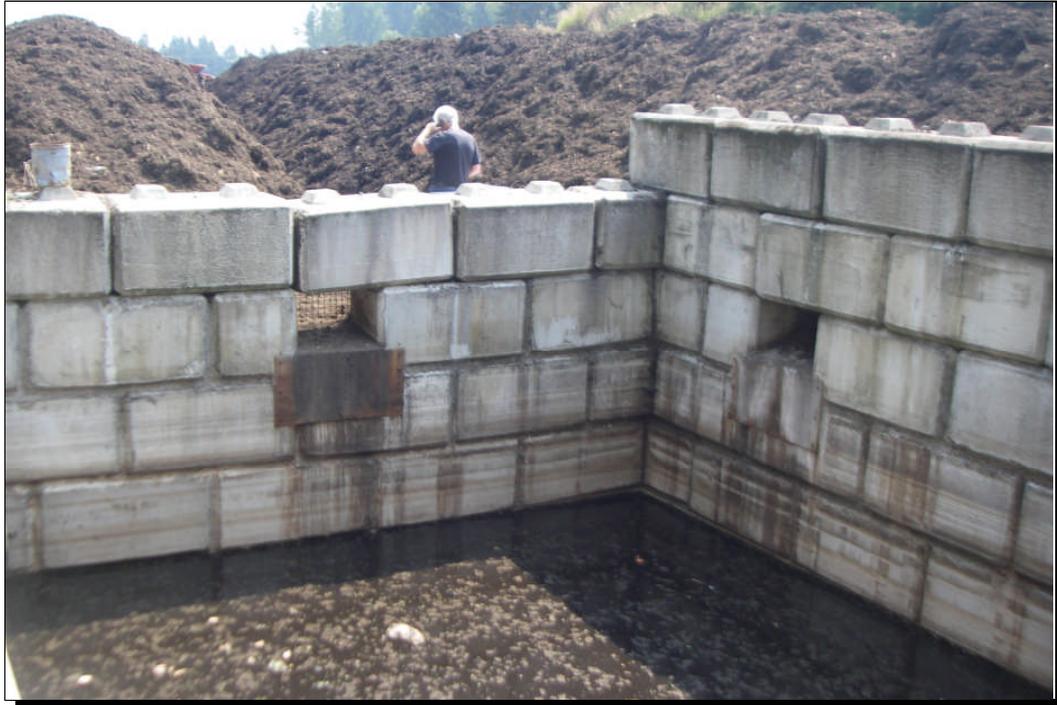
The waste material is brought to the site and placed on an impermeable asphalt pad during curing and processing. Leachate and precipitation runoff that is generated is directed to a leachate collection pit constructed of grouted concrete block to prevent leaking (Photo 13). The leachate collection tank is approximately 6.75 m x 6.75 m x 2.25 m deep and floored by asphalt. The leachate is re-used on the composting piles. Once the compost meets Class A standards it is transferred to another part of the site and is stored on the native ground (Photo 14) and is sold as is or mixed with soil that is imported to the site (Photo 15) to create a top soil mix.

Photo 13
Constructed leachate collection pit at Central.

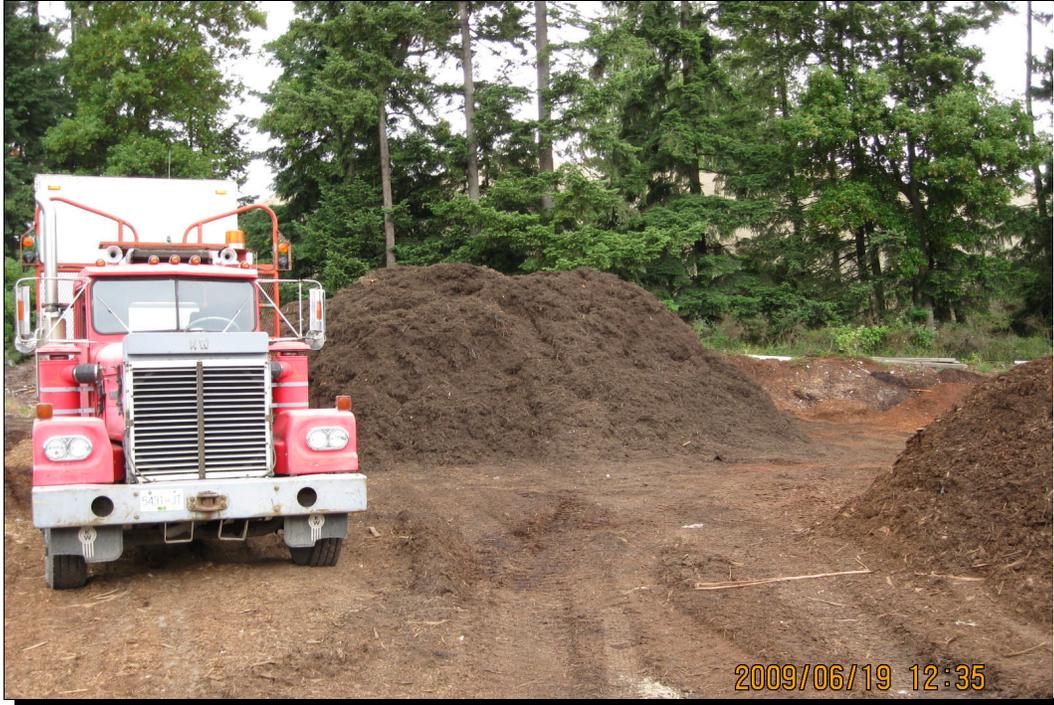
Photo 14
View of Central's Class A compost finished product.

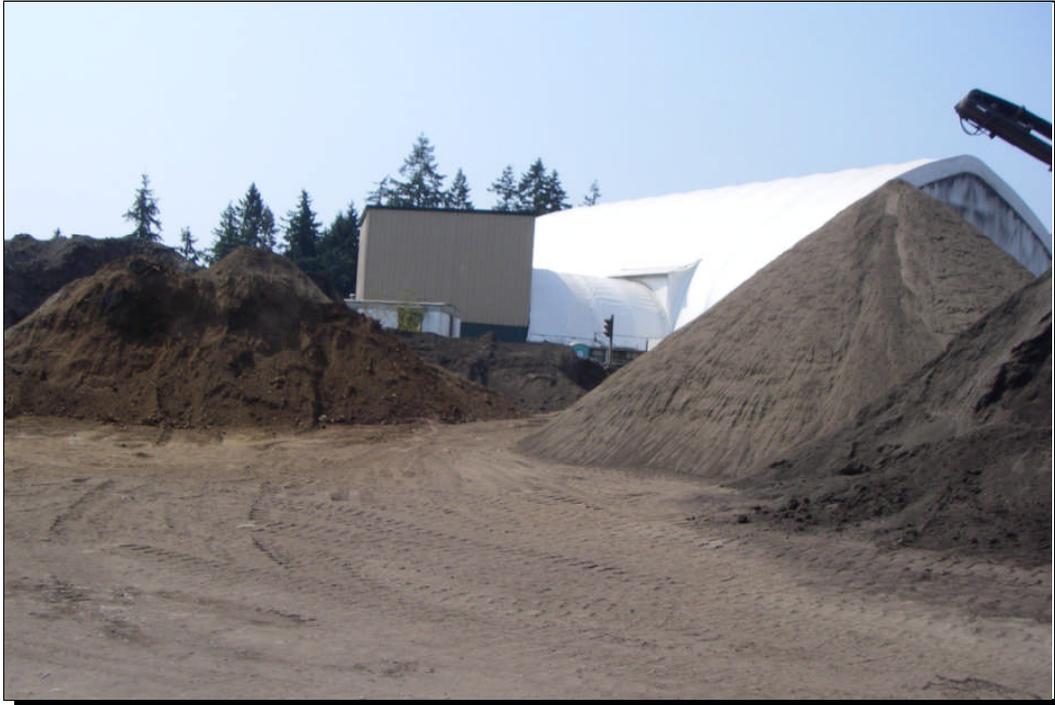
Photo 15

Imported mixing soil for Class A compost to create a topsoil mix at Central.

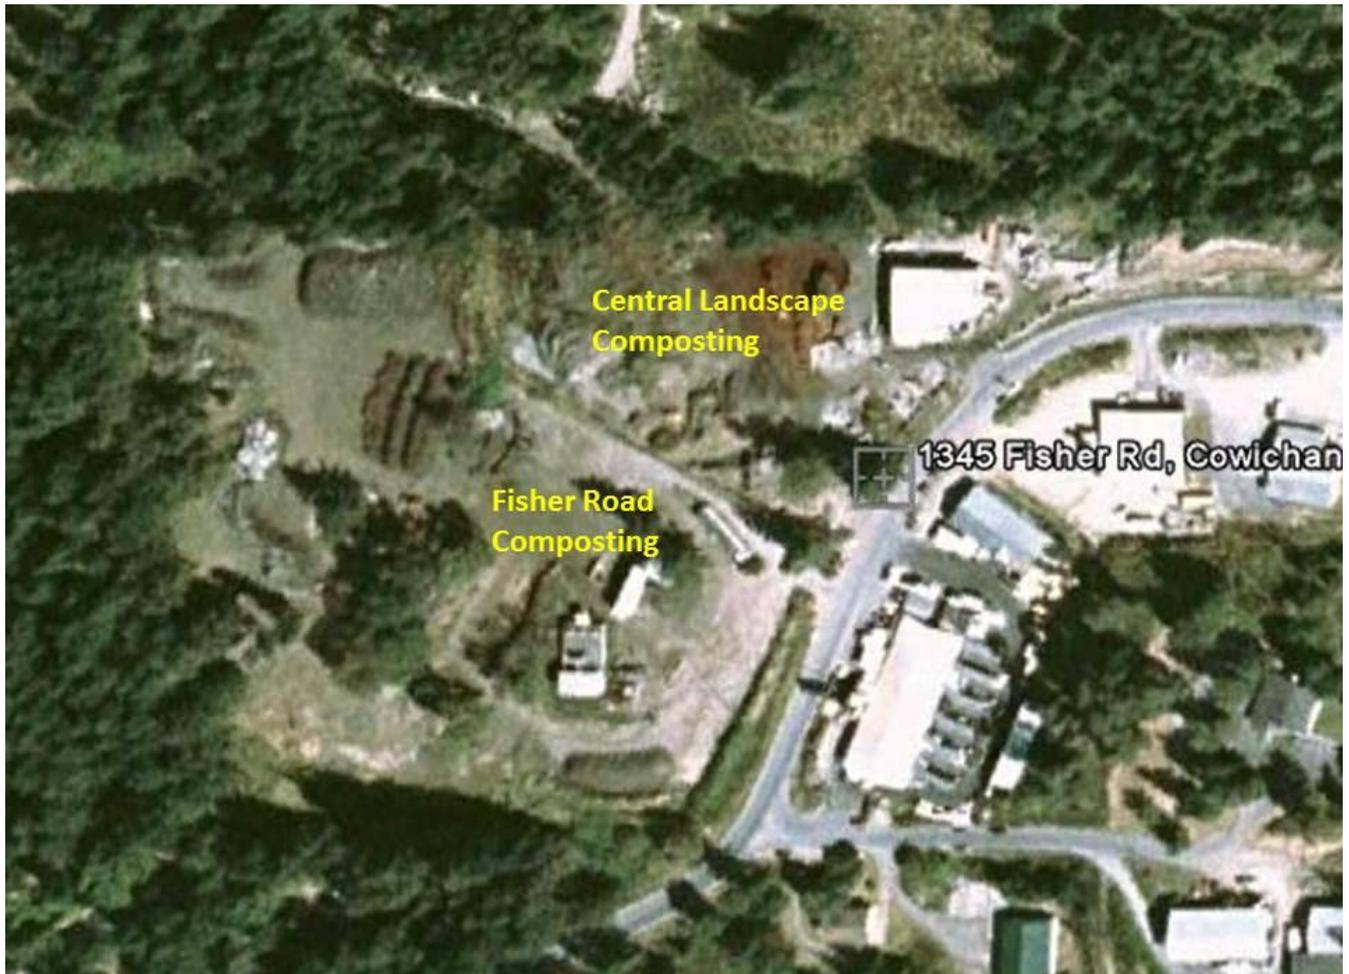
Location of the Composting Facilities

The map below shows the location of the two composting facilities. The map is from 2005, which predates the upgrades to the Fisher Road Recycling Facility and the Central Landscape Composting Facility.

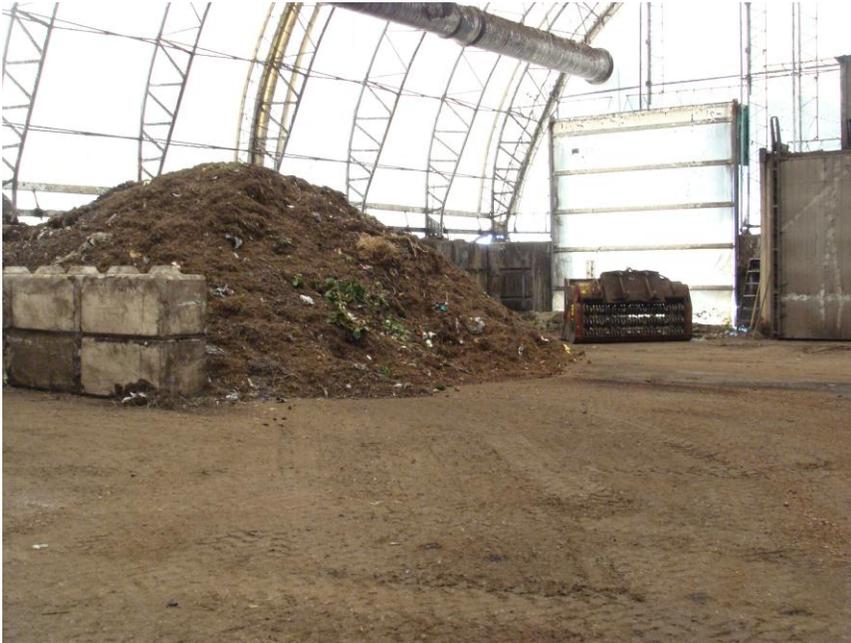
The photograph to the left shows the receiving and mixing area in the 120 ft wide by 130 ft long tarp structure. This building has an air extraction rate of 30,000 CFM,

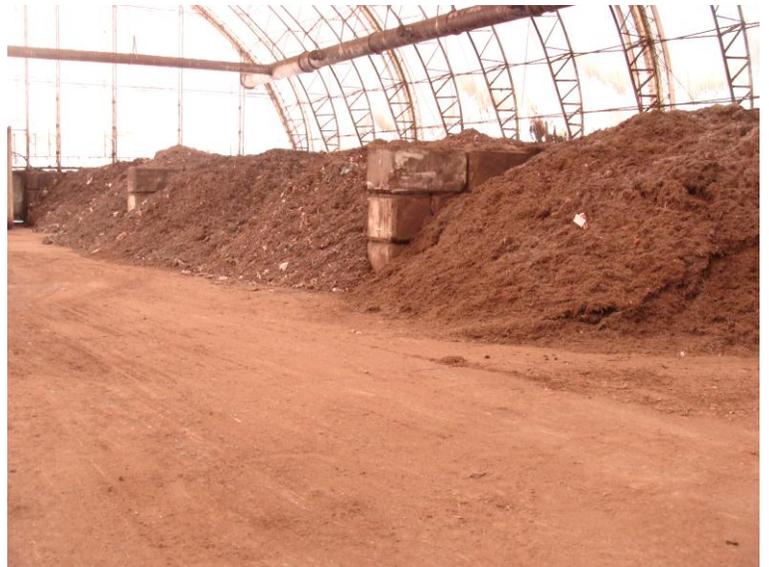
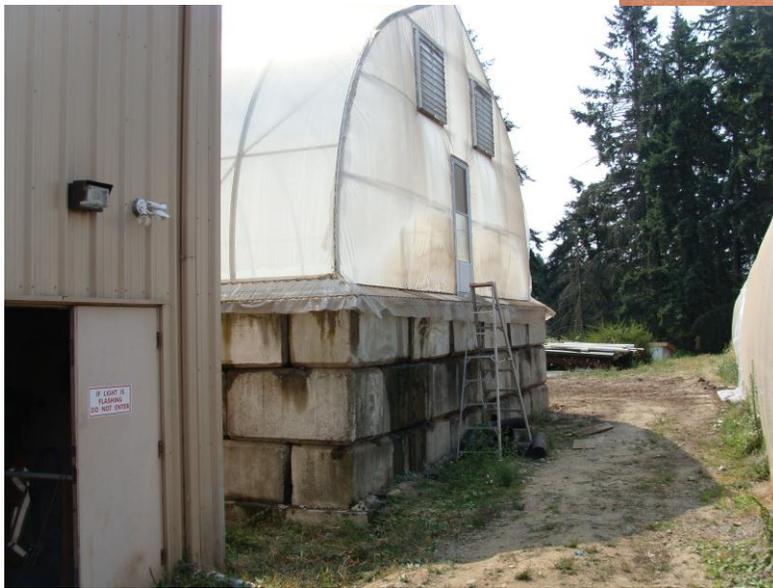
The photograph below shows the covered building where the biofilter is located that processes the air from the primary in-vessel composting boxes.

At the time of our visit, the facilities were clean, the air inside the receiving, mixing and curing building had minimal odour, and the biofilters appeared to be functioning very well.

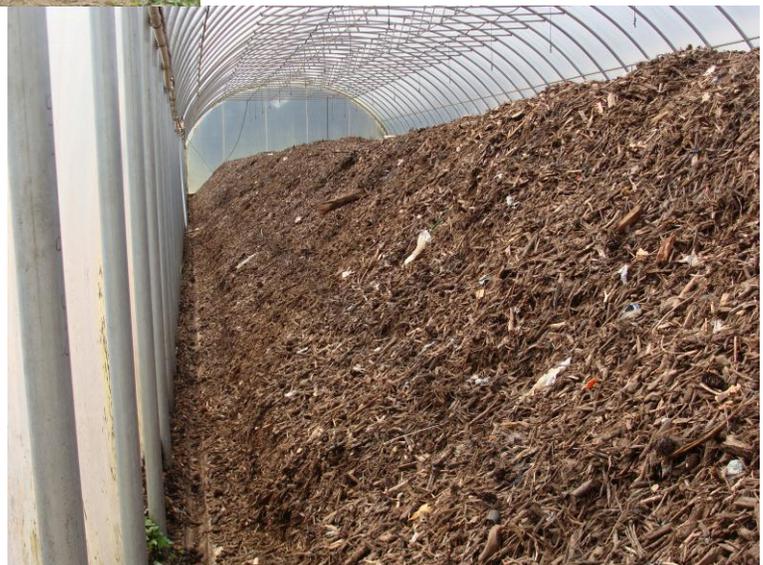
The photograph on the right shows one of the covered biofilter buildings that process the air from the receiving, mixing and curing building.

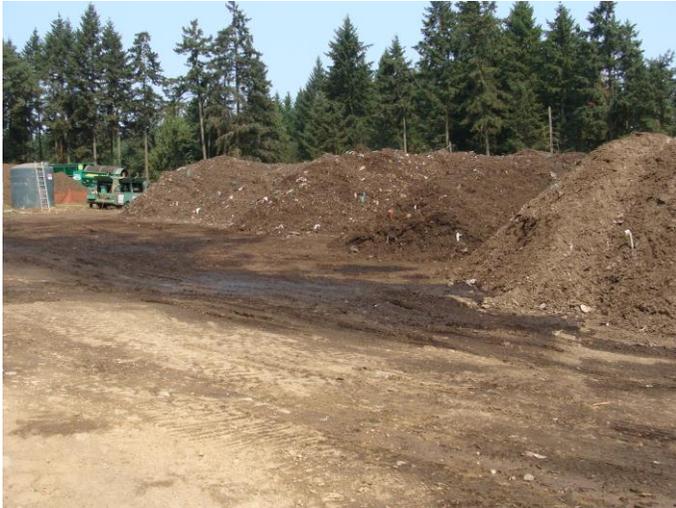
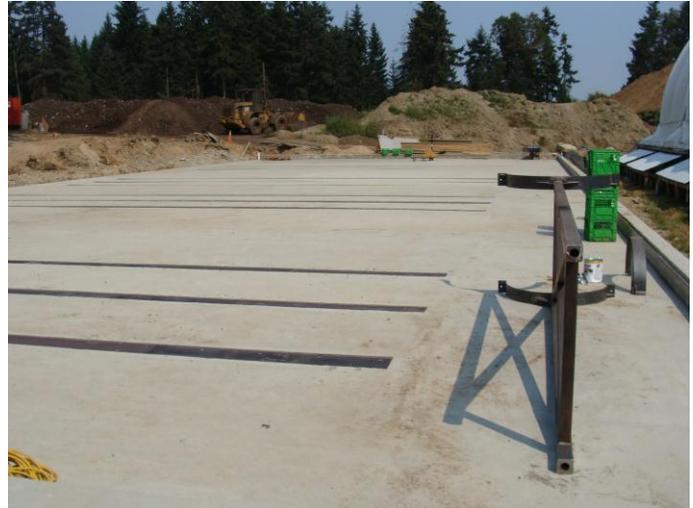
The above left photo shows the storage and further curing of the compost after processing in the composting and curing building. The above right photo shows a new curing and storage floor that the owners were installing to allow them to store and further process the material in an environmentally safe manner.

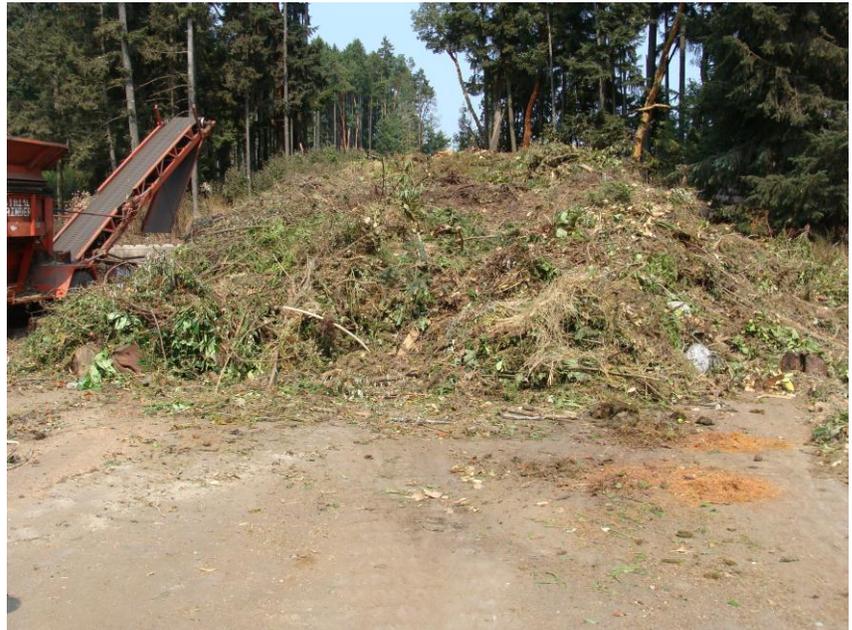
The photograph to the right shows the greenwaste receiving and grinding area.

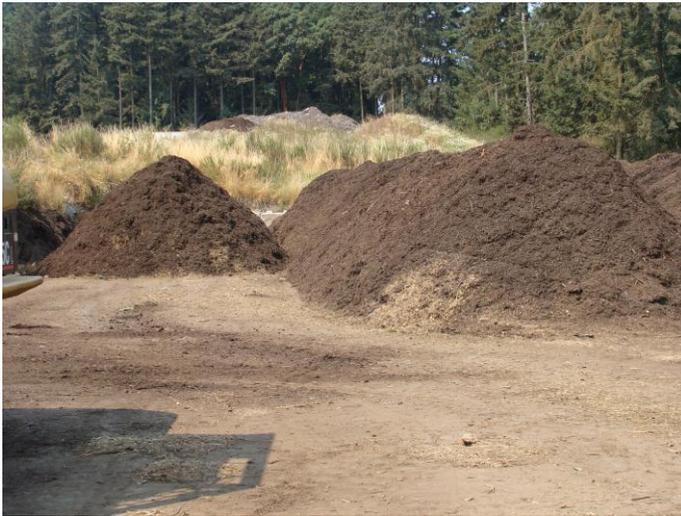
The photograph on the left shows the composting windrows. These windrows are approximately 5 m wide and 3 m high.

The area for active composting, curing and storage appears to be approximately 1000 m³ (25 m wide by 40 m long), which is confirmed in Scott Gamble's Assessment of Compliance dated March 27, 2009. This allows 4 windrows measuring 5 m wide by 3 m high by 35 m long.

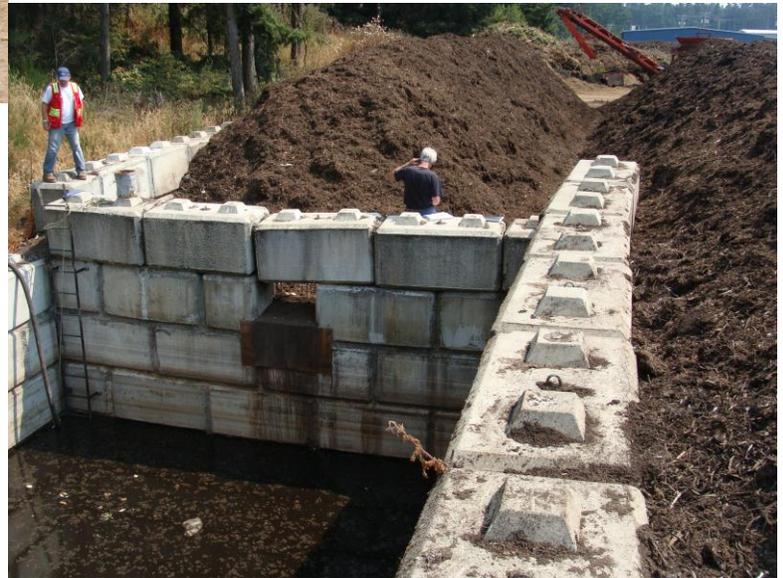
The leachate collection tank (photograph on right) measures approximately 6.75 m by 6.75 m by 2.25 m deep (3 layers of blocks?) to the asphalt layer. Discolouring on the blocks show that the level of leachate in this tank has been higher than the intake at the west end.

There is no active aeration in any of the composting material, and the leachate collection tank did contain leachate. Some odour was evident at this facility. It was not possible to distinguish whether it was odour from the leachate collection tank, or from the active windrows.
