Bright Angel Park Recreation Rejuvenation Project

final report photos

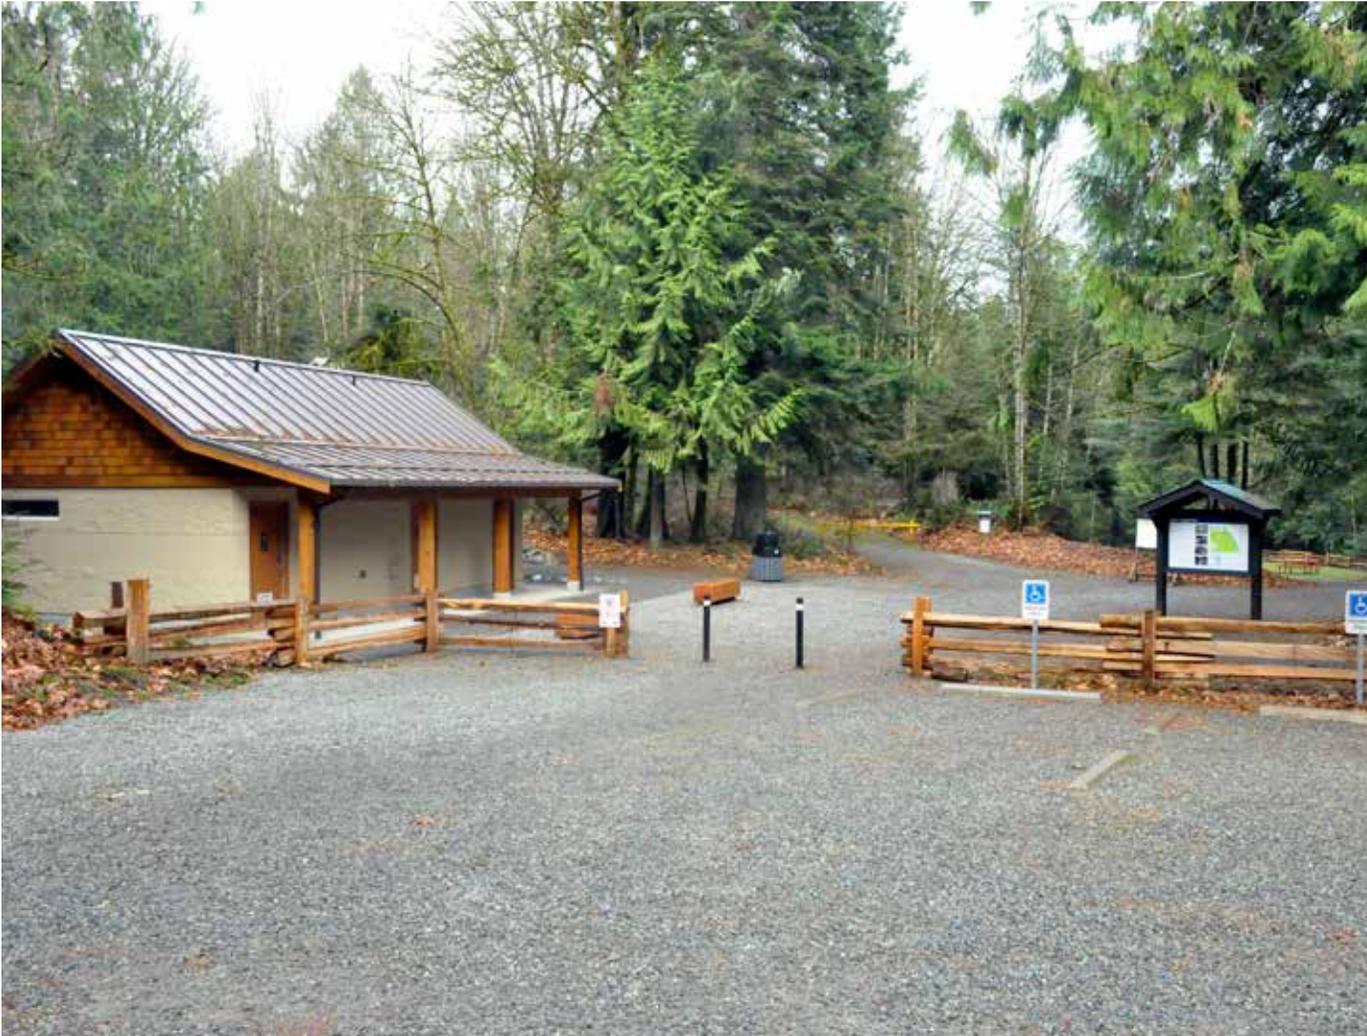
photo 1

This photo is facing north taken in the main parking area which was reconfigured and surfaced during this project. The view in the photo shows the new washroom building and main intersection of 6 trails including the main accessible loop as well as the shorter direct link between the field, playground and exercise equipment and the washroom building.

The reclaimed greenspace and new picnic area is in the background of the photo.

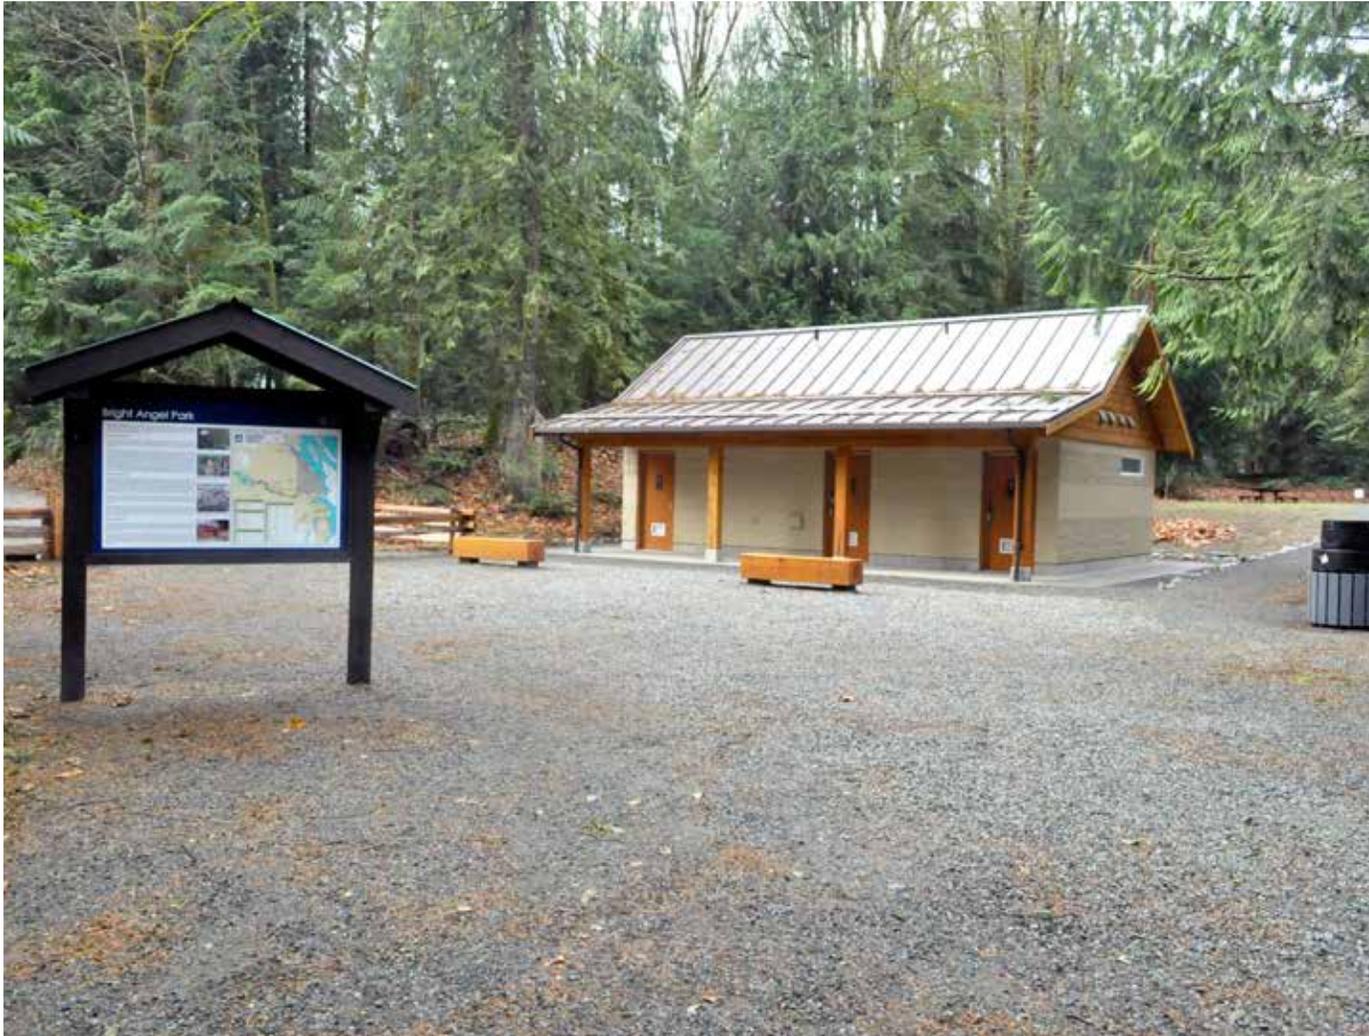
photo 2

This photo is facing south west at the main intersection of trails or the hub of the park. This view shows a new two sided kiosk, in ground garbage receptacle, new washroom building and the main parking area behind the split rail fence.

The new septic field for the washroom building is in the background beyond the picnic table.

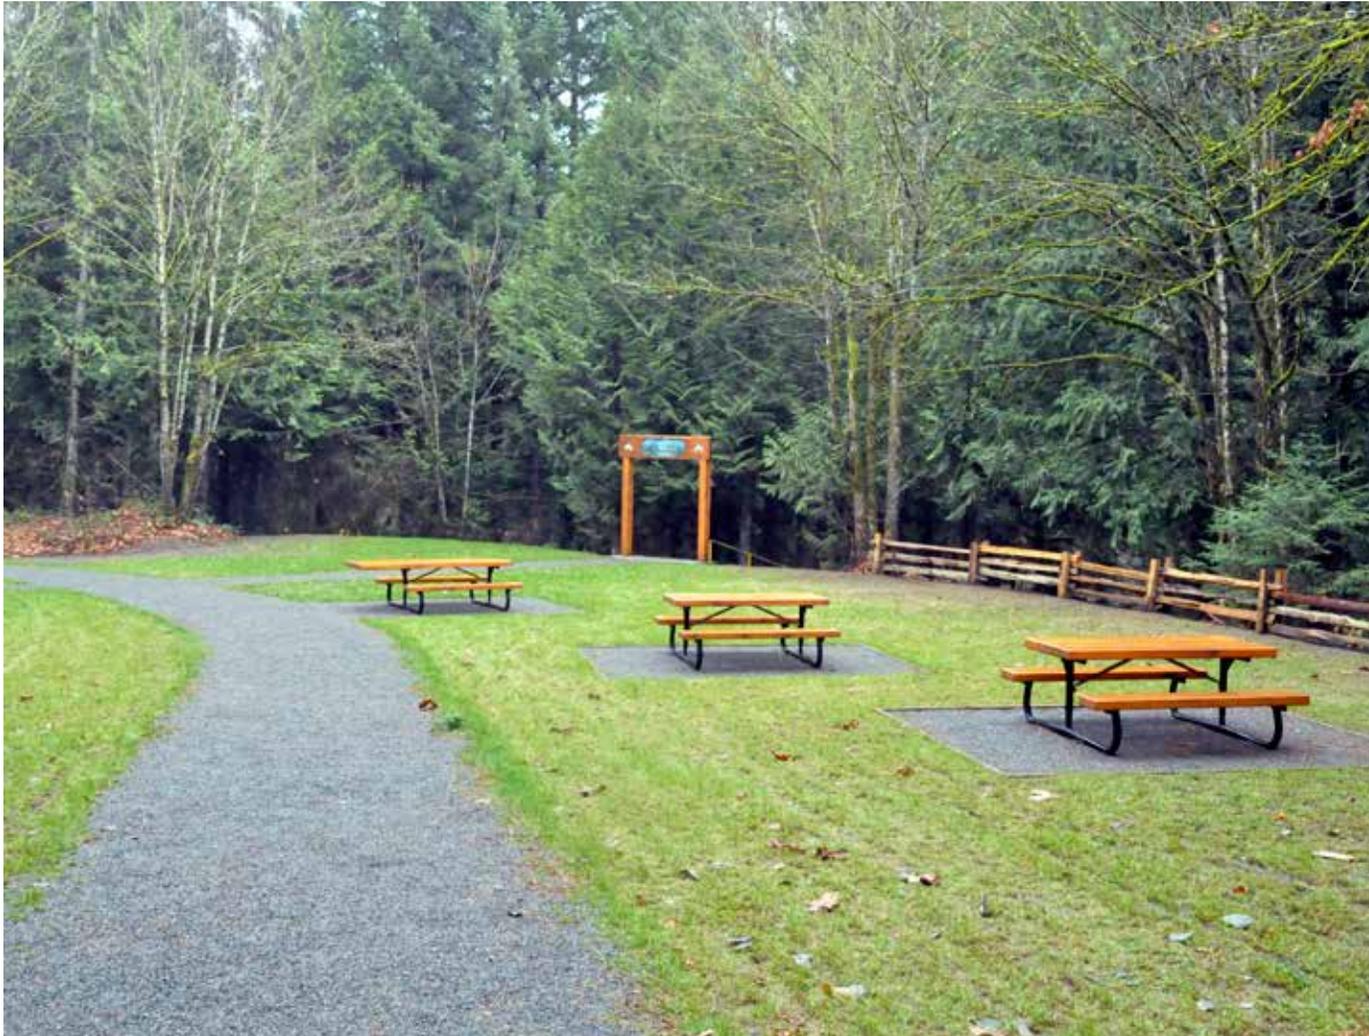
photo 3

This photo is facing north along the new accessible trail where it transects a new picnic area. The arched gateway in the background guides park visitors to the suspension bridge over the Koksilah River.

This reclaimed green space was once a vehicle parking area prior to the BAP Recreation Rejuvenation Project.

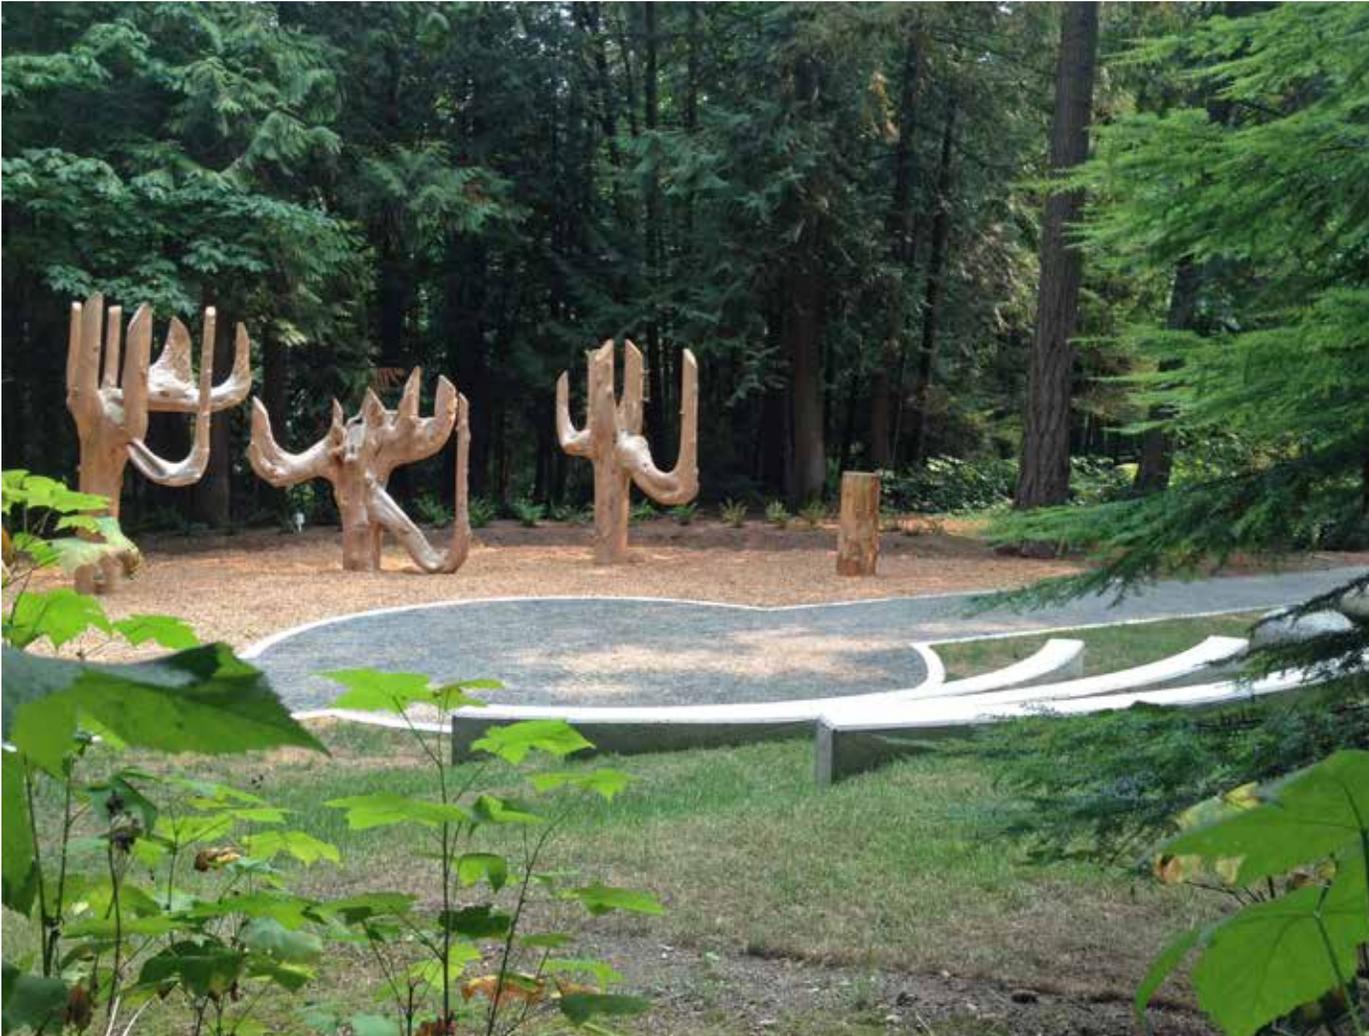
photo 4

This photo is facing north west along the northern extent of the new accessible trail.

This location is where the old playground once stood. The site was utilized to provide a natural playscape and small amphitheatre/outdoor classroom.

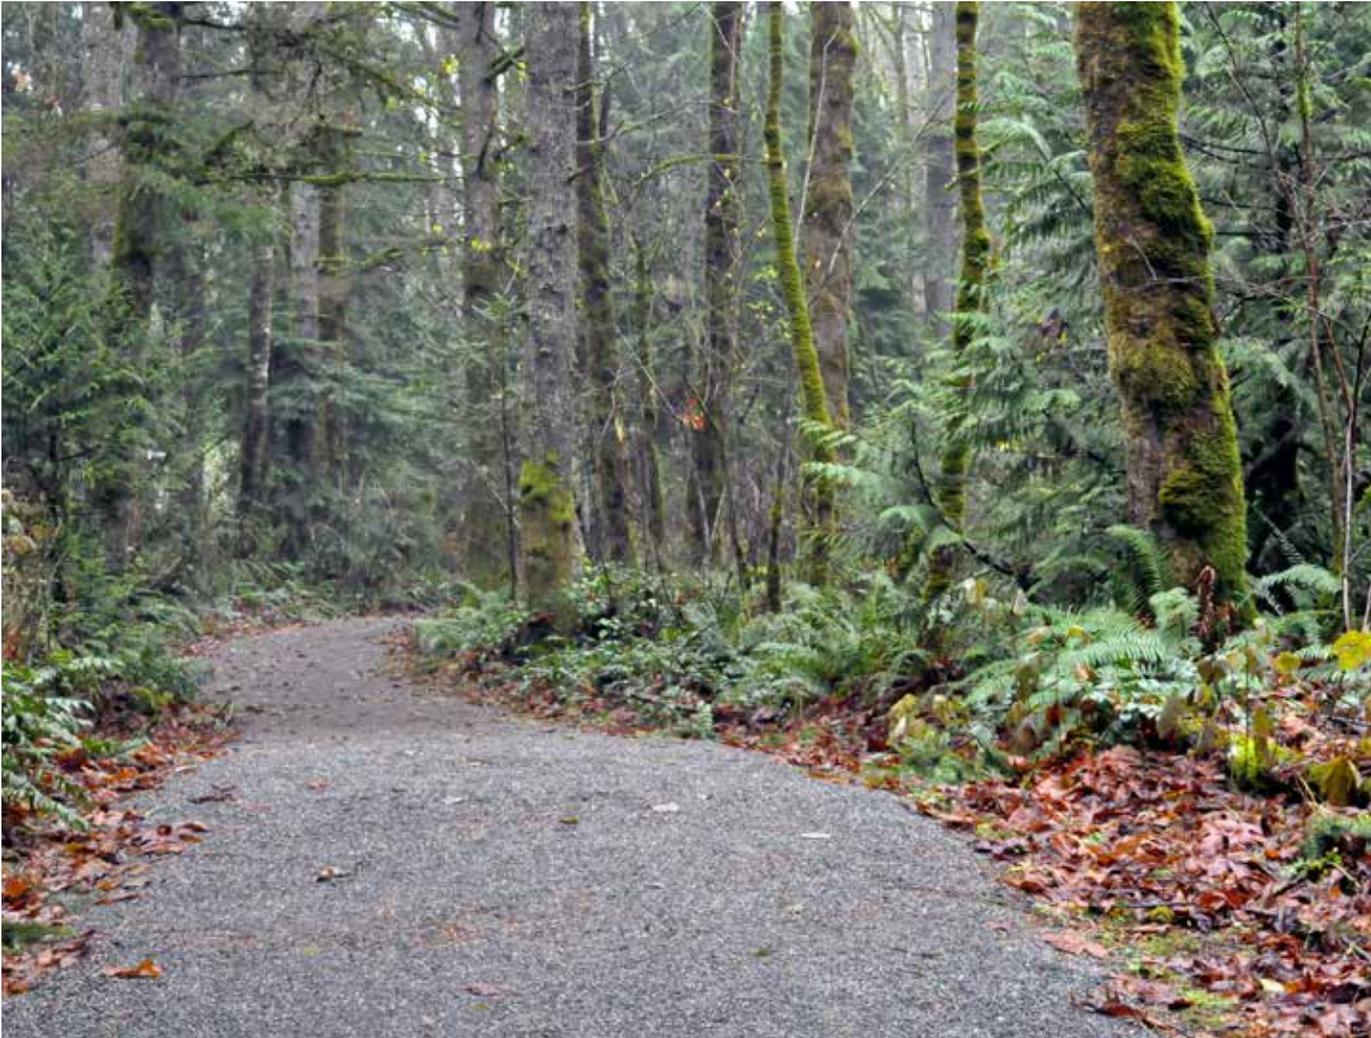
photo 5

This photo is facing north along the accessible trail loop that connects the playfield to the new nature playscape and amphitheater/outdoor classroom at the western boundary of the park.

The new 2-2.25 metres wide accessible trail is surfaced with compacted angular screenings and an average longitudinal slope of less than 5%.

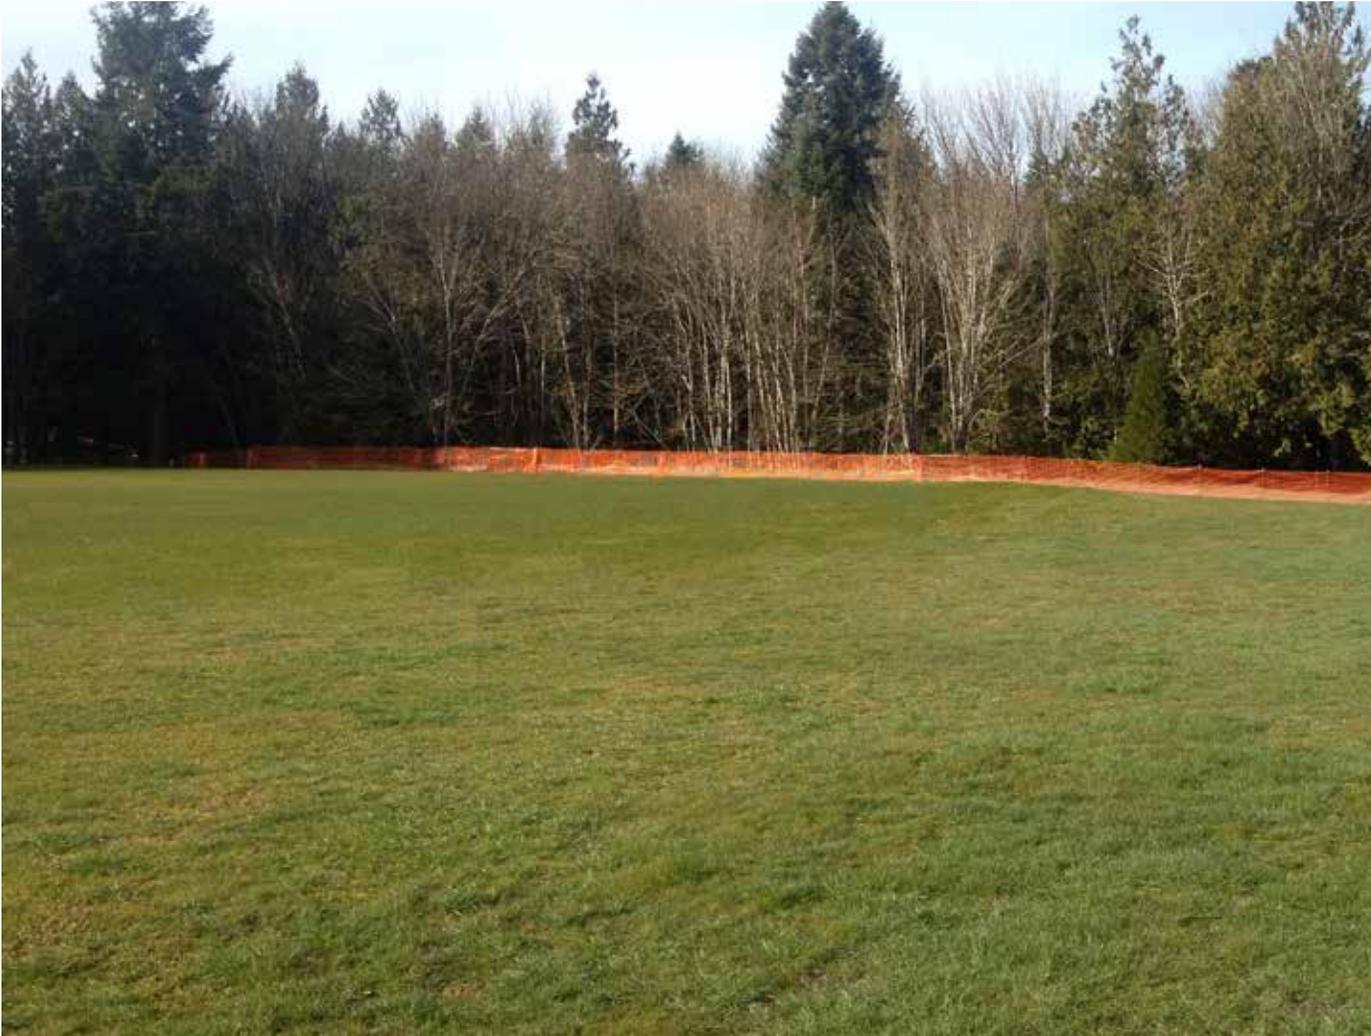
photo 6

This photo is facing north west across the upgraded playfield. This field was regraded providing better drainage and resurfaced with appropriate soil and grass.

The playfield is an unprogrammed recreation area. This field is booked for a variety of recreation and community events.

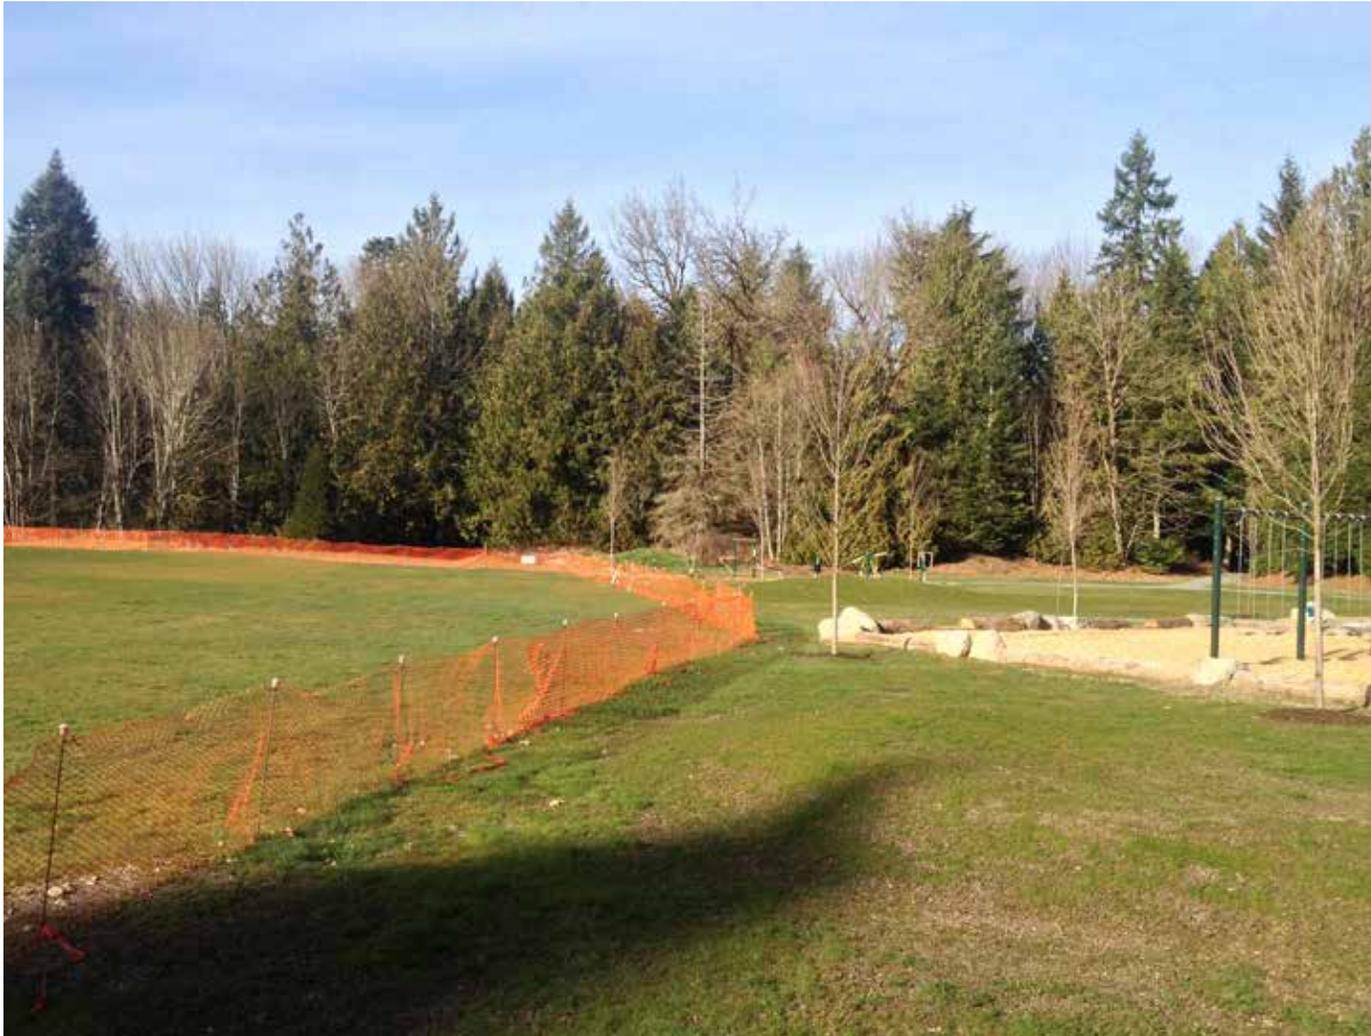
photo 7

This photo is facing north towards the new play equipment (background) and shows the intersection between the playground and playfield. Both areas have received new grass seed and are recovering from excavation.

A total of 13 trees were planted in the playground and exercise equipment area.

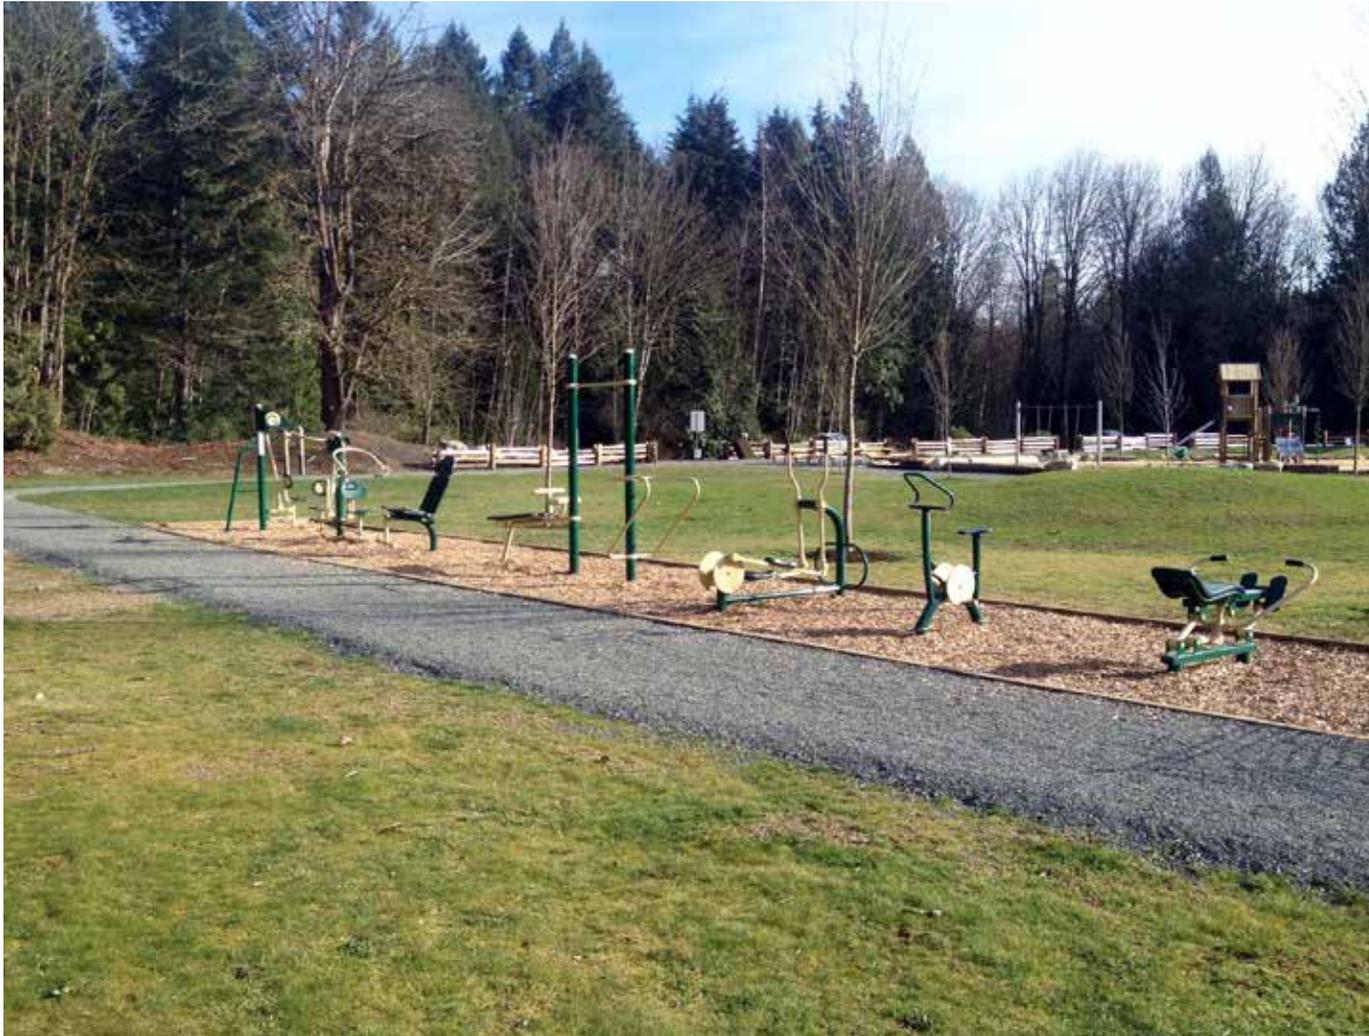
photo 8

This photo is facing east on the north side of the playfield looking over the new accessible 2.5 metre wide trail, the 10 exercise stations and the new playground in the background.

New trees and undulating mounds surrounding this area signal a different use and create interesting playful topography around the playground.

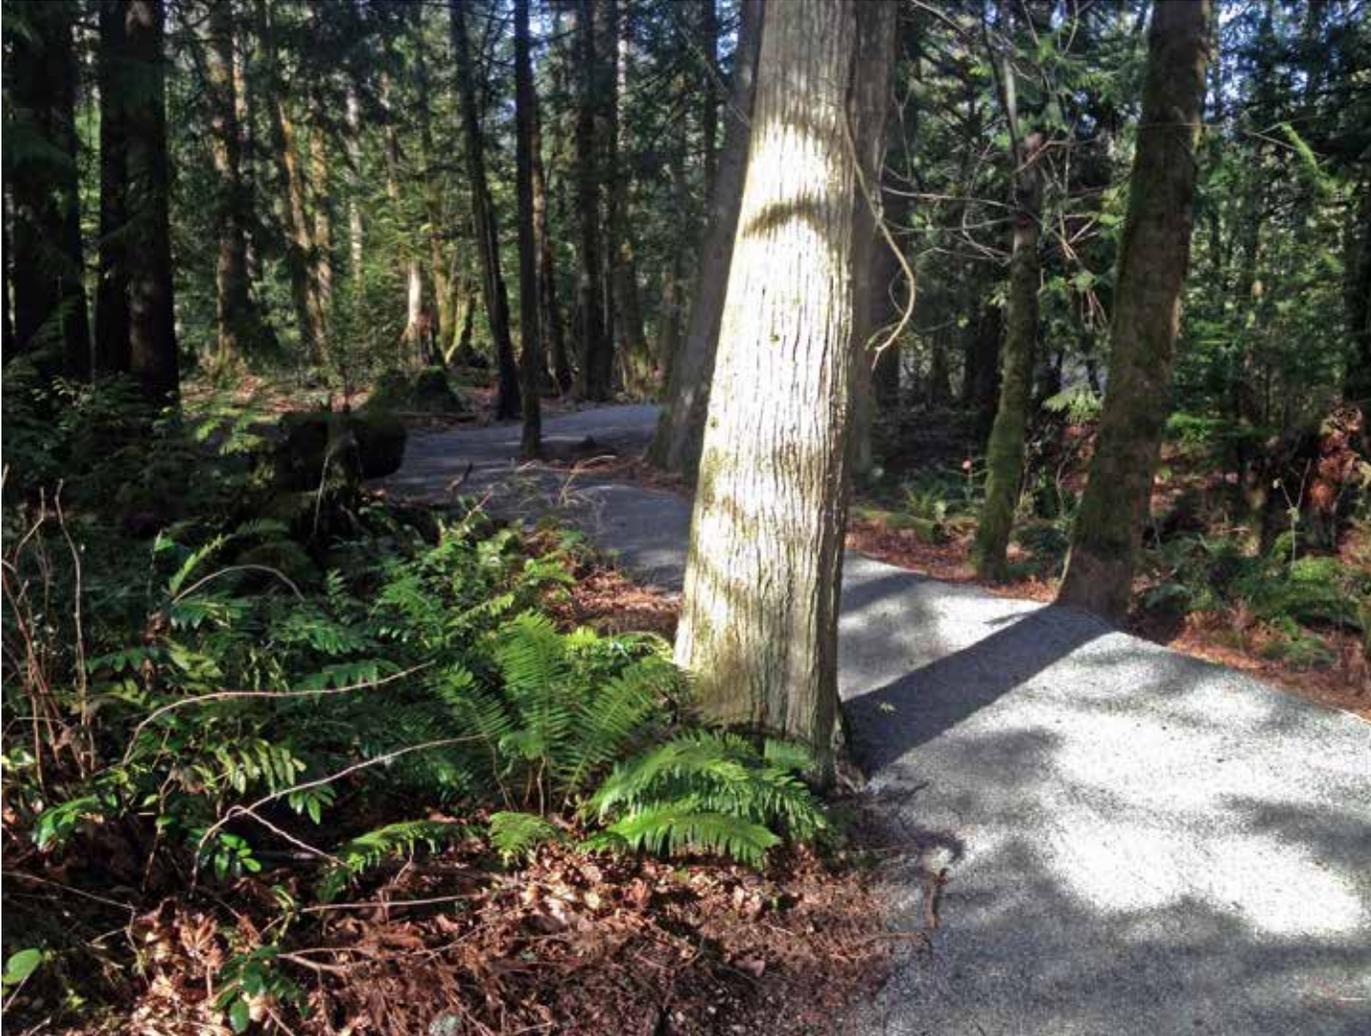
photo 9

This photo is facing north on an inner loop of the accessible trail that is shorter route leading directly from the recreation area of the playfield, playground and exercise stations to the washroom building.

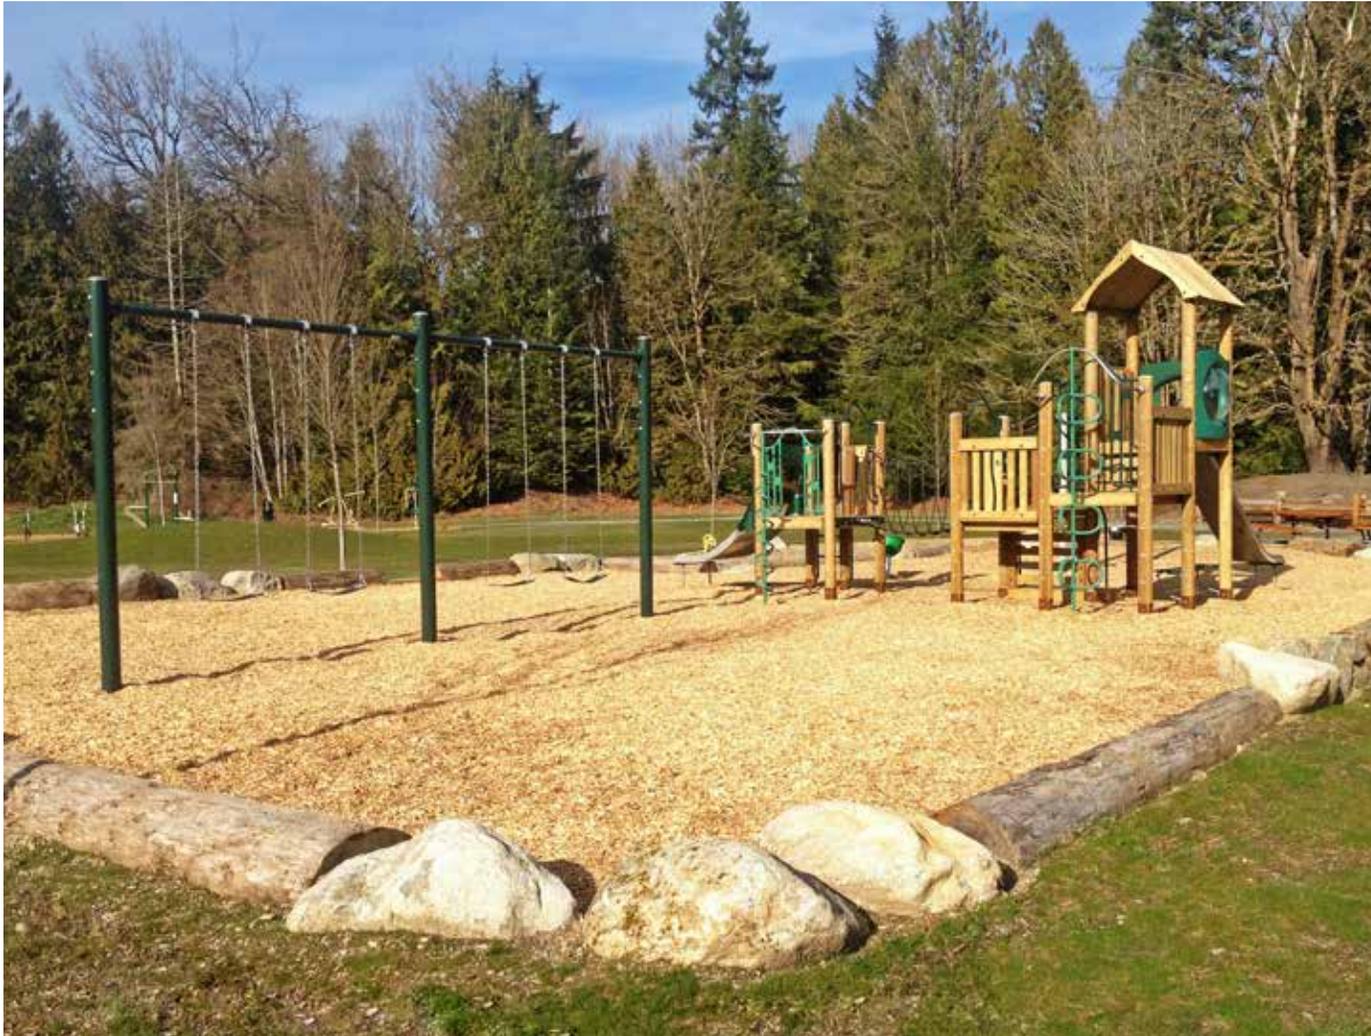
photo 10

This photo is facing north on the south edge of the playground. In the background is the accessible trail and 10 exercise stations.

The playground incorporates natural materials and utilizes natural colours to connect to the park surroundings.

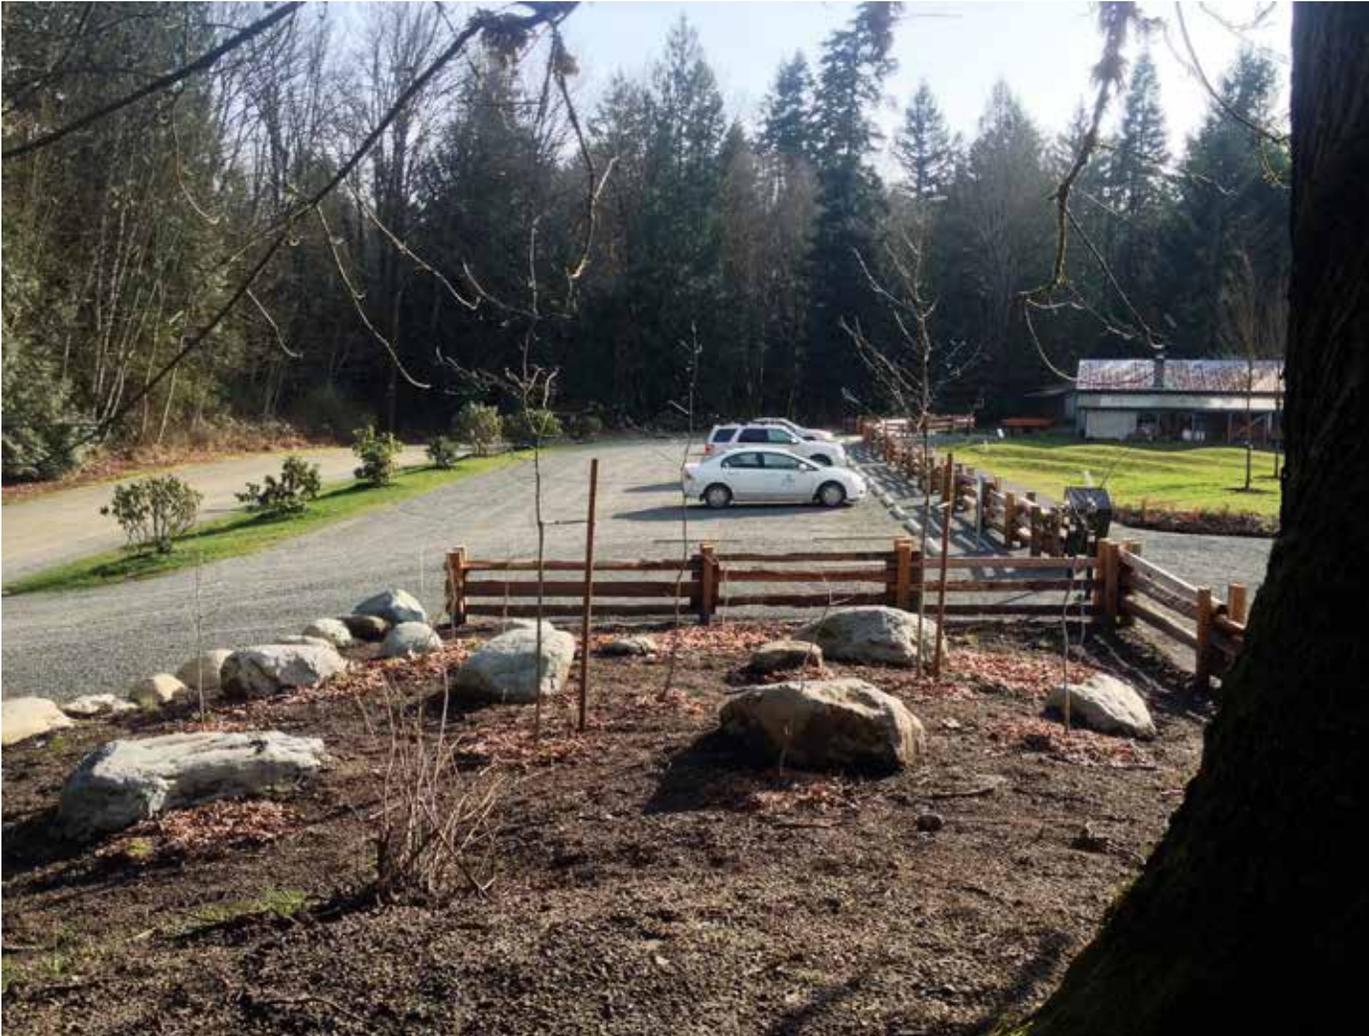
photo 11

This photo is facing south above a small Garry Oak restoration area with the new parking lot behind. Cedar split rail fence was used to separate vehicles from the active recreation area. The playground is located to the right where mounding and new trees can be seen.

The new water system is located beyond the building in the background of this image. The utilities are buried along the driveway edge to the new washroom building 150 metres behind this location.

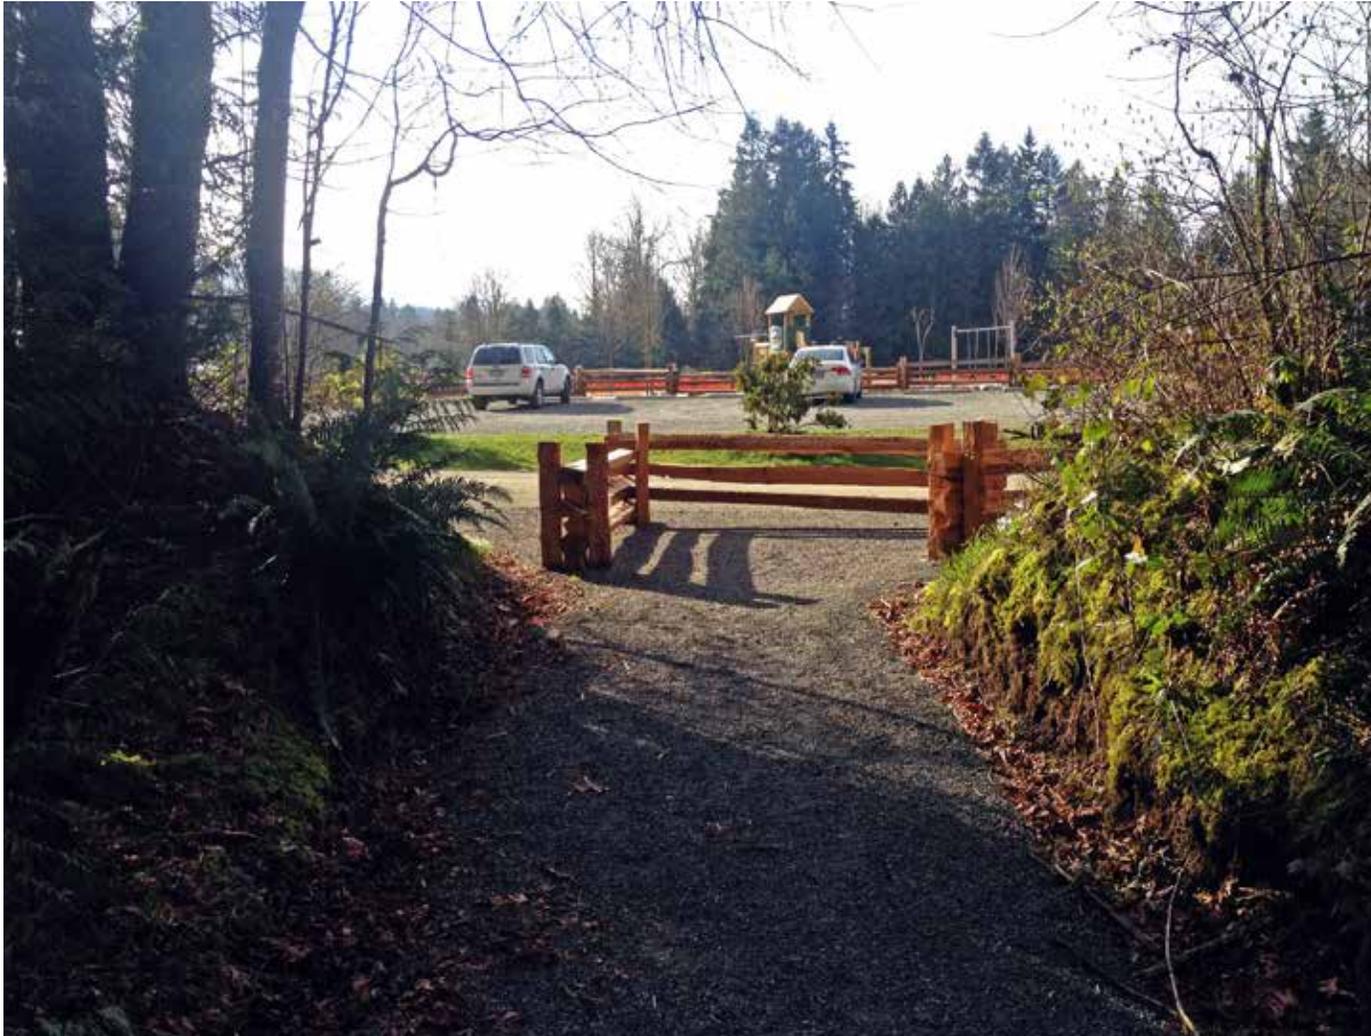
photo 12

This photo is facing west at the intersection of the accessible trail and the park driveway. The spitrail fencing slows pedestrian traffic before reaching the intersection.

The new parking area playground, exercise stations and playfield are in the background.

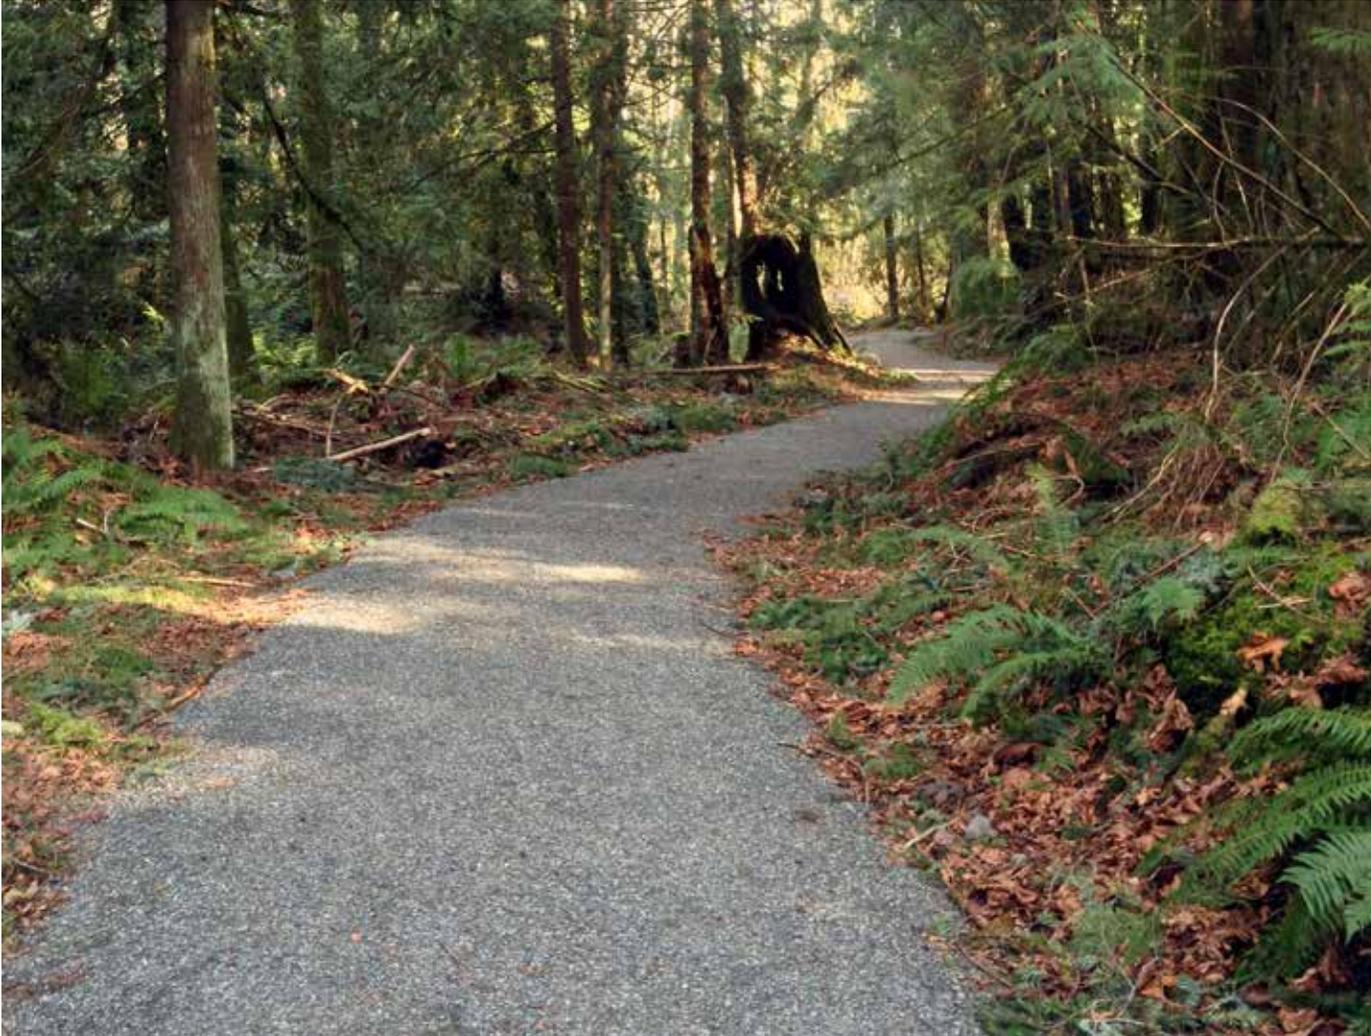
photo 13

This photo is facing east along the eastern section of the accessible trail. This section passes wetlands that are home to western toads, red legged frogs and Pacific chorus frogs.

This portion of the trail connects the lower parking area to the recreation area where the playground, exercise equipment and playfield are located.

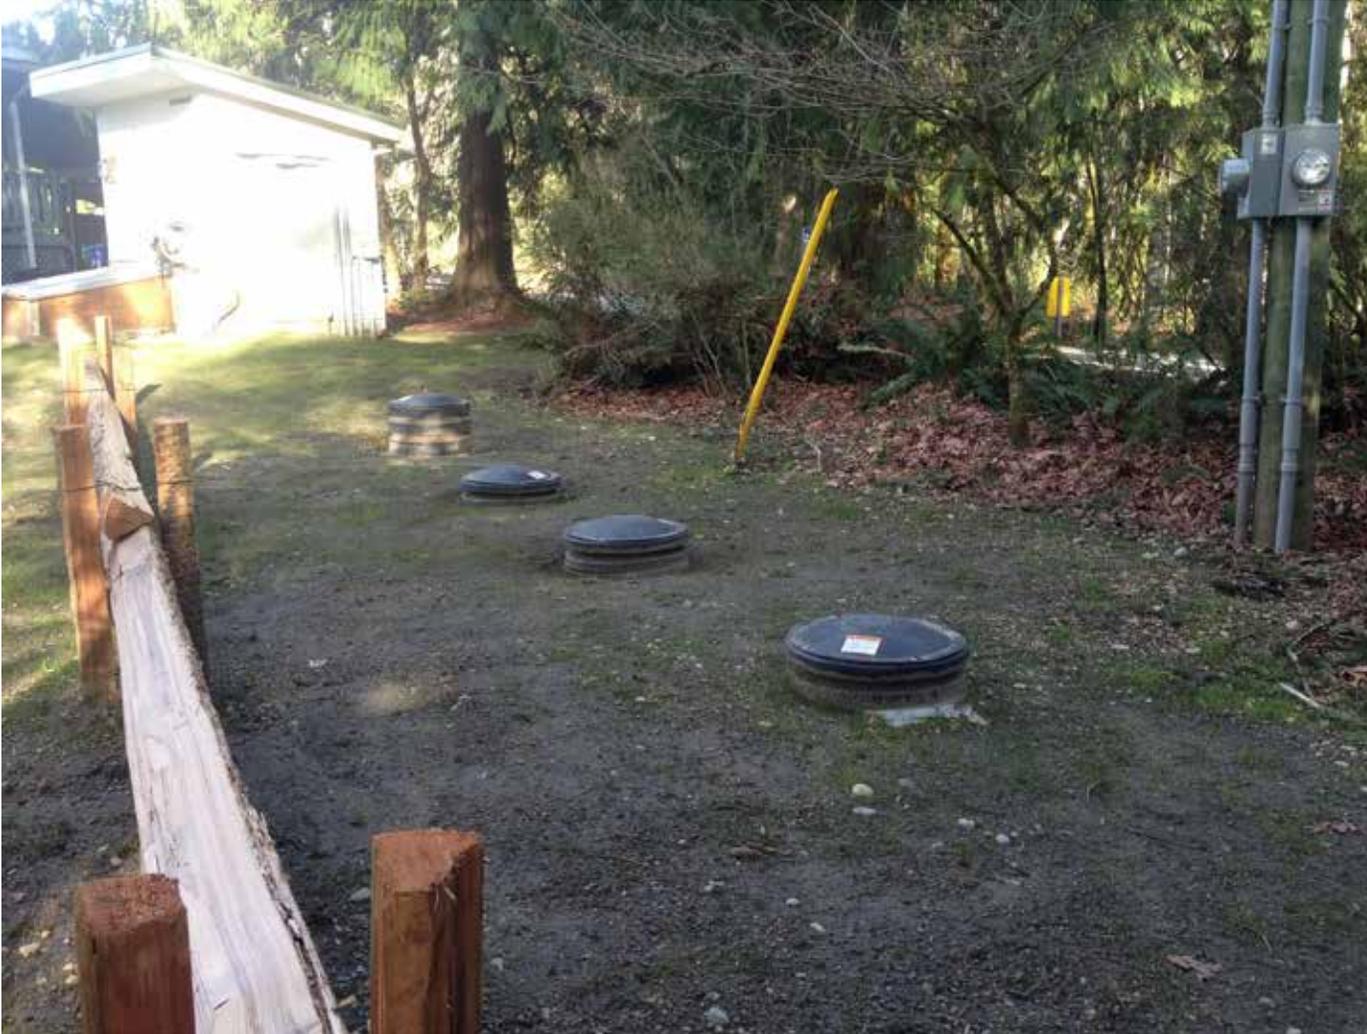
photo 14

This photo is facing north at the new well, water storage and utilities site. The well head and main utilities controls are located in the shed in the background of the image. The water storage necessary for supporting the new washroom building needs (3500 gal) is located underground and accessed through the four valves shown in the photo.

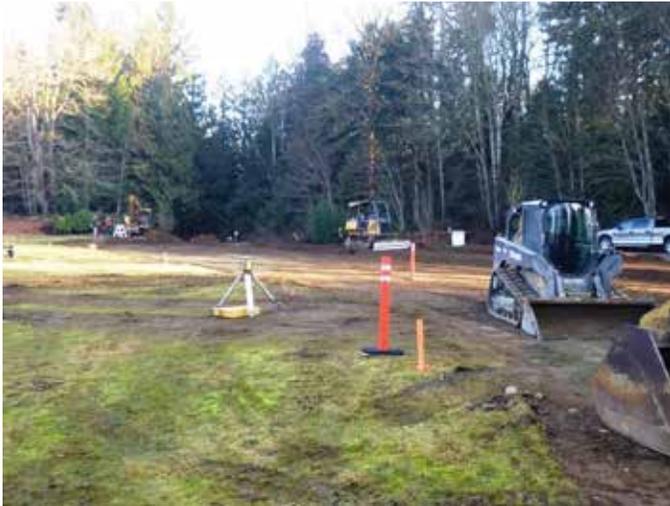
Initial utilities layout and excavation of upper parking area.

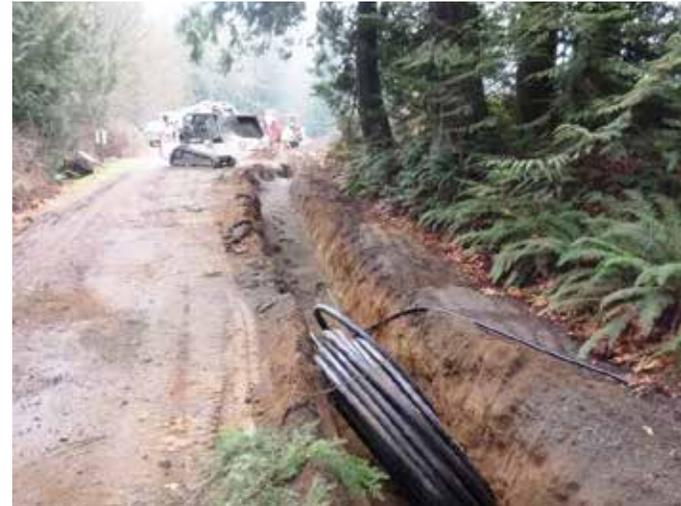
Ditch along park driveway and laying of utilities.

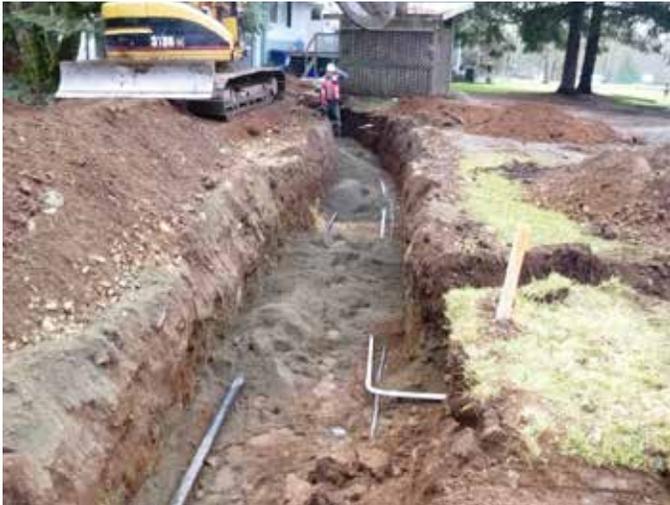
Utilities and connections to well, pump etc..

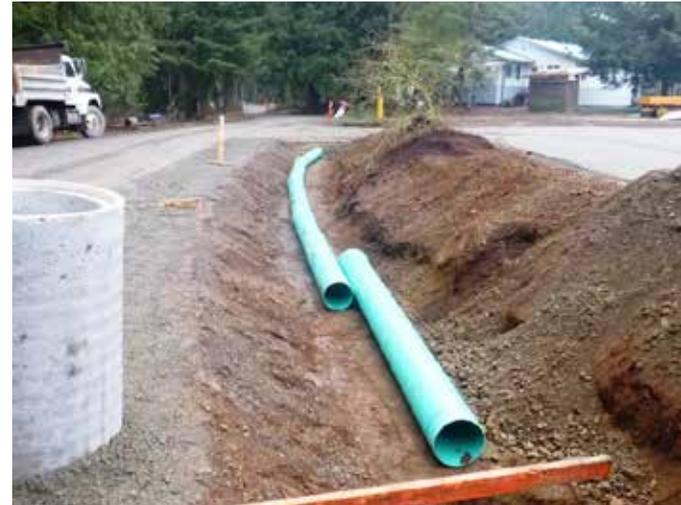
Drainage ditch adjacent to parking area.

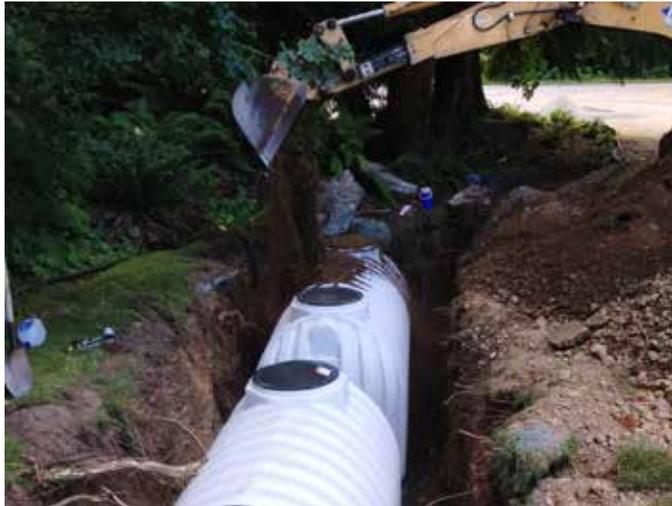
Backfilling around water storage tanks.

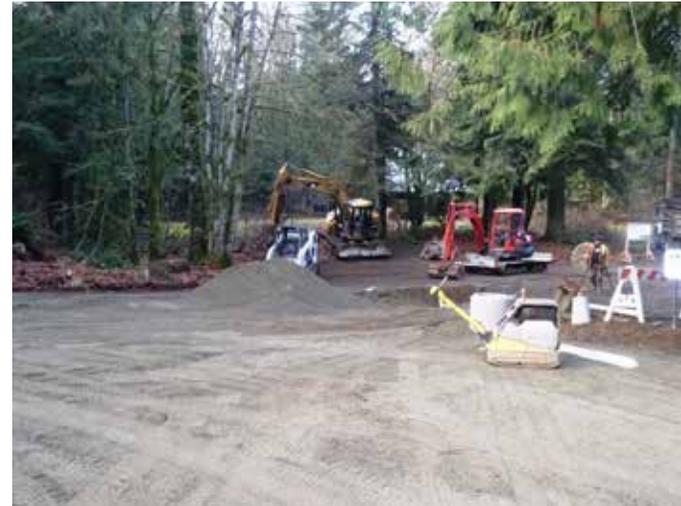
Preparing new washroom site and utilities connections.
