Bright Angel Park Recreation Rejuvenation Project

final report photos

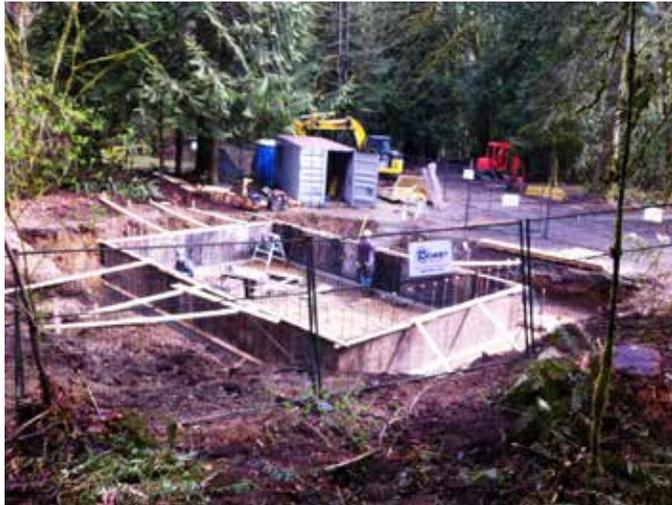
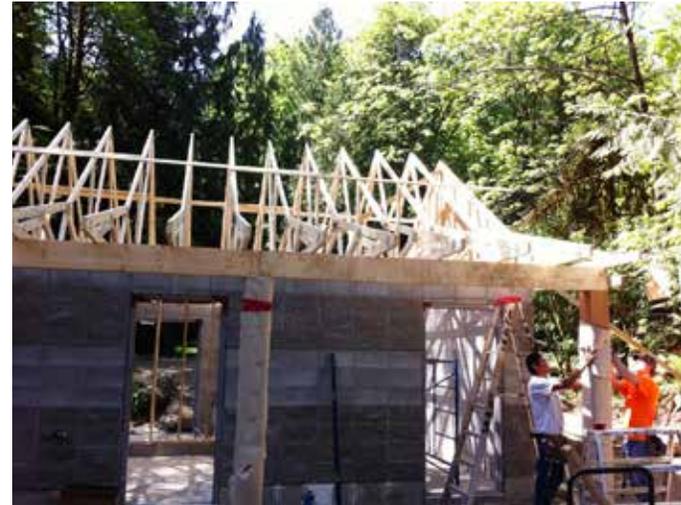
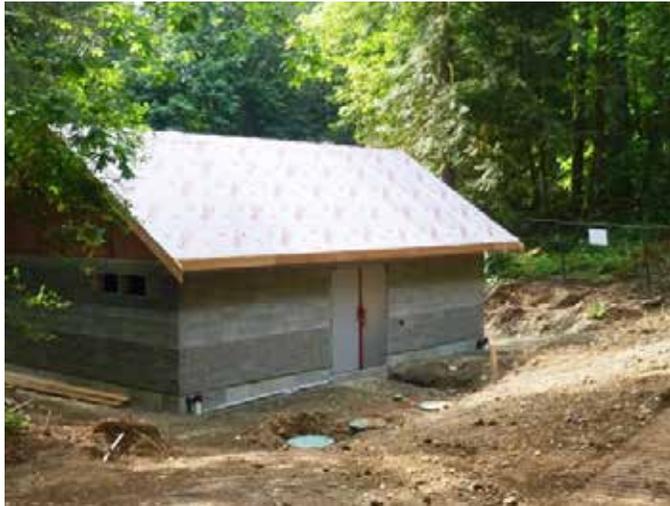
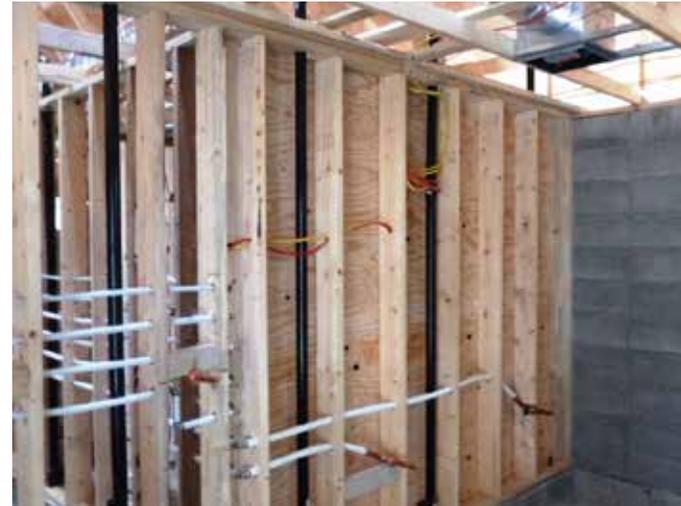
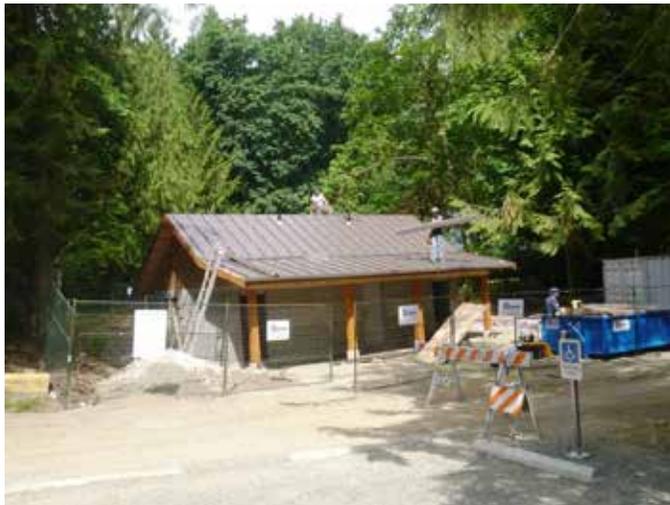
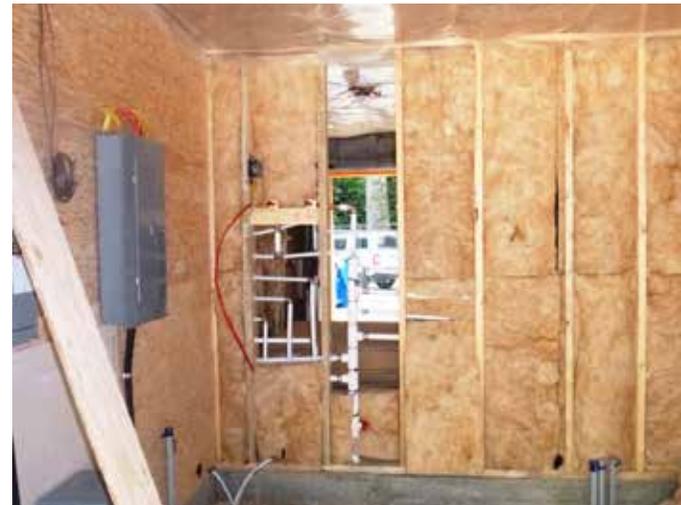
Washroom building construction.

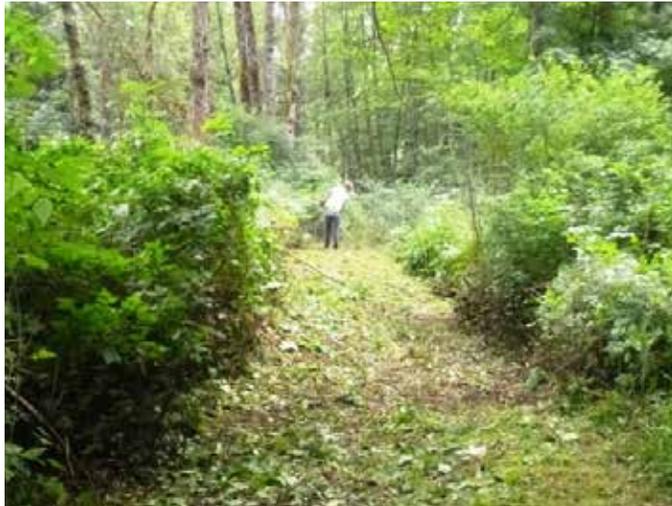
Clearing bush for trail development.

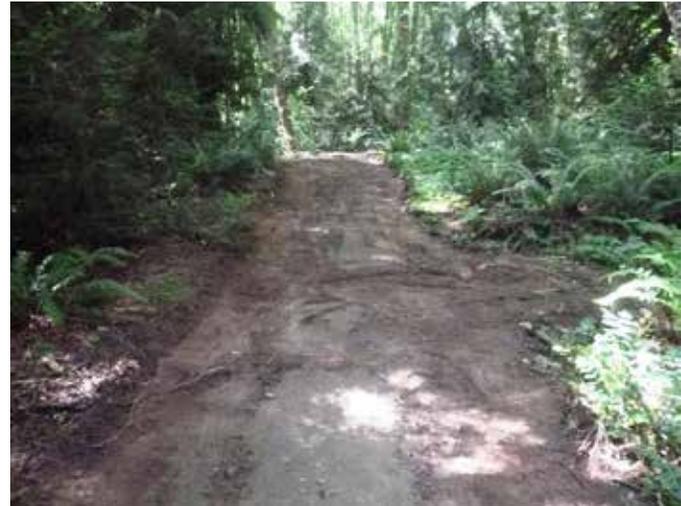
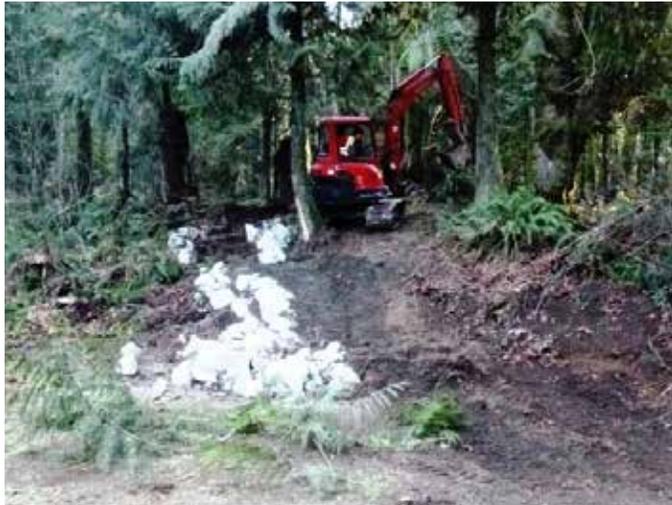
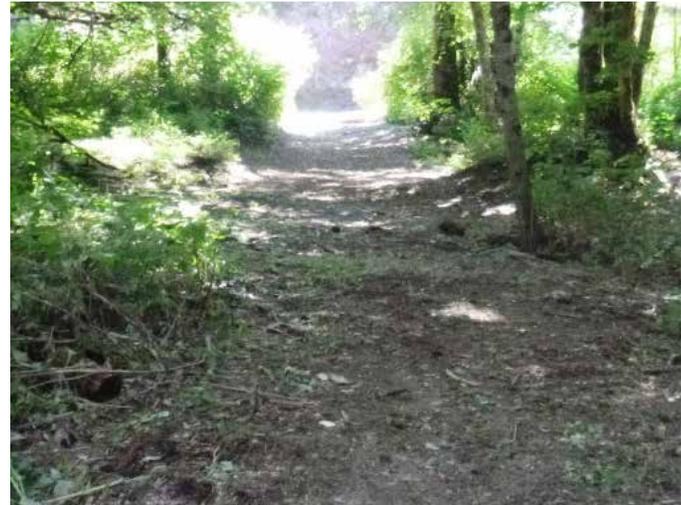
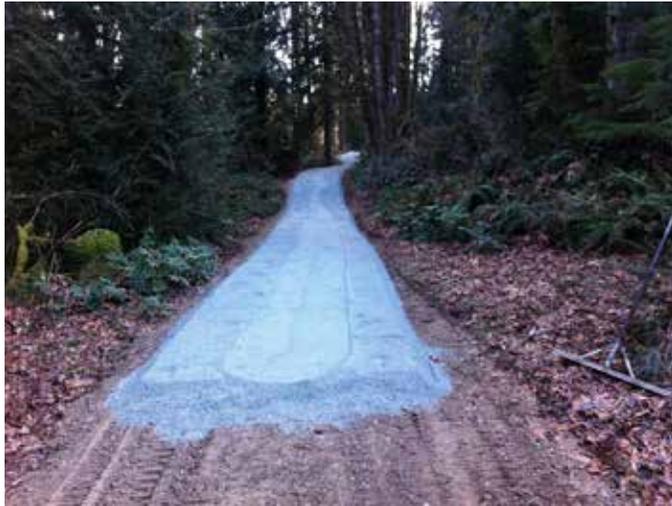
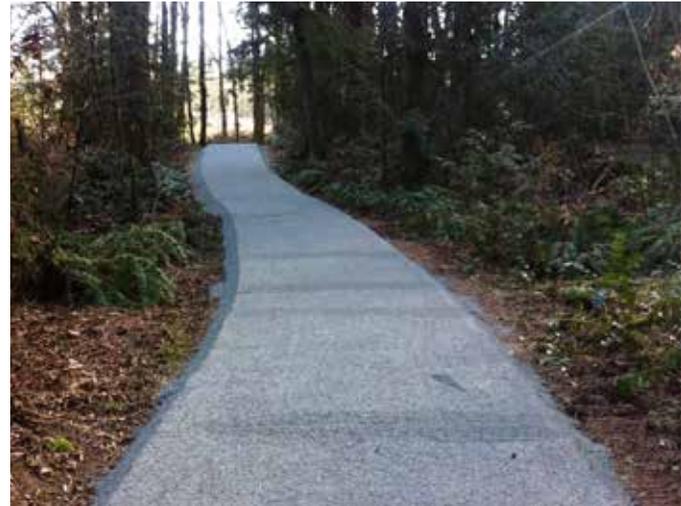
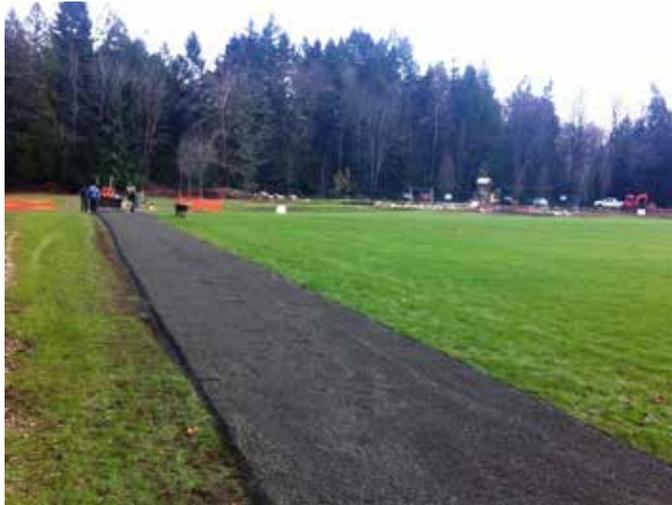
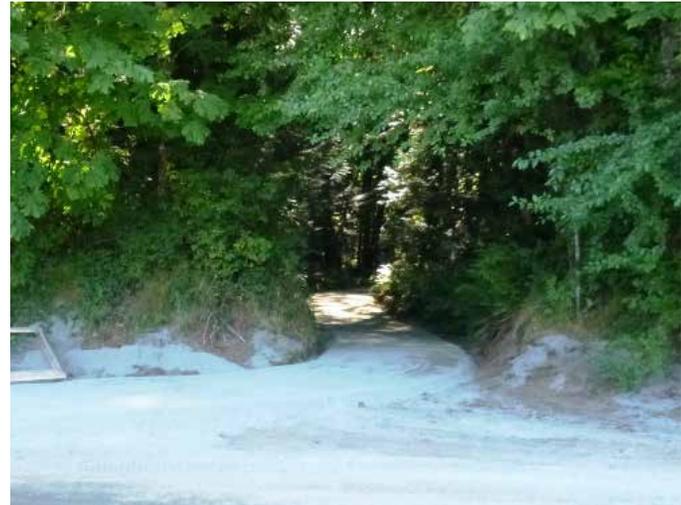
Accessible trail development.

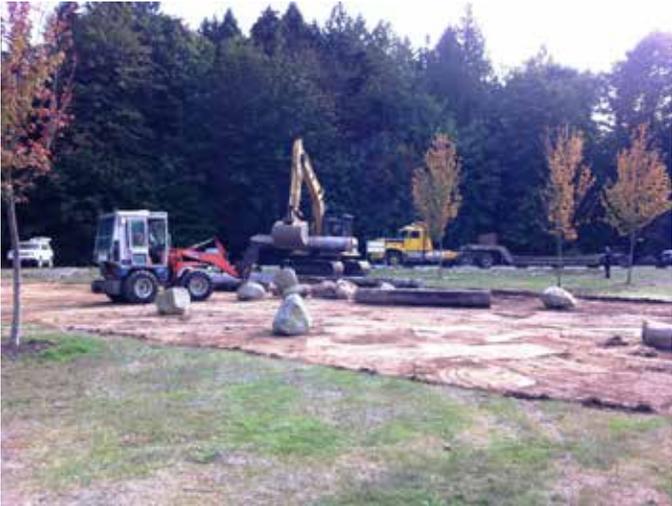
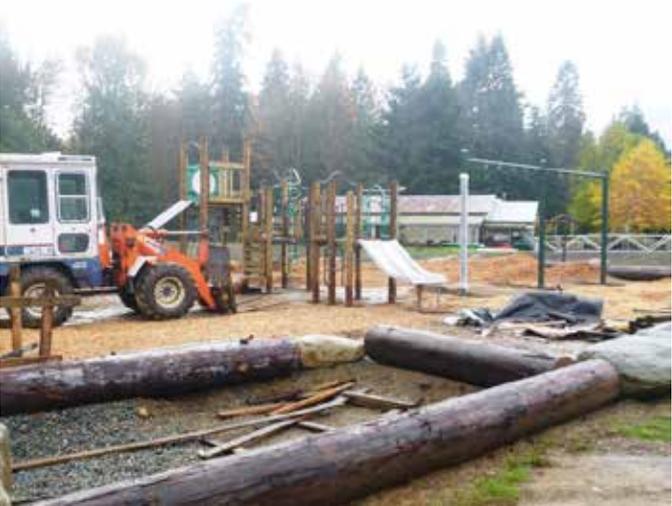
Playground development.

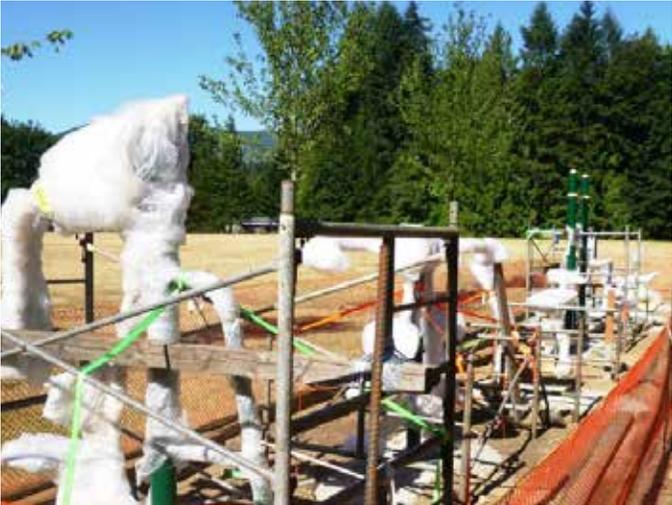
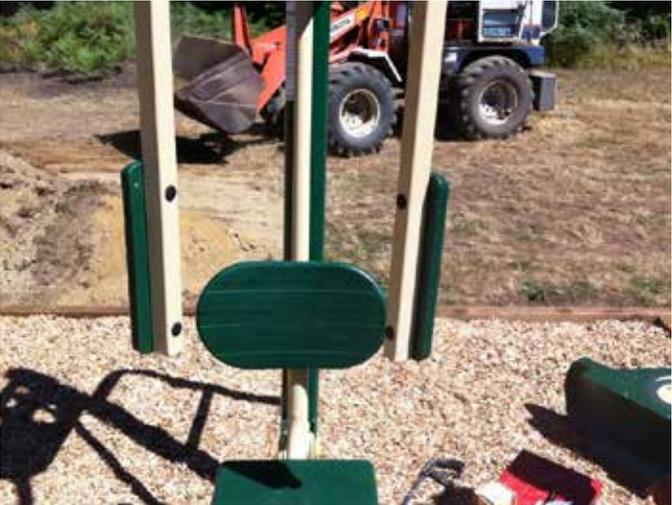
Exercise station development.

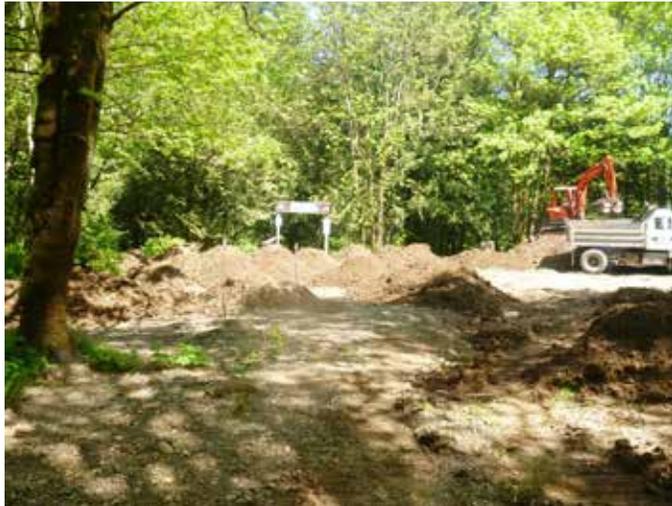
Site grading for accessible trail connection.

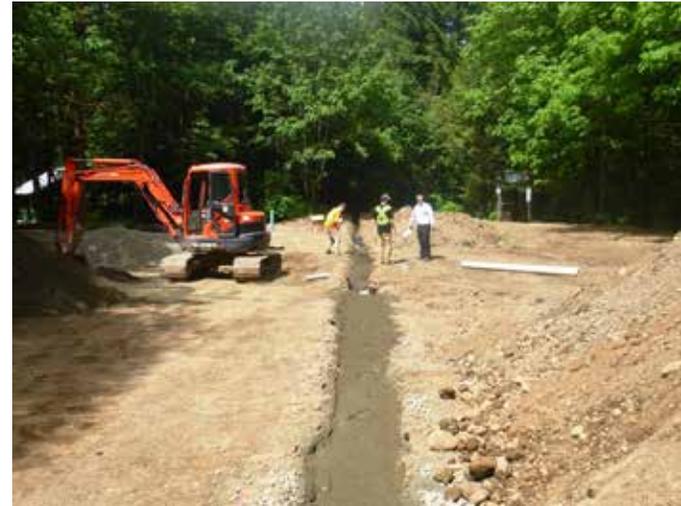
Site grading and drainage for accessible trail connection.

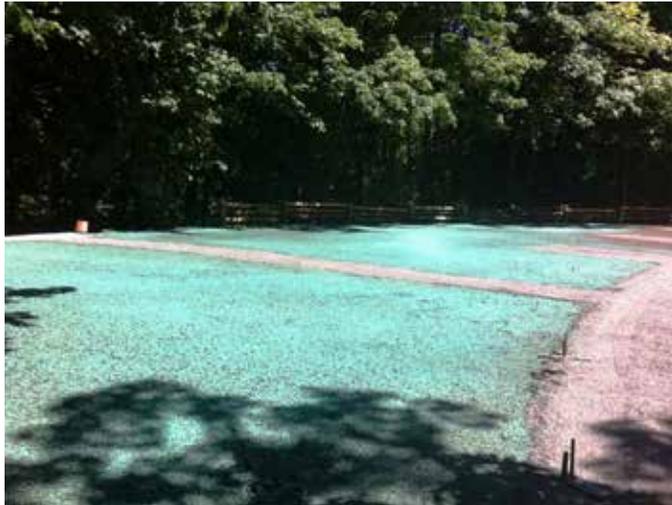
Hydroseeding adjacent to accessible trail

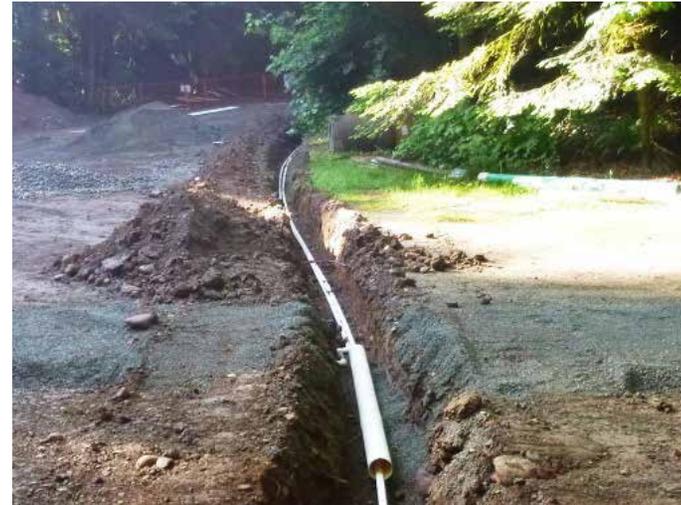
Temporary irrigation line installation.

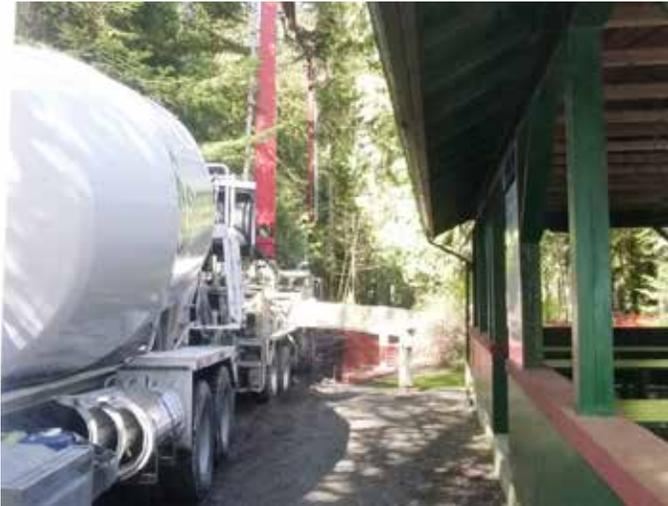
Concrete and pumper truck placing concrete at outdoor classroom/ amphitheatre

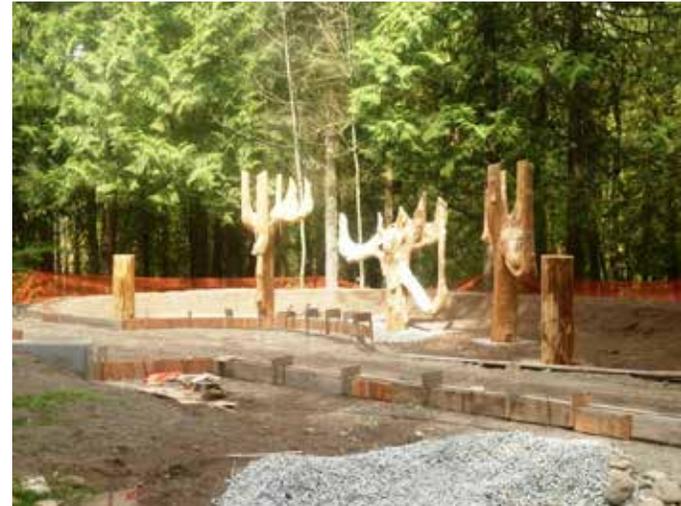
Formwork, grading and naturescape development.

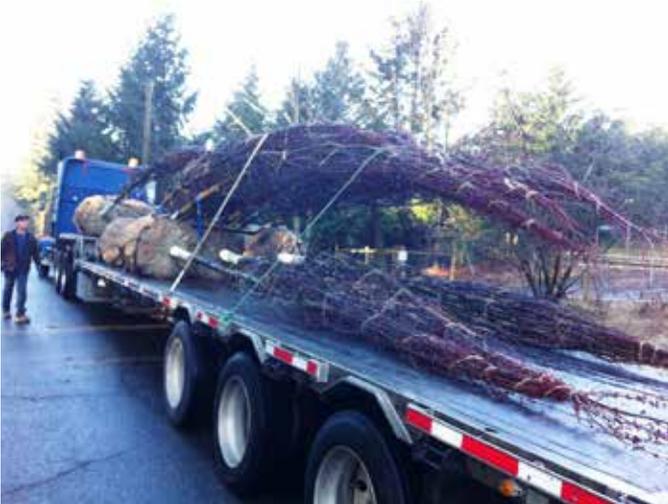
Delivery of trees for playground area.

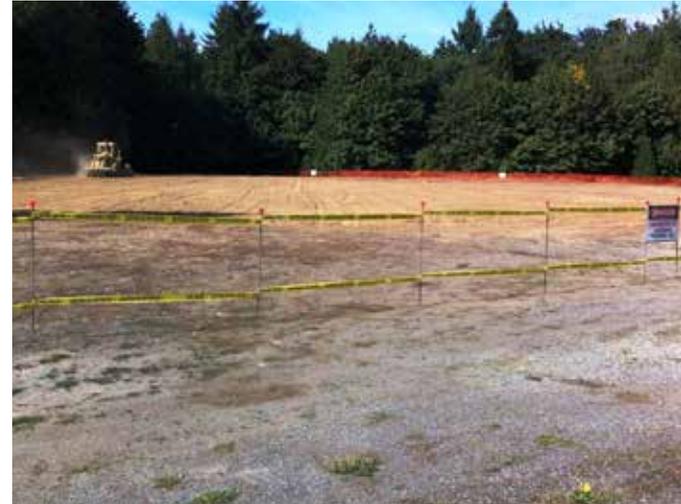
Initial grading of playfield.

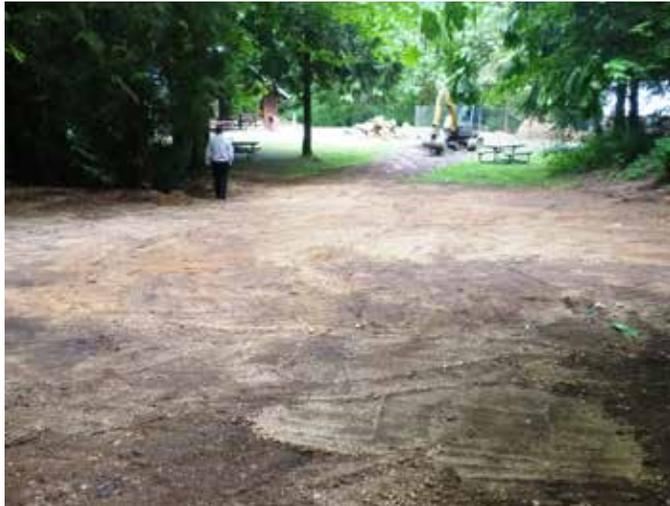
Inspection of new septic field.

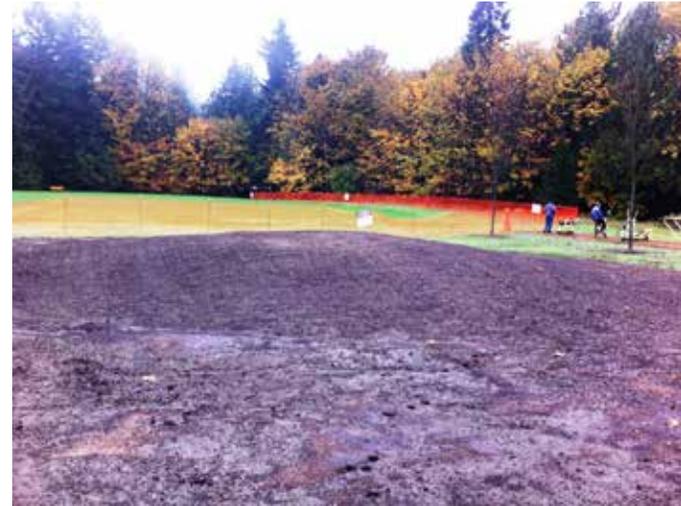
Mounding and grading around playground and exercise stations.

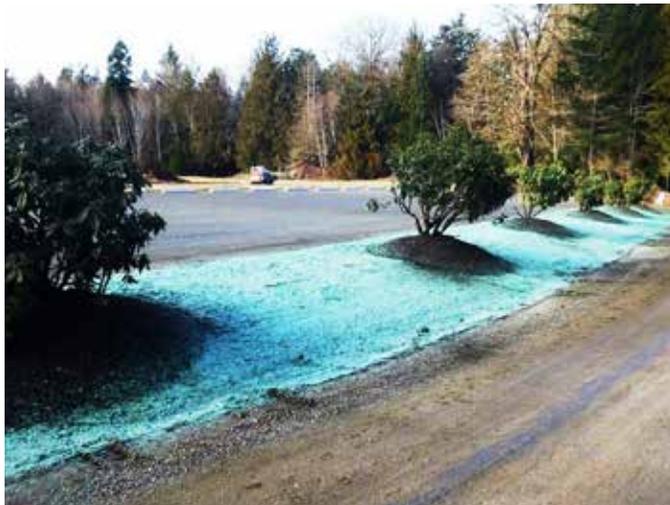
Hydroseeding on boulevard.

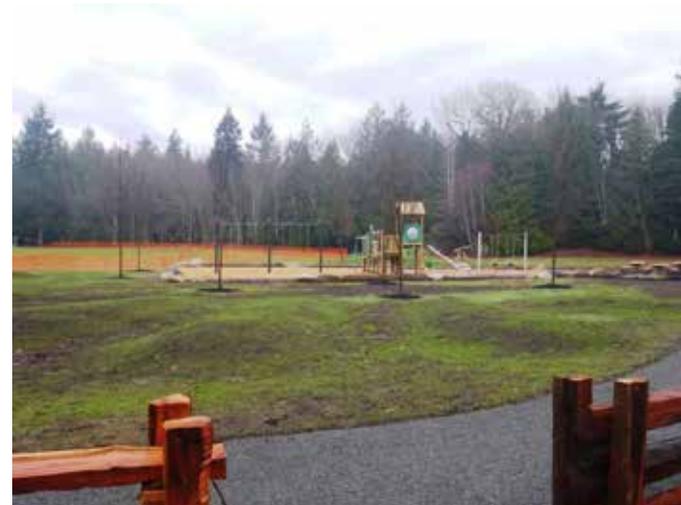
Mounding, grading and grass seeding around playground.
