Dam Safety Review and Risk Assessment of Shawnigan Lake Weir

March 2019

GK-18-020-CVD

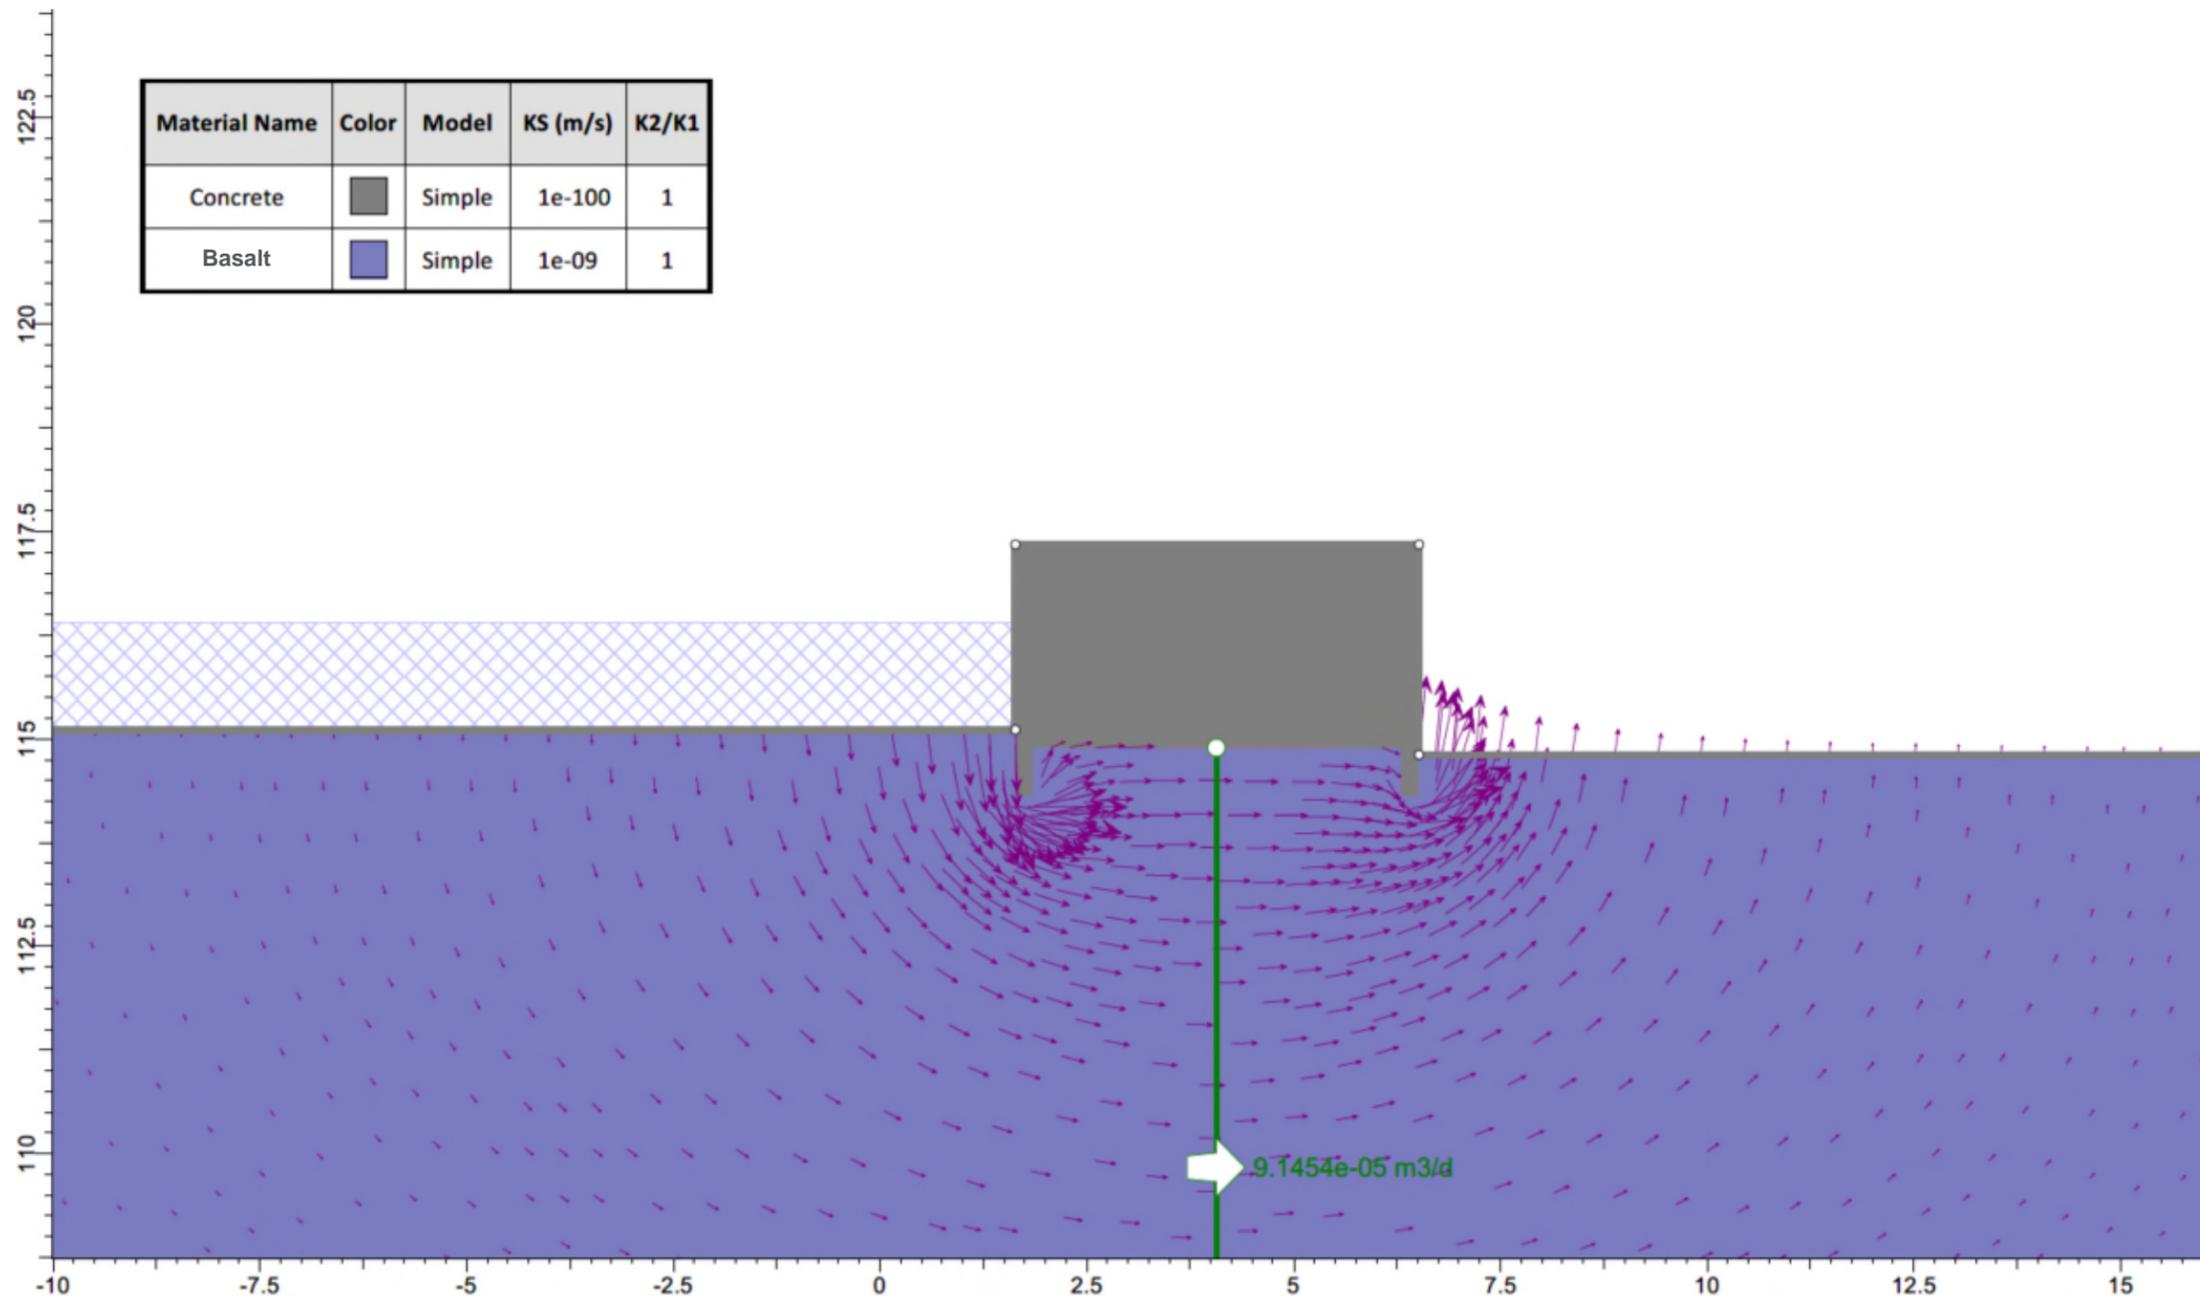
Figure 8.3

The flow field from the steady state analysis of the dam is provided on Figure 8.3.

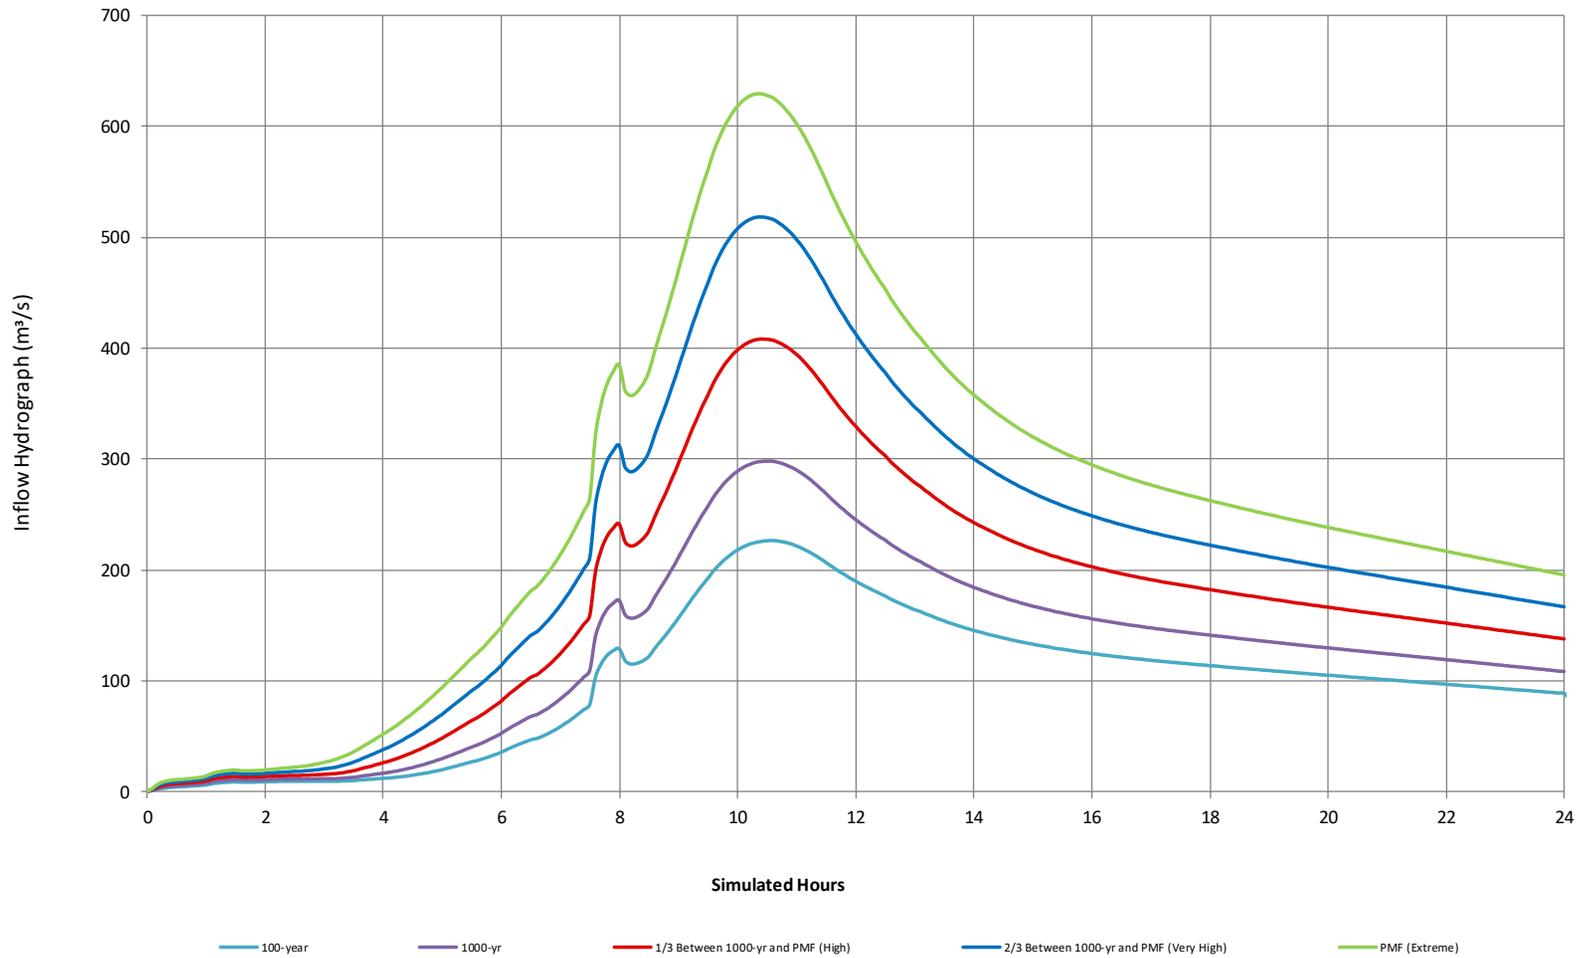
Figure 9.4

The peak inflow to Shawnigan Lake Weir during the IDF was determined to be 408 m³/s. The hydrographs for calculated return periods are shown on Figure 9.4.

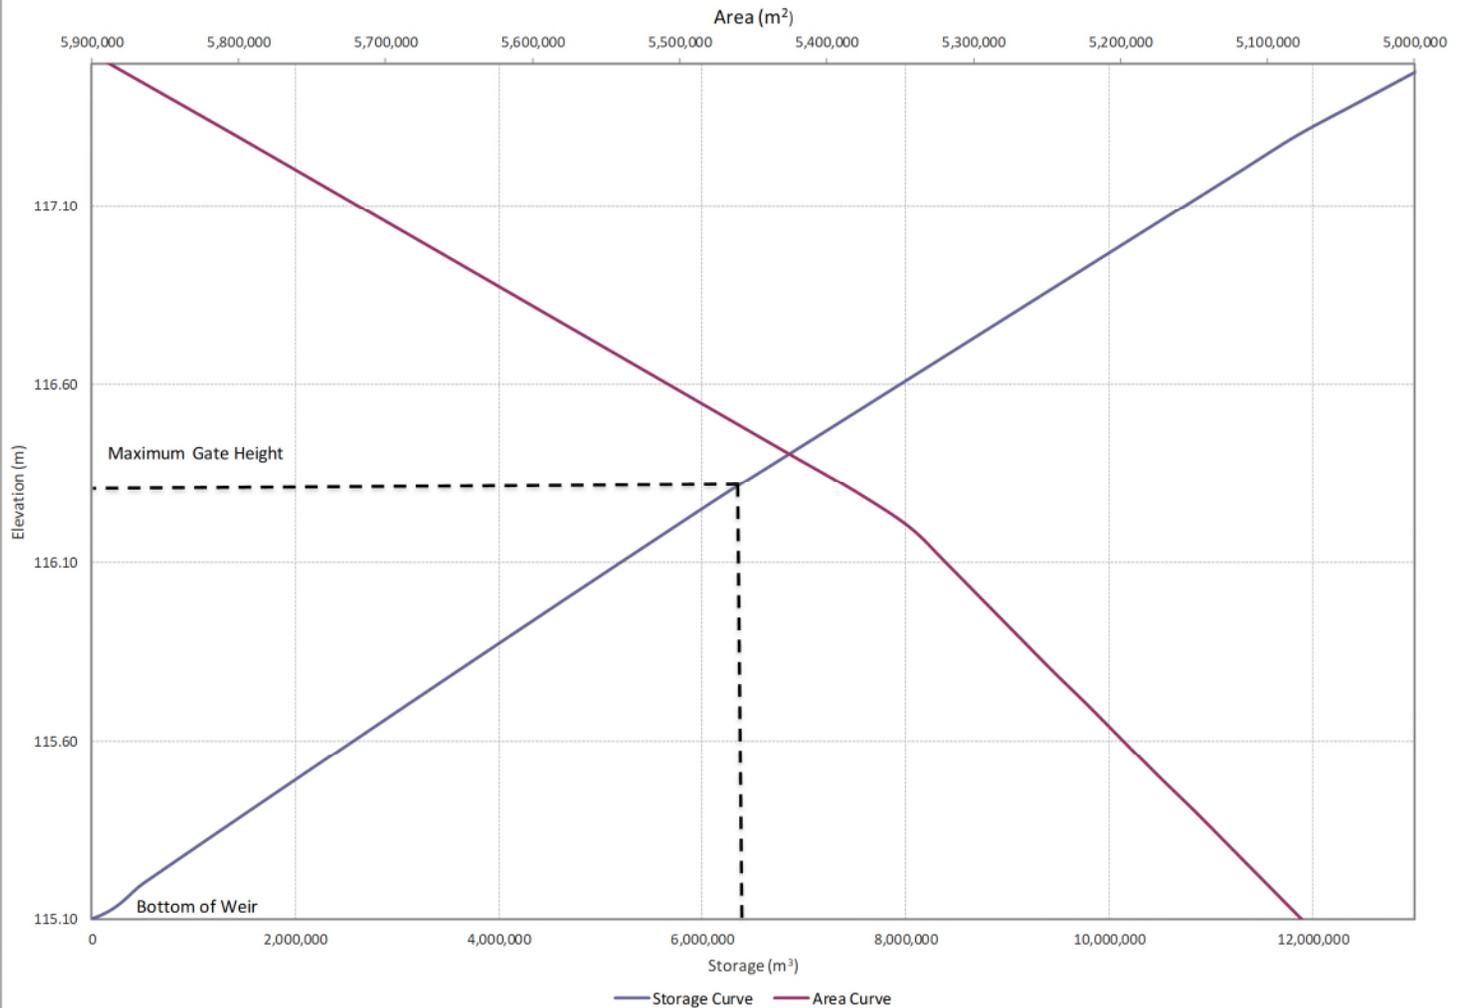
Figure 9.5a

The volume-area-elevation relationship for Shawnigan Lake was determined utilizing lake bathymetry of Shawnigan Lake completed for the BC Ministry of Environment dated March 1979. Based on this information, Shawnigan Lake has a live storage capacity of 6,270,000 m³ between the elevations of 115.1 m and 116.3 m. In addition, the structure has a potential storage capacity 10,200,000 m³ measured between the elevations of 115.1 m and 117.0 m. The lake surface area at the minimum weir crest is estimated at 5,070,000 m². The minimum weir crest level is at an elevation of 115.1 m and the maximum is at 116.3 m. The area-elevation-storage relationship is illustrated in Figure 9.5a.

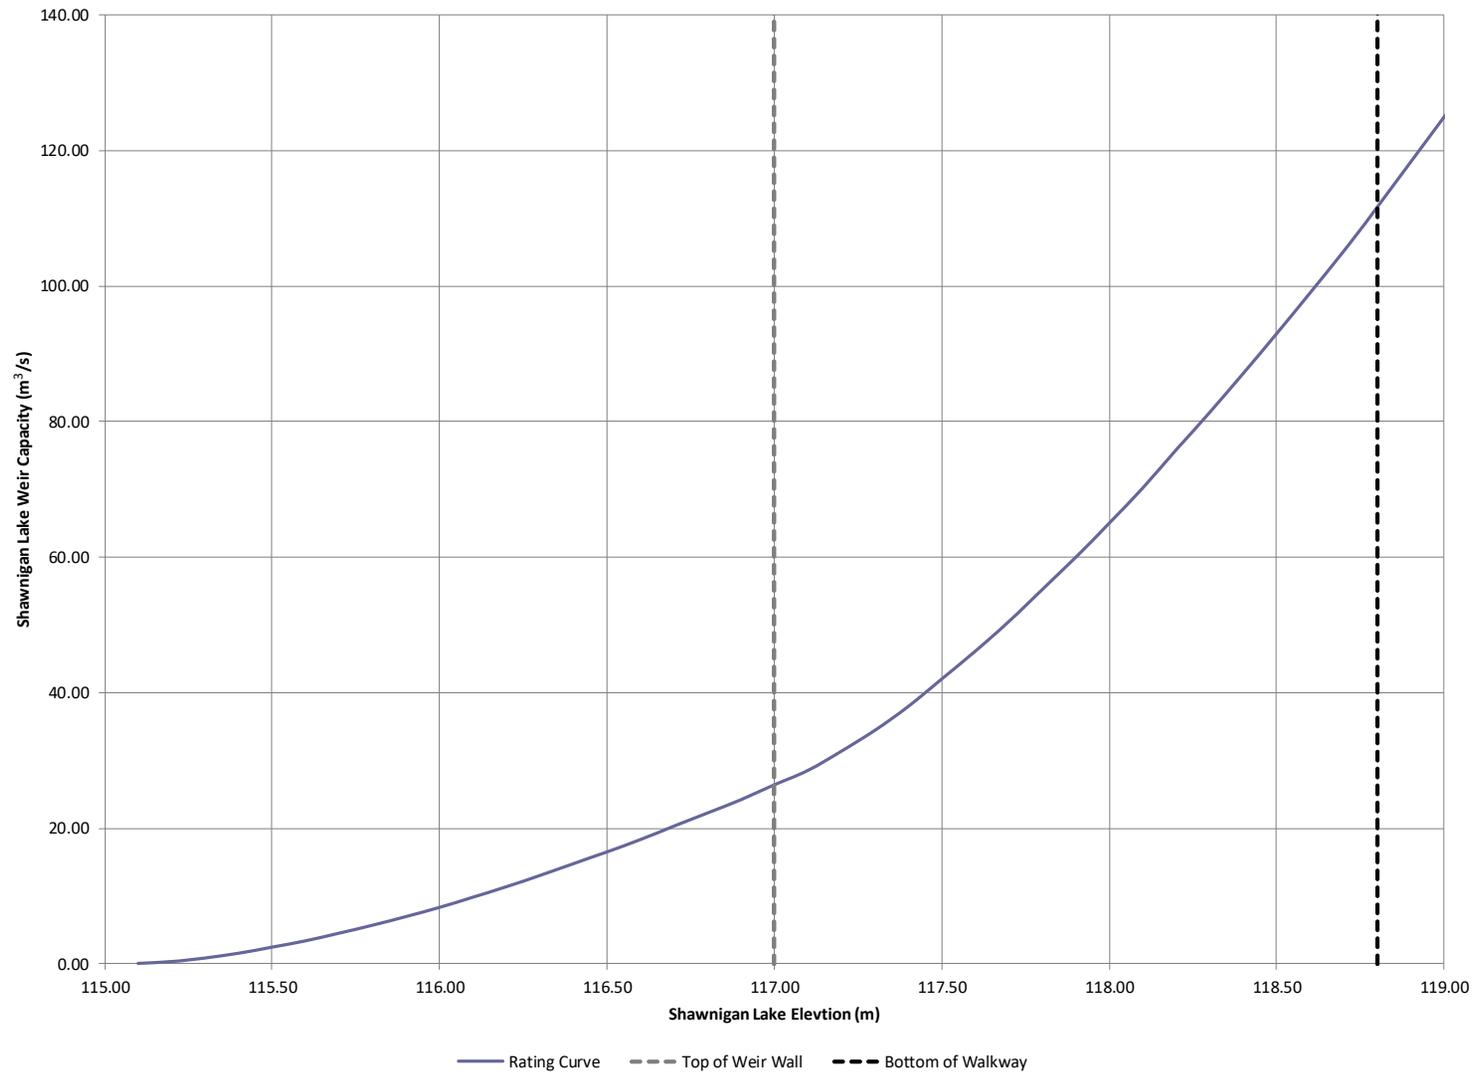
Figure 9.5b

The concrete dam crest will act also as a weir if the flood overtops the main gated channel. The rating curve developed for the Shawnigan Lake weir is shown on Figure 9.5b. The capacity of the weir in the open position as measured to the dam crest, 117.0 m, is 26.4 m³/s.

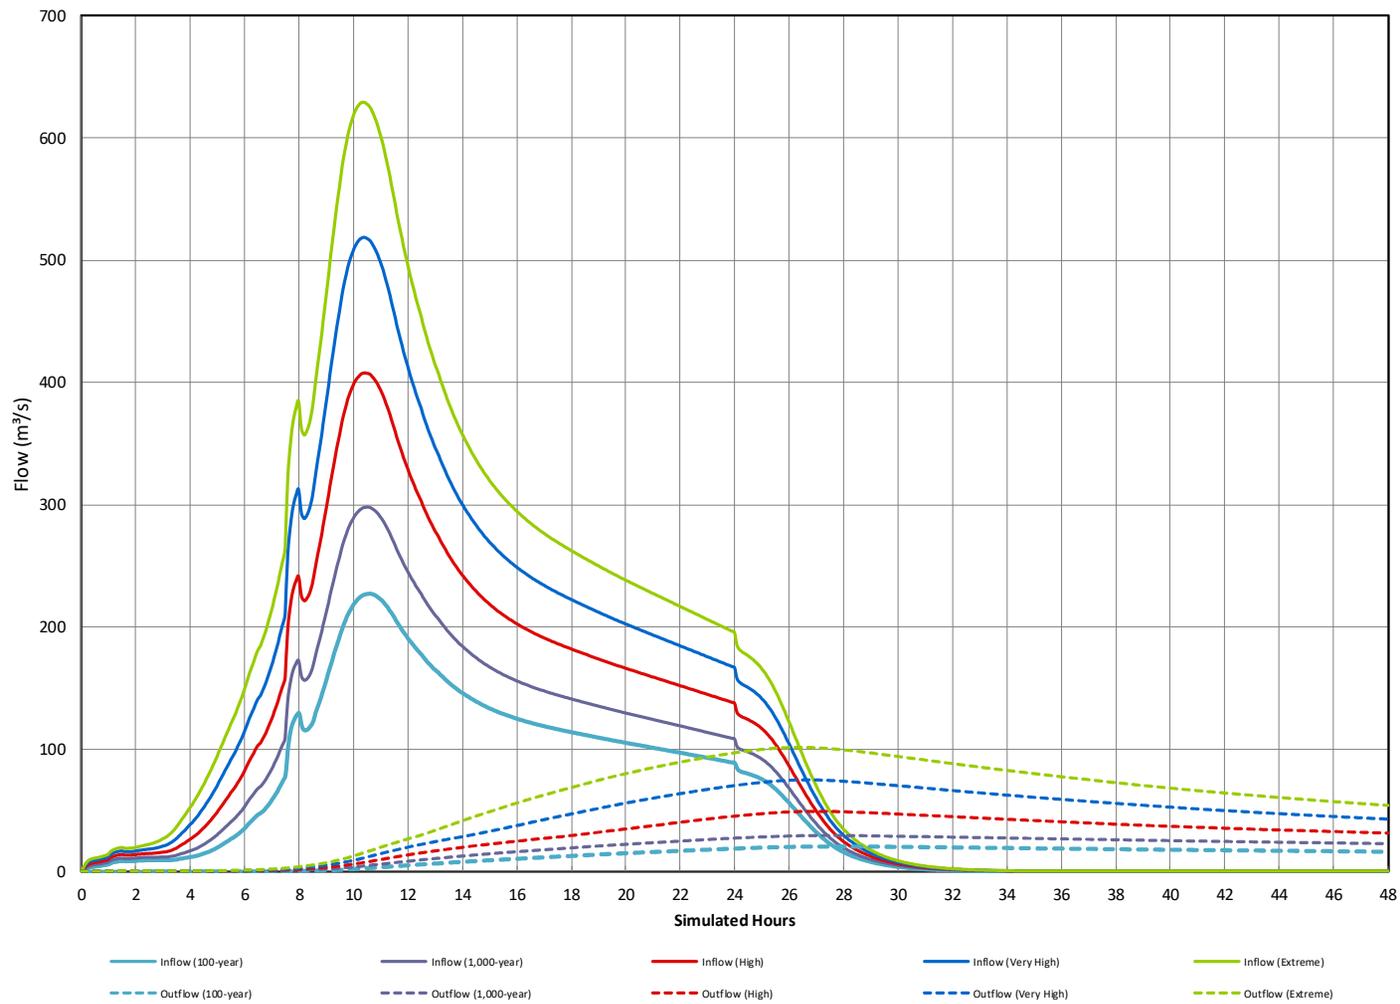
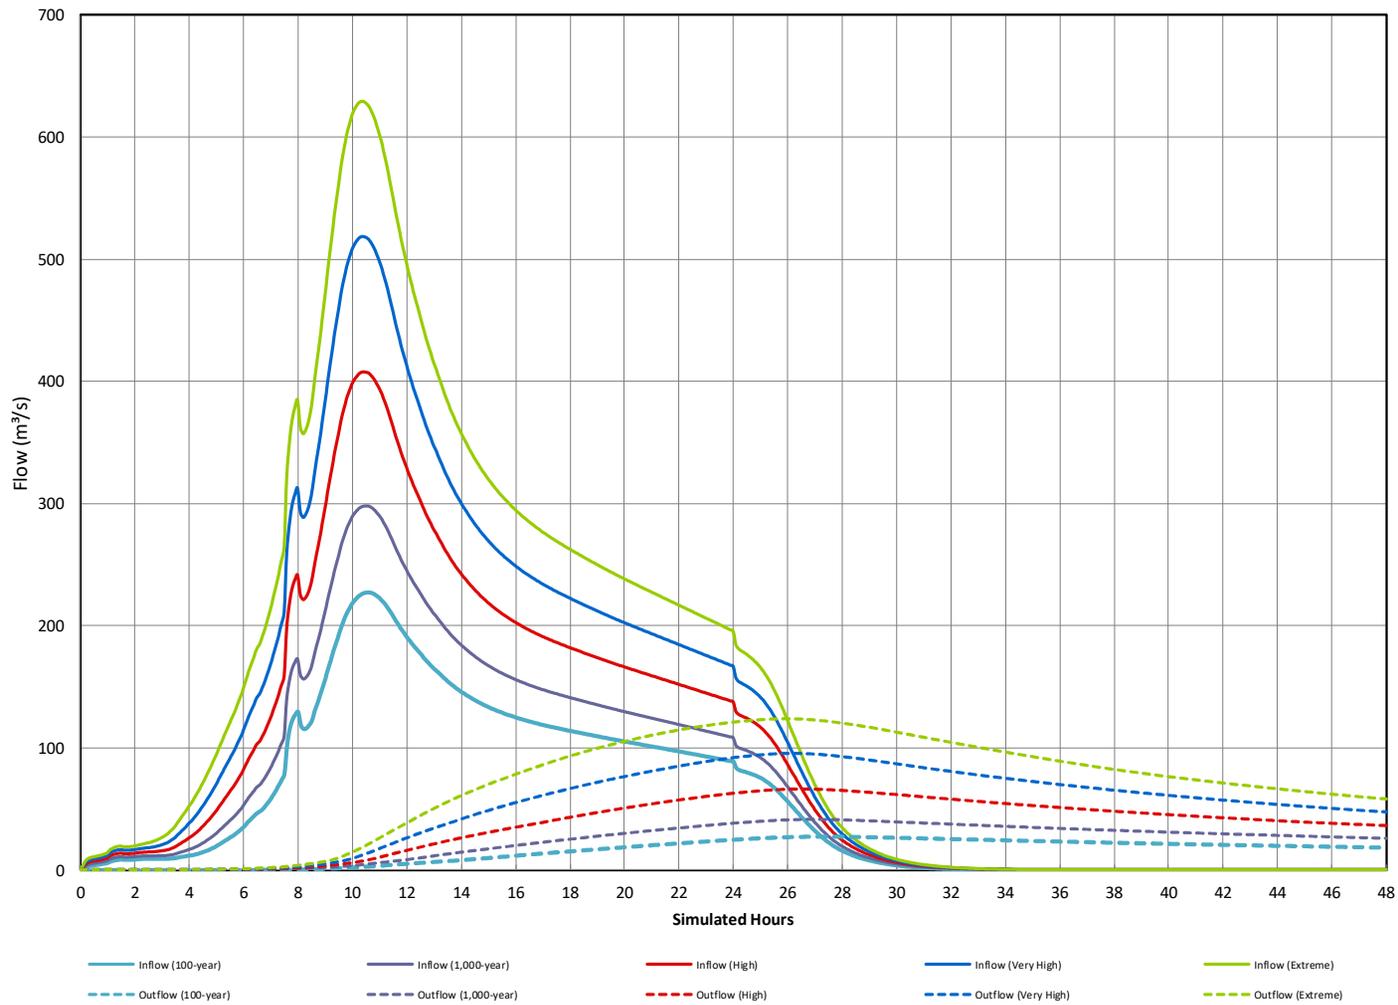
Figure 9.5c

The flood routing was performed using the HEC-HMS model, which includes a routing component for flows through reservoirs. Two scenarios for flood routing were considered, namely, with the gate in the open and closed positions. The starting water surface elevation was assumed to be at the weir crest elevation of 115.1 m. The results of the HEC-HMS flood routing during the IDF corresponding to the “High” classification as well as other design flows are summarized in Table 9.5.a and Table 9.5.b. Table 9.5.a is for the gate in the open position and Table 9.5.b is for the gate in the closed position. Figures 9.5c and 9.5d represent the results of the flood routing graphically.

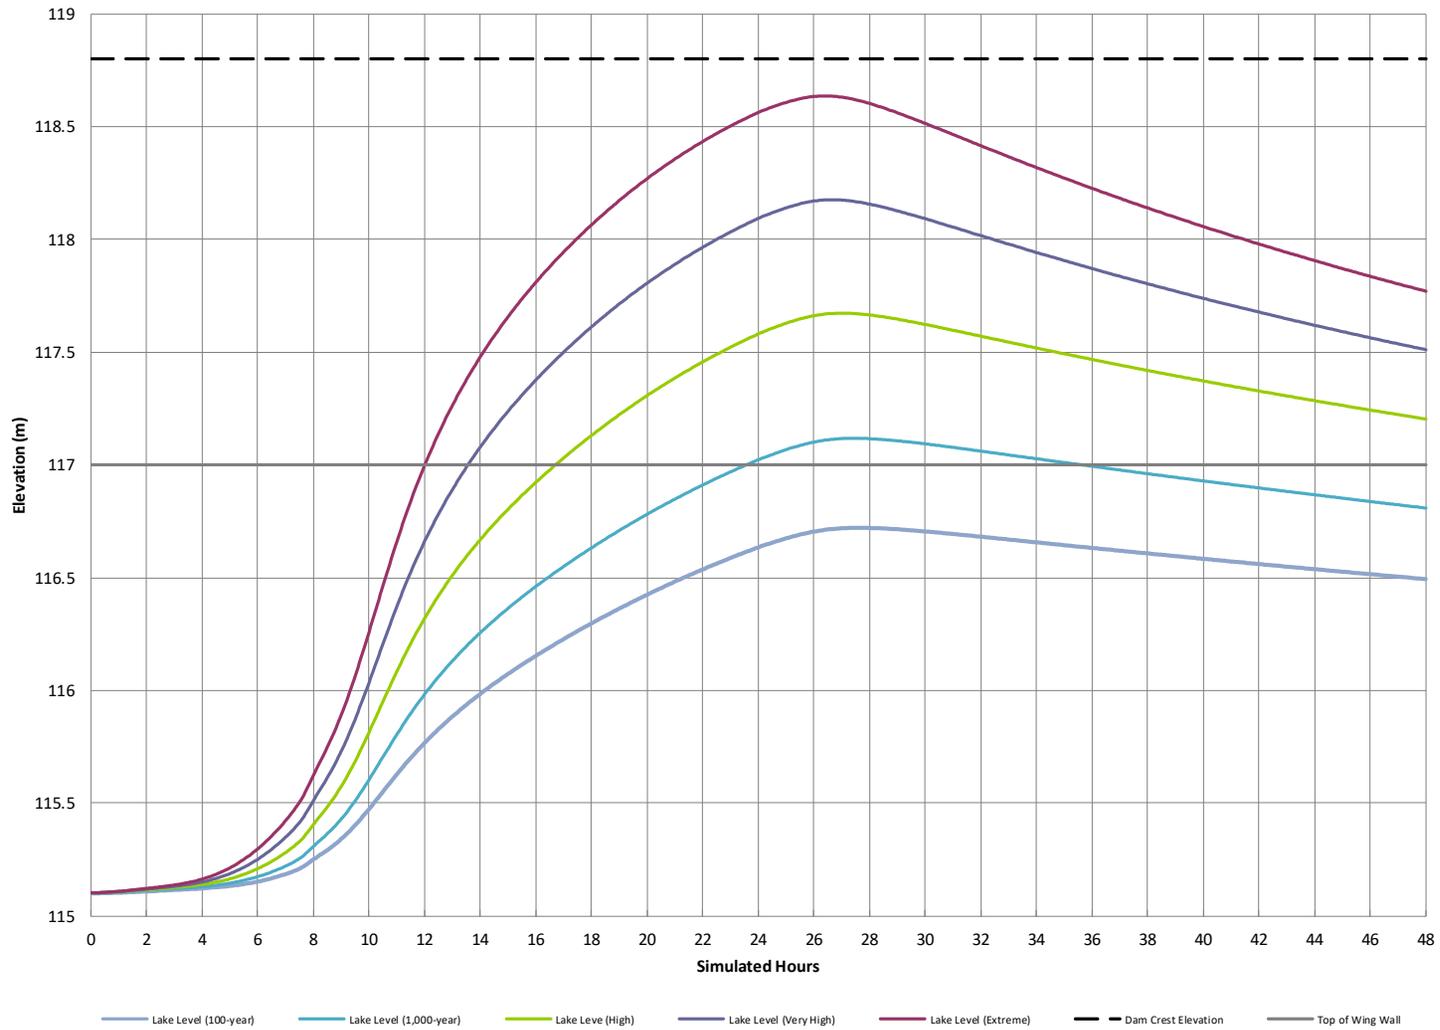
Figure 9.5e

The results above indicate that for the “High” consequences inflow design flood there is no overtopping of the dam. The lake level response from the IDF for the open and closed scenarios are shown in Figures 9.5e and 9.5f. Peak outflows would reach 66.5 m³/s during the “High” consequences IDF. Note that the “Significant”, “Very High” and “Extreme” results are included for comparison only, as it is considered that “High” is the appropriate classification.

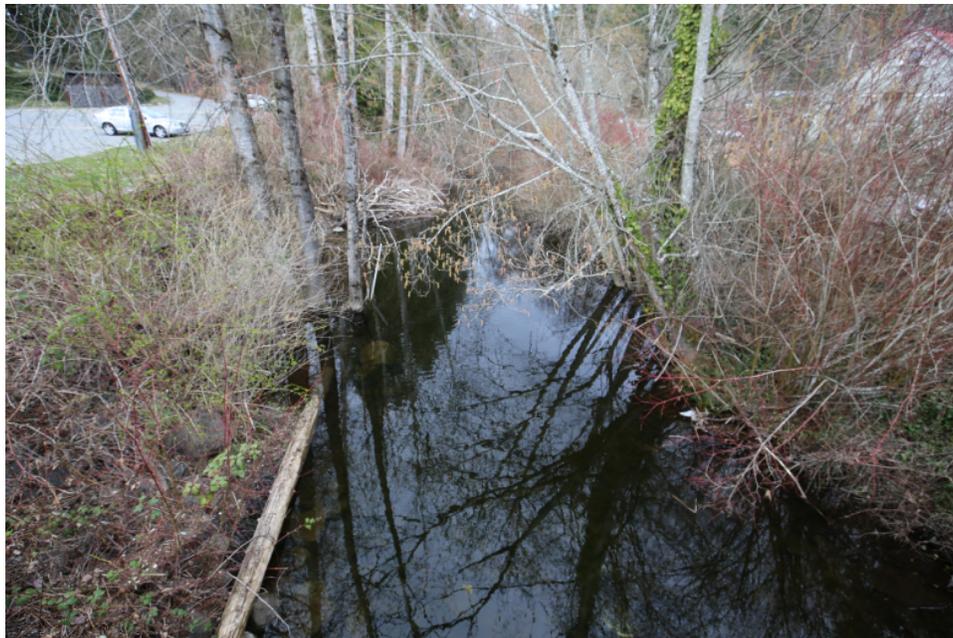
Photo 2 Shawnigan Creek looking downstream from Renfrew Road bridge.

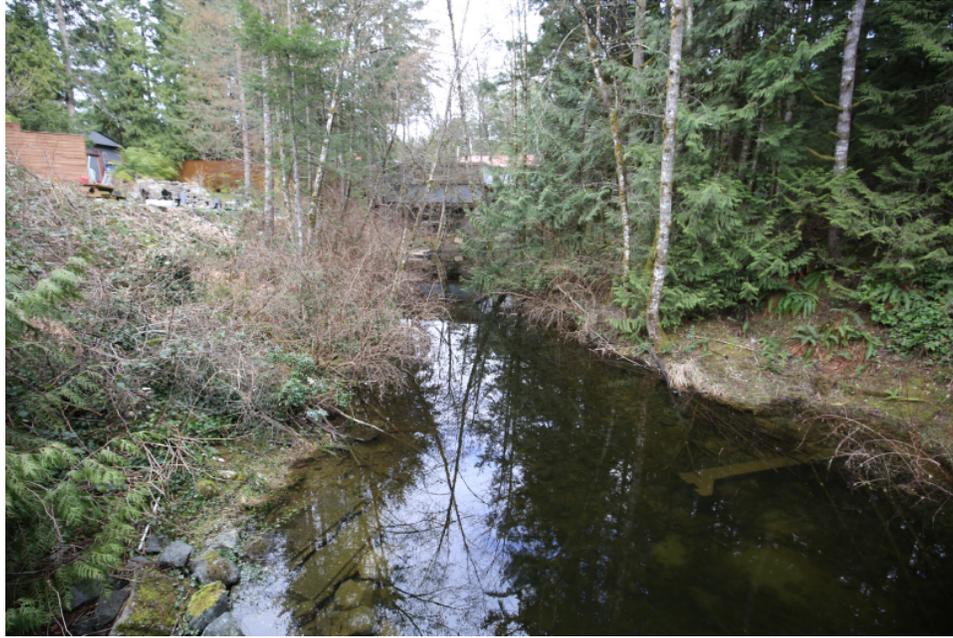
Photo 3 Shawnigan Creek upstream of weir.

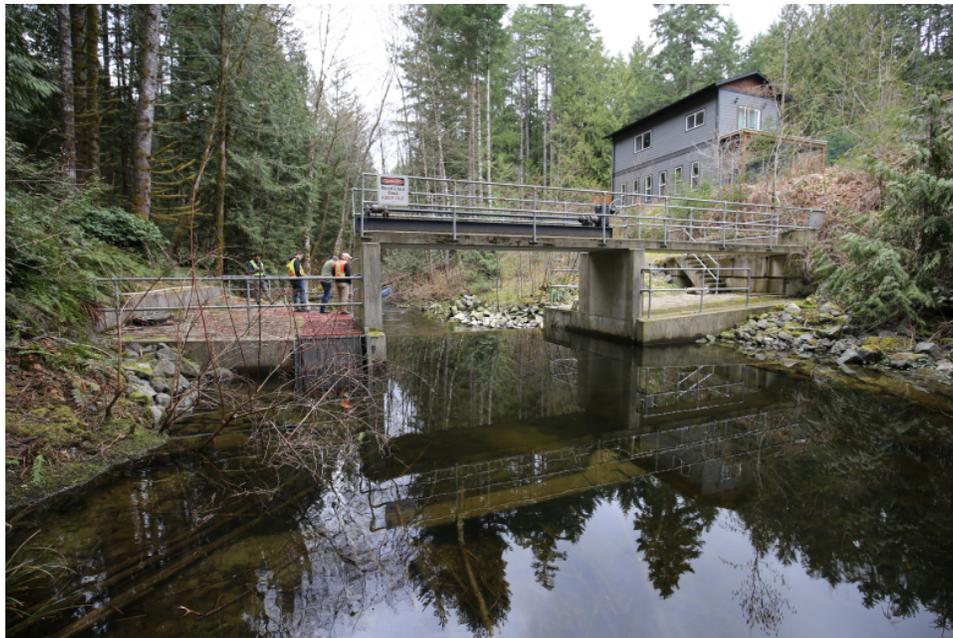
- The weir structure is located downstream of the outlet of the lake;
- Residential properties are located in close proximity to the structure (Photo 4);
- The weir incorporates a fishway on the left side of the structure (Photo 5);
- The flywheel on the gate hoist is locked in place with a lock and chain (Photo 9);
- The hoist can be accessed by a walkway on the right side of the dam and by a ladder on the left side of the dam (Photos 17 & 18);
- Riprap has been placed on the downstream sides of the structure (Photo 19); and
- Some erosion at downstream end, no displacement of riprap noted.

Photo 4 Upstream view of the structure.

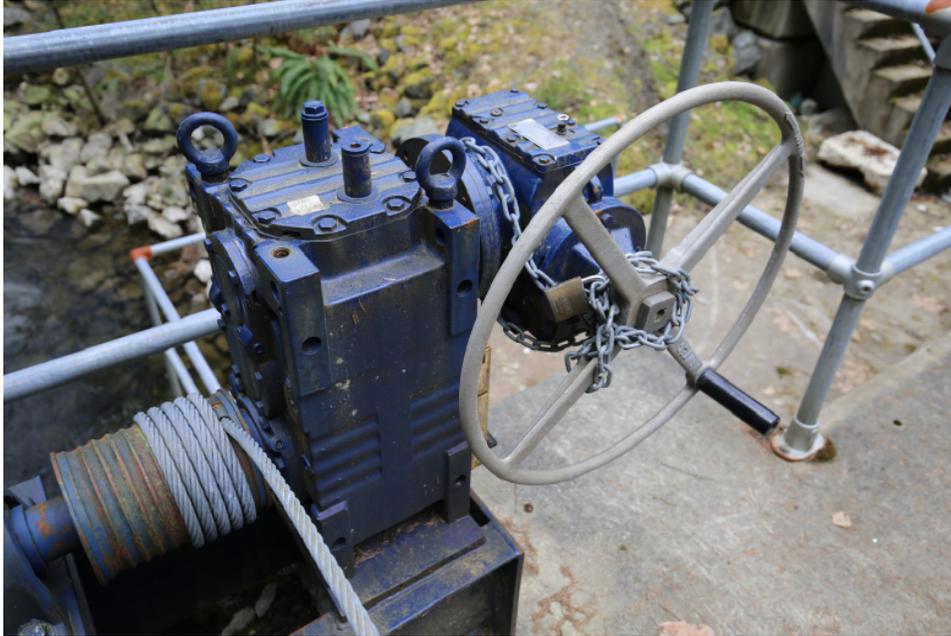
Photo 9 Cable reel hand crank. Locked in place.

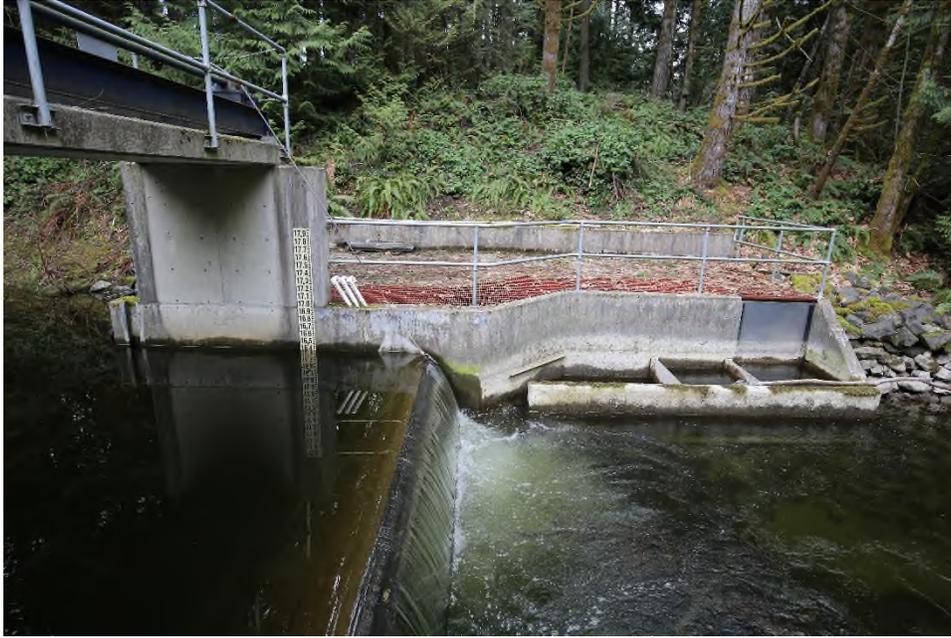
Photo 15 Left side of the weir as viewed from the right.

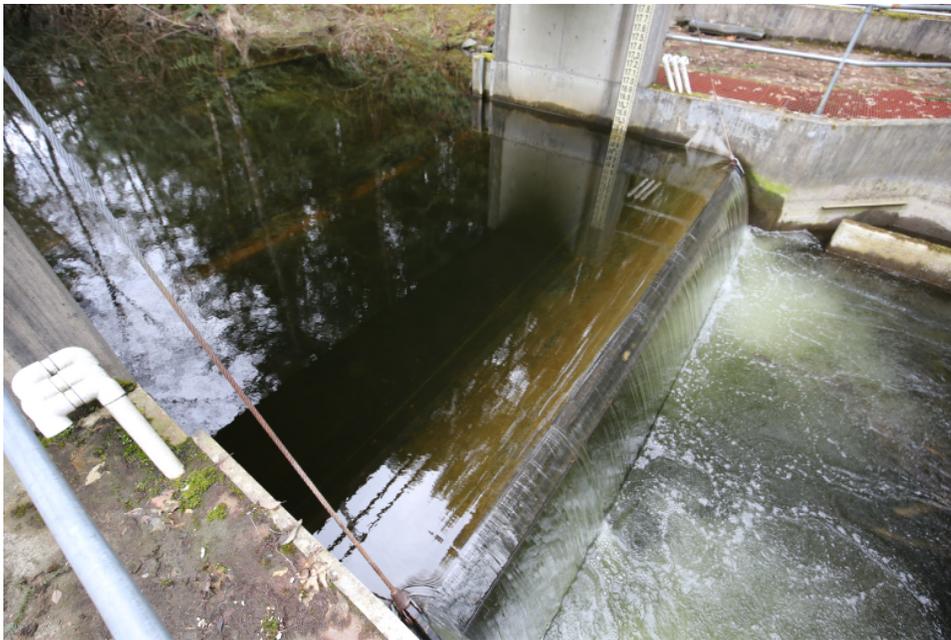
Photo 16 Weir/gate at the center of the structure.

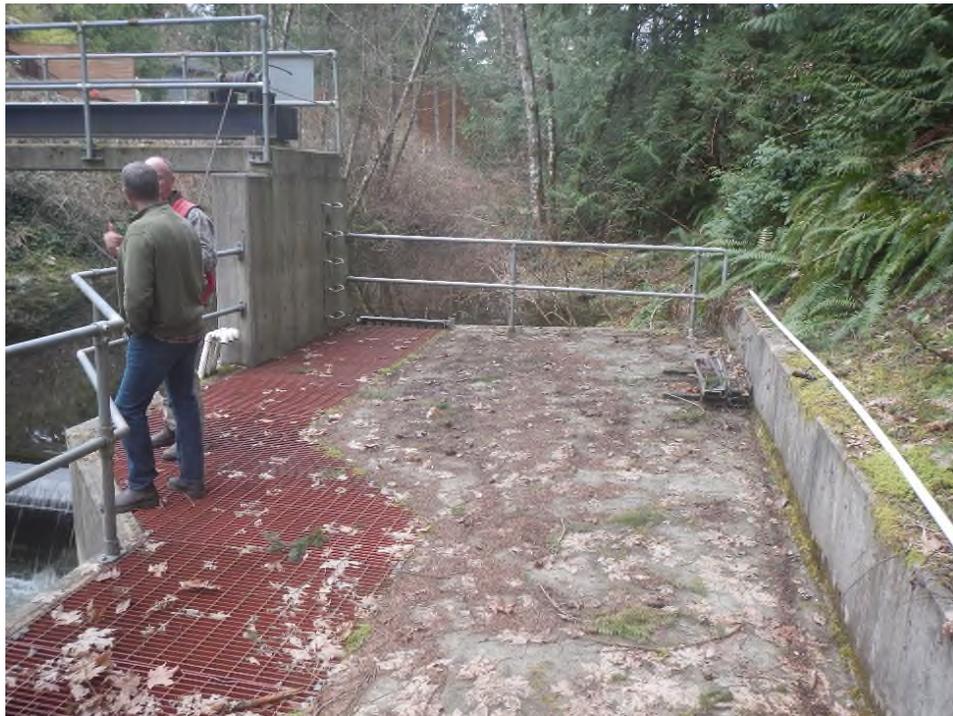
Photo 18 Platform at the left side of the weir.

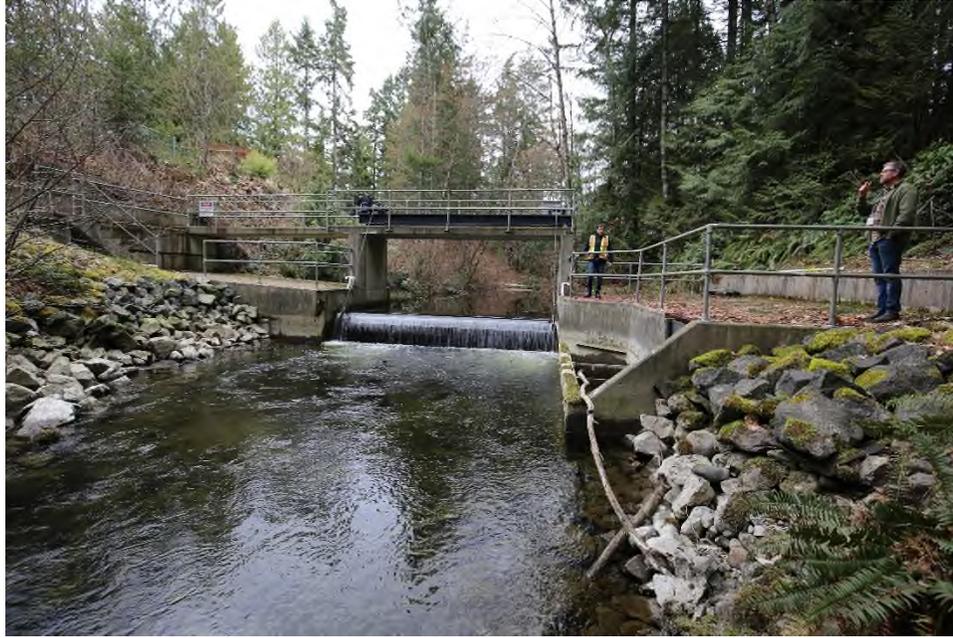
Photo 19 Downstream face of the weir structure.

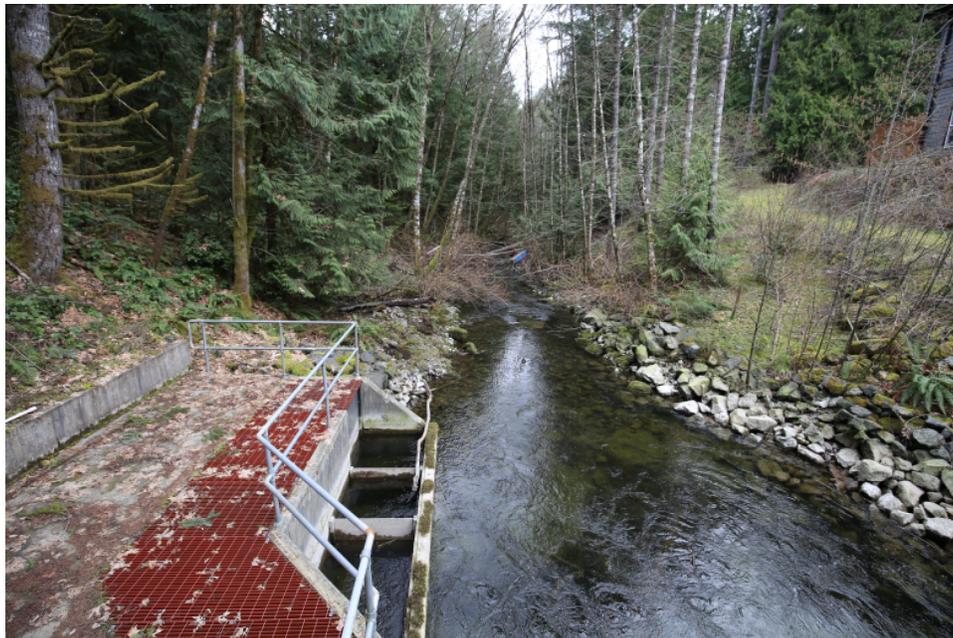
Photo 20 Shawnigan Creek downstream of Shawnigan Lake Weir.
