Dam Safety Review and Risk Assessment of Stocking Lake Dam

November 2018

GK-18-020-CVD

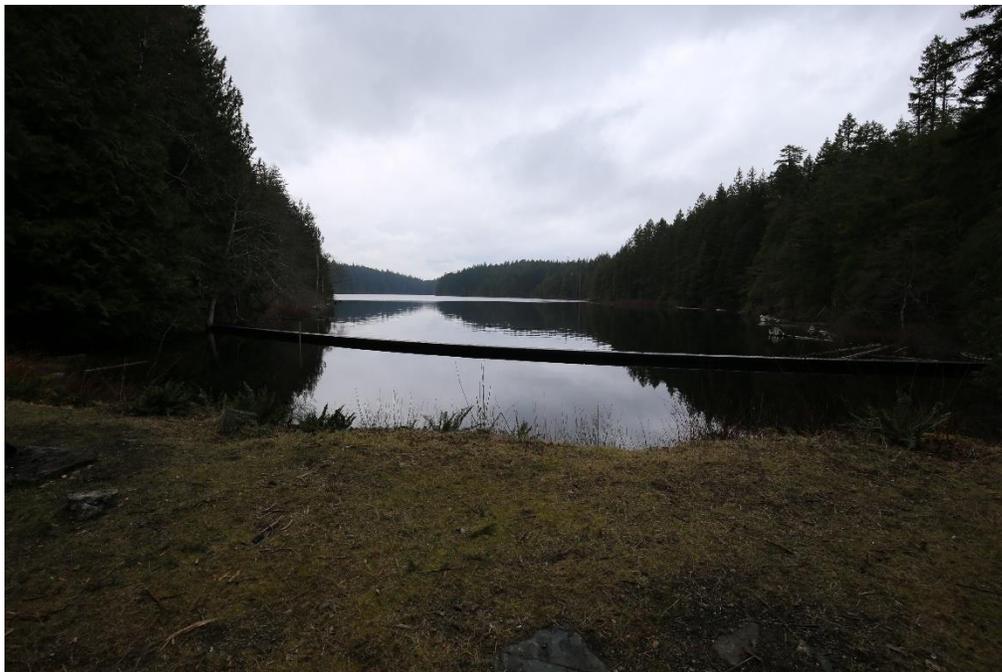
Photo 1 Stocking Lake Dam, January 17, 2018

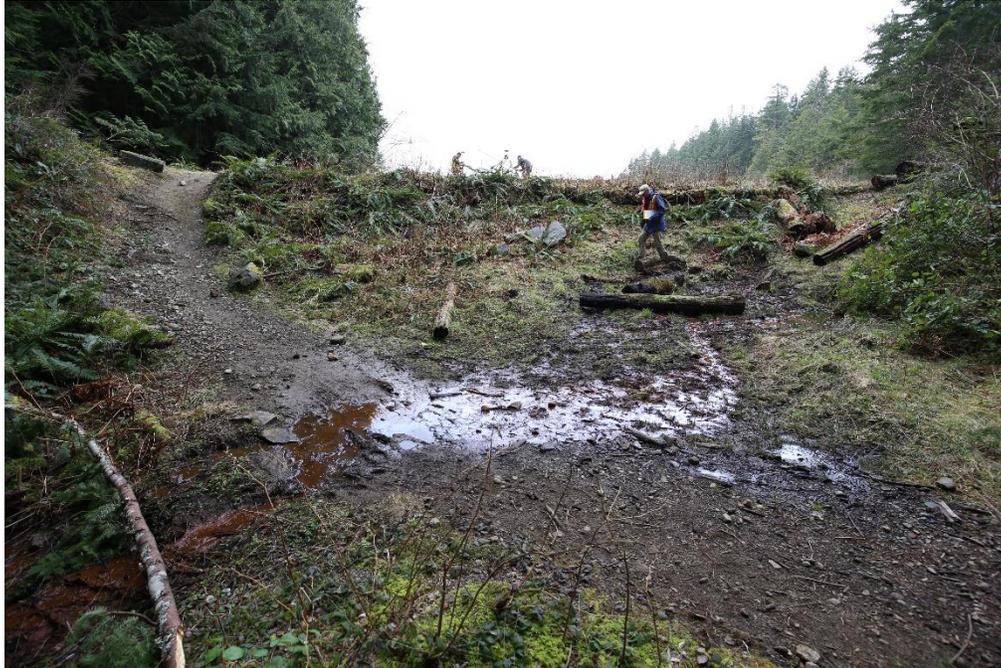
Photo 2 Stocking Lake Dam, March 29, 2018

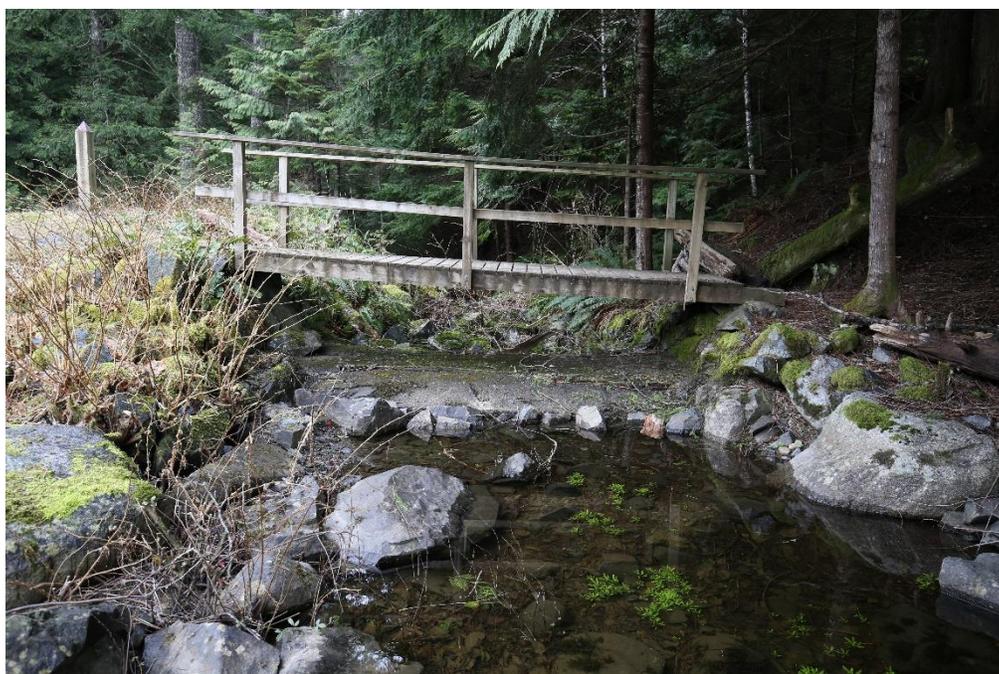
Photo 5 Spillway channel, January 17, 2018

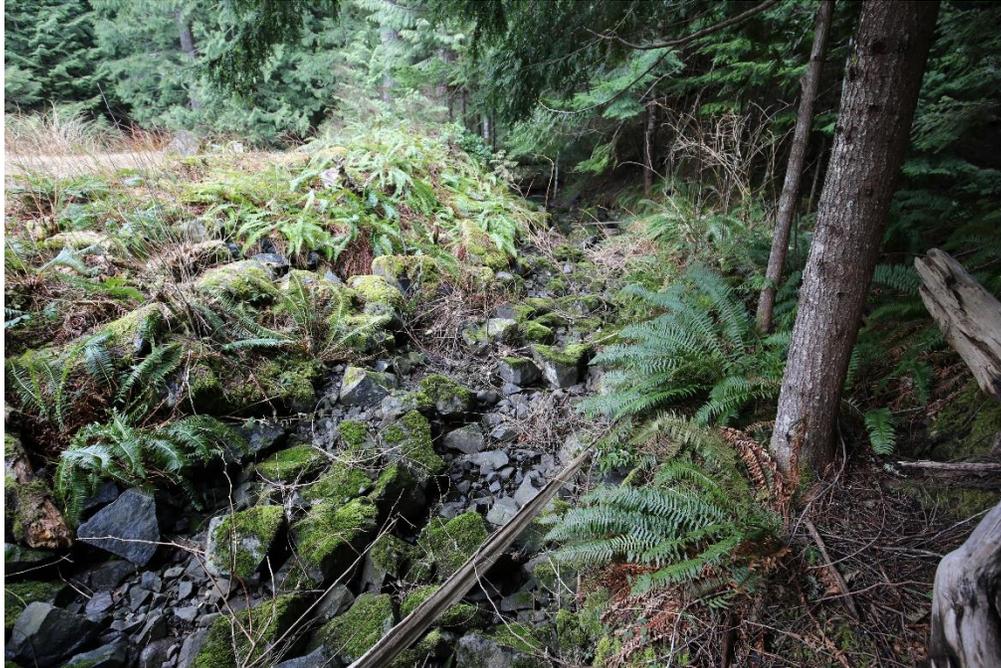
Photo 6 Spillway channel, March 29, 2018

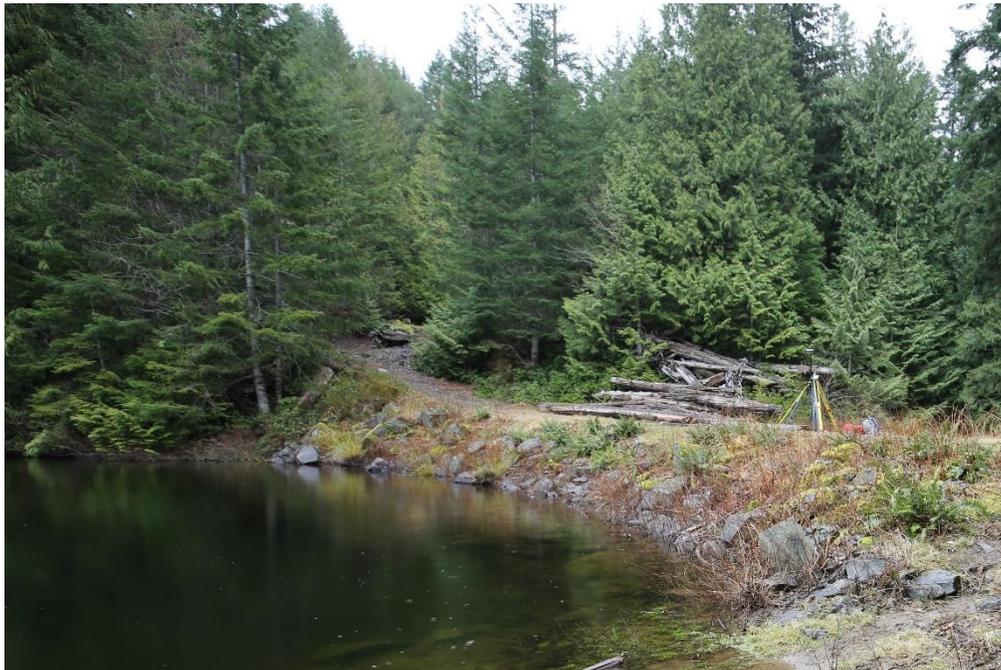
Photo 11 Dam crest wider than design drawings

Dam Crest	Crest is noted to be wider than indicated on design drawings.		
Spillway	Debris was noted to be in the spillway at the time of inspection.		
Spillway	Measured to have 4.7 m top width, approximately 0.8 m deep and have a bottom width of 4 m.		
Downstream Face	Rip-rap, 0.4 – 0.7 m in size, extends to toe of dam.		
Downstream Face	Sign locate at base of dam in the spillway channel.
